GROUP <b>Safety Recall Campaign</b>	MODEL <b>2006~2012MY Sedona (VQ)</b>
NUMBER <b>SC100 (Rev 2, 03/06/2014)</b>	DATE <b>December 2013</b>

**SUBJECT:** FRONT LOWER CONTROL ARM INSPECTION, REPLACEMENT  
OR APPLICATION OF PREVENTATIVE ANTI-CORROSION MATERIAL (SC100)

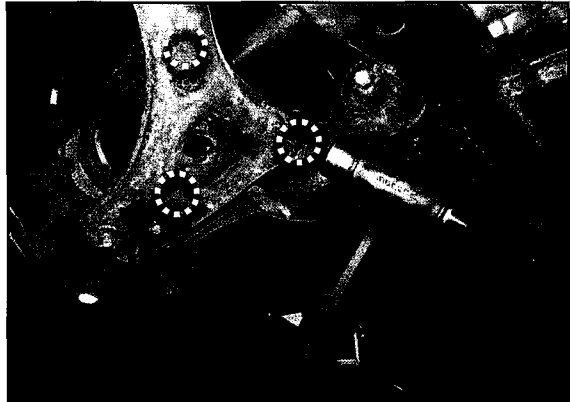
2. Use a hammer to strike the lower control arm at multiple spots. Check for weak spots in the metal and overall integrity of the lower control arm. If the lower control arm fails, proceed to the Service Procedure on Page 5. If overall integrity is confirmed, proceed to step 3.

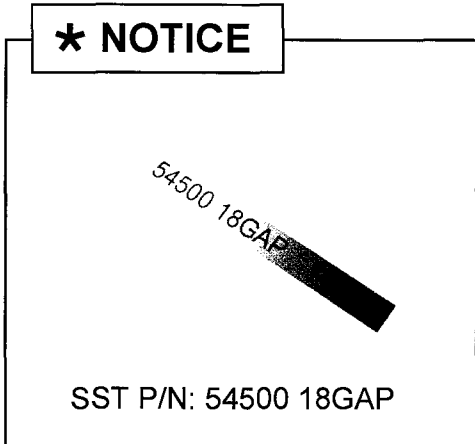
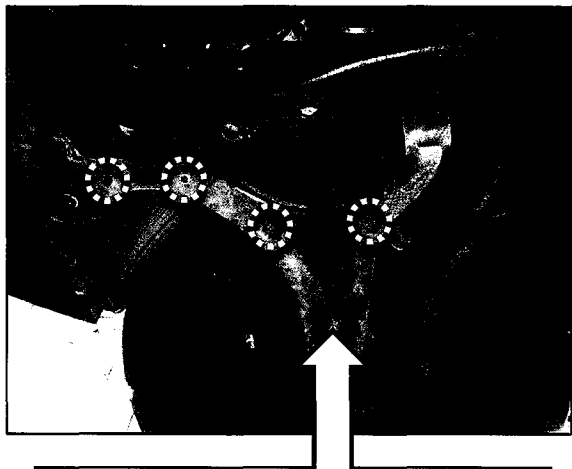
- 5. After removing all loose rust flakes from inside the lower control arm, use the SST gauge (see below) to check the material thickness at all holes in the lower control arm, as shown.

- 6. If the gauge can be inserted over the material's edge, proceed to the Service Procedure on Page 5.
- 7. If the gauge cannot be inserted over the material's edge, and the lower control arm passed the visual inspection and the hammer strike test, proceed to the Reconditioning Procedure on Page 8.
