PRODUCT SAFETY RECALL

SUBJECT: Power Seat Wiring Harness Chafing

MODELS: 2013 Chevrolet Malibu
Equipped with 8-Way Power Front Seat Feature (AG1/AG2) and without
Memory Seat Feature (A45)

GM Recall #13342

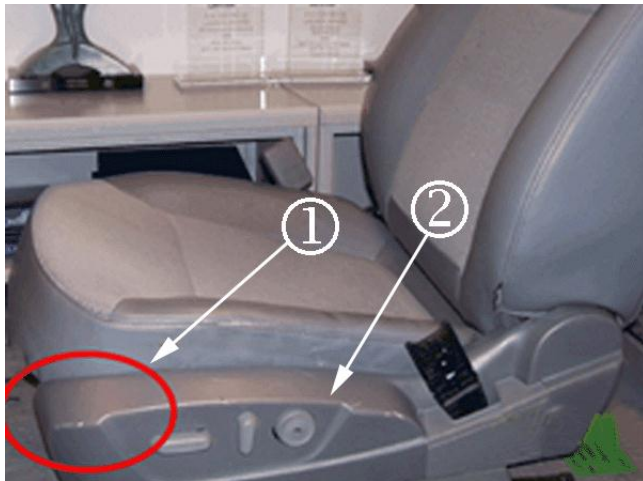
3642508

Note: On certain 2013 model year Malibu vehicles with the non-memory power seat option, the wiring harness may wear against the seat frame. Inspect the seat wiring harness on vehicles equipped with driver seat RPO AG1-A45 or passenger seat RPO AG2. Wire harness abrasion occurs at the forward, outboard frame on either driver or passenger seat. Refer to the photograph to review the area (1) to examine.

1. Determine if the driver and/or passenger seat must be inspected by reviewing seat RPO information.
2. Remove the driver and/or passenger seat outer recliner finish cover (2). Refer to *Driver or Passenger Seat Outer Recliner Finish Cover Replacement* in SI.

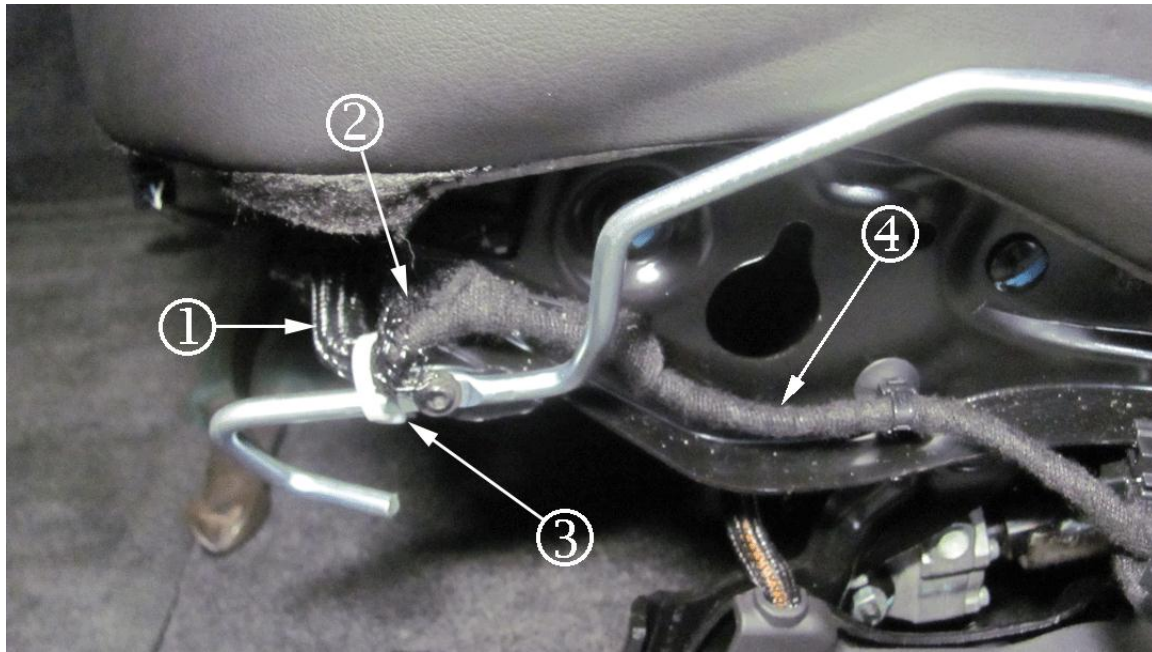
3642534

3. Examine the seat wiring harness (4) to determine if it has a harness protector (1), tie strap (3) and Velcro tape patch (2) on the front edge of the seat frame.
 - If the harness protector, tie strap and Velcro tape patch are present, no further action is required. Install the driver and/or passenger seat outer recliner finish cover. Refer to *Driver or Passenger Seat Outer Recliner Finish Cover Replacement* in SI.
 - If the harness protector, tie strap and Velcro tape patch are NOT present, proceed to step 4.
4. Inspect the seat wire harness wrapping for damage. If the wiring insulation becomes worn or cut through to the conductor a short to the grounded seat frame may occur. Repair wire harness, if necessary. Refer to the appropriate wire repair procedures in SI.
