# Safety Recall

Code: 97Z9

Subject: 2009-2011 MY Tiguan  
Fuse (Plug-In Position F16)

January 3, 2014

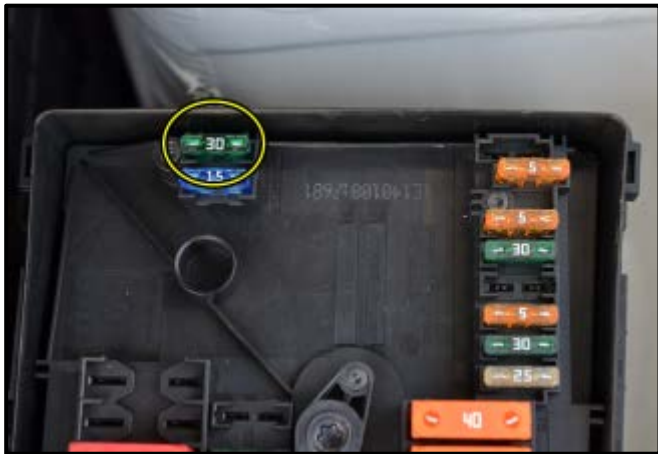
- ⇐ Remove the fuse from position F16 <arrow>.
- Inspect the F16 fuse slot on the fuse panel for any visible damage.

- If any visible damage is found, Service Manager or Shop Foreman MUST sign off on repair order. Proceed to Section D, Fuse and Fuse Panel Replacement.

Tip: Permissible damage for replacement of the fuse panel is limited to the F16 location. Any other physical damage to the fuse panel is not covered by this action.

- If no visible damage is found, proceed to Section C, 30A Fuse Replacement
