# Safety Recall

Code: 97Z9

Subject: 2009-2011 MY Tiguan  
Fuse (Plug-In Position F16)

January 8, 2014

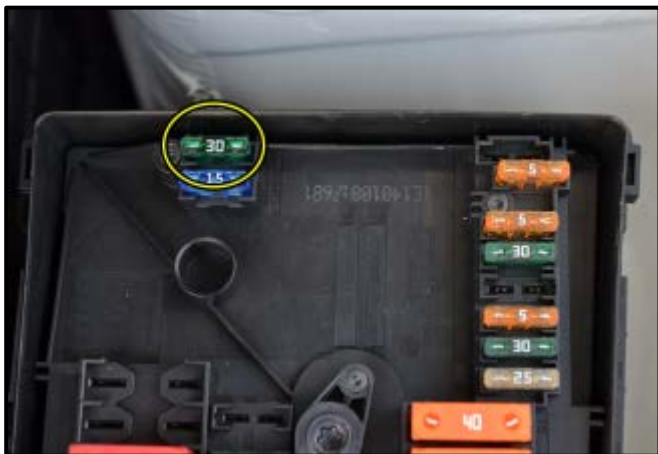
- ⇐ Remove the fuse from position F16 <arrow>.
  - Inspect the F16 fuse slot on the fuse panel for any visible damage.
  - **If no visible damage is found, proceed to Section C, 30A Fuse Replacement**
- OR
- **If any visible damage is found, Service Manager or Shop Foreman MUST sign off on repair order. Proceed to Section D, Fuse and Fuse Panel Replacement.**

Tip: Permissible damage for replacement of the fuse panel is limited to the F16 location. Any other physical damage to the fuse panel is not covered by this action.
