**RE: Defect Information Supplemental Report No. 2
13V-605, FL-655, Sterling Bullet Left Tie Rod Ends
Representative Interim Dealer Notice**

April 2014
FL655
NHTSA #13V-605
Transport Canada #13-423
INTERIM RECALL BULLETIN

Subject: Sterling Bullet Left Tie Rod Ends

Models Affected: Specific Sterling Bullet vehicles manufactured October 15, 2007, through November 10, 2008.

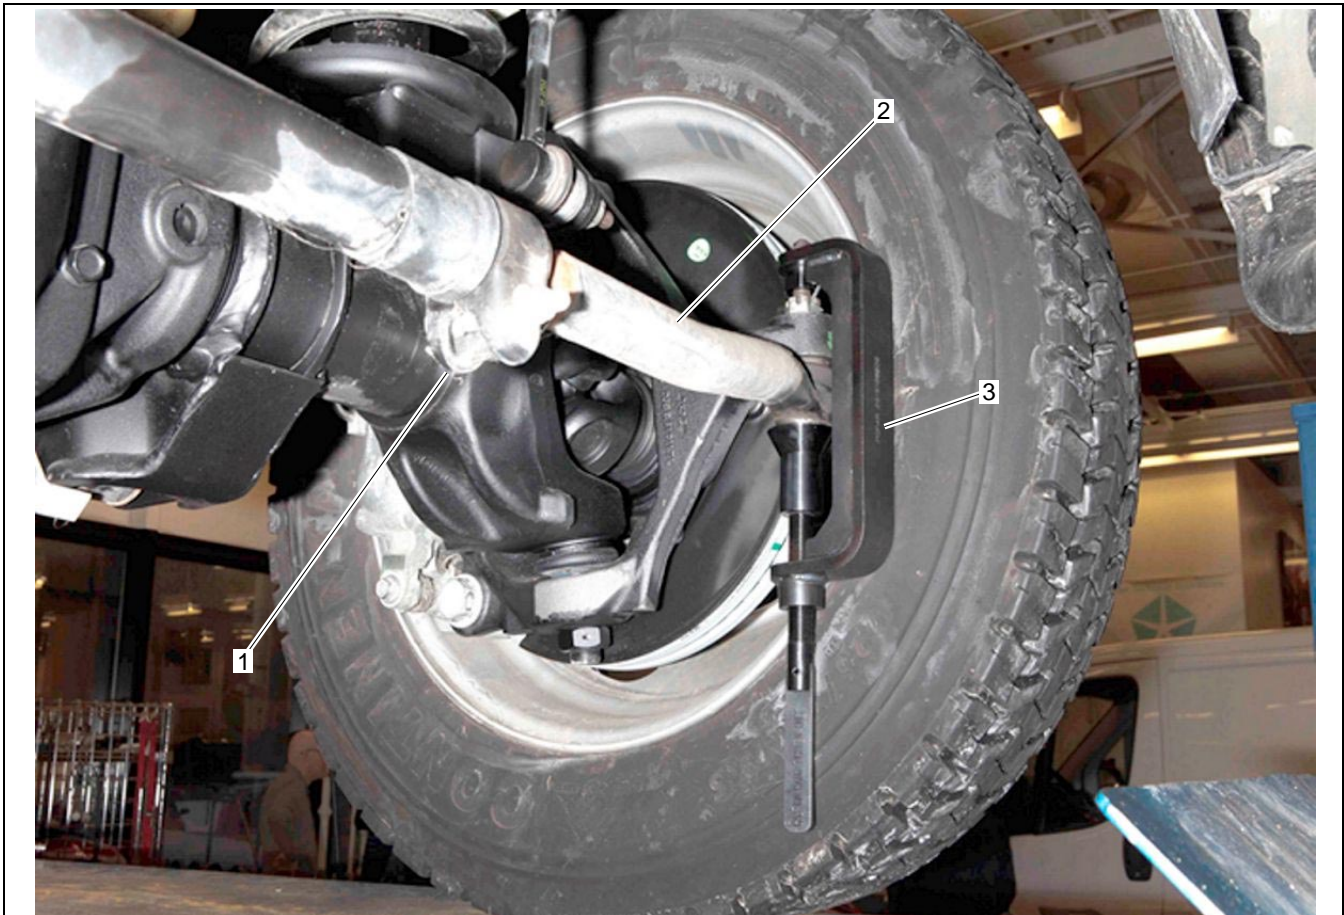
Fig. 1, Left Tie-Rod Alignment

If the bottom face of the tie rod is flush against the tool, the tie rod is properly aligned—remove the special tool and go to the last step in these instructions.

If the bottom face of the tie rod is not flush against the tool, go to the "Tie Rod Replacement and Alignment" section of these instructions.

1. Park the vehicle on a drive-on type hoist with the front wheels in the straight ahead position, shut down the engine, and set the parking brake. Chock the tires.
2. Install special tool 2015100020 hand-tight onto the left tie rod as shown in **Fig. 1**.

19. Set the toe and center the steering wheel following the alignment rack manufacturer's instructions.
20. Install special tool 2015100020 onto the left tie rod as shown in **Fig. 1** and hand-tighten it until the bottom face of the tie rod is flush against the tool.

21. Tighten the left tie rod adjuster clamp nut and bolt to 66 lbf·ft (90 N·m).
22. Remove the special alignment tool from the left tie rod.
