SR13-93 IMMI Retractable Shoulder Belt Difficult to Unlatch

## SAFETY RECALL

**SR13-93**

| SUBJECT: | IMMI Seat Belt may be difficult to unlatch | | |

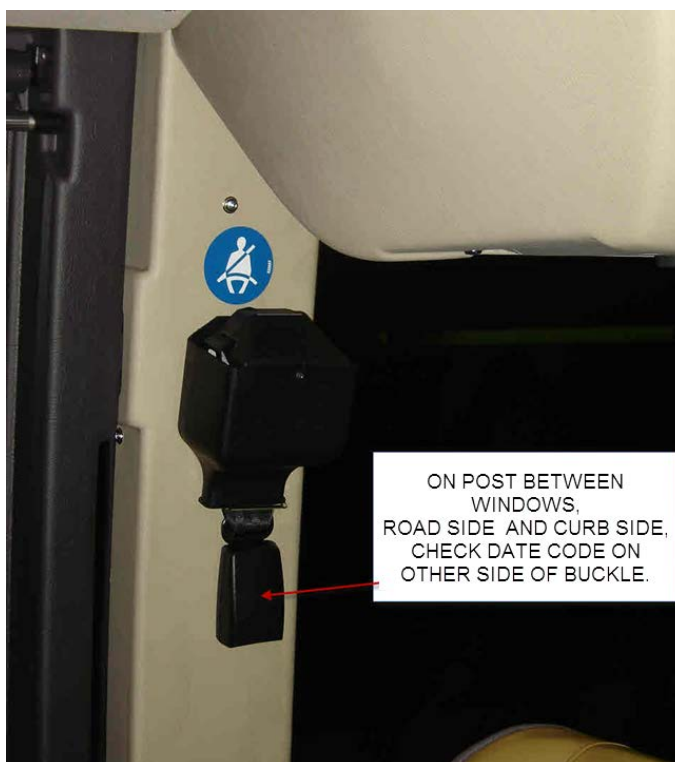
Locate the side-wall mounted retractable shoulder belts in the vehicle.  
Check the date code on the other side of the buckle.

Two suspect date code ranges are involved:

**13220 through 13256**

AND

**214 13 through 256 13.**

If the buckle date code is within either of the ranges above, replace the part.

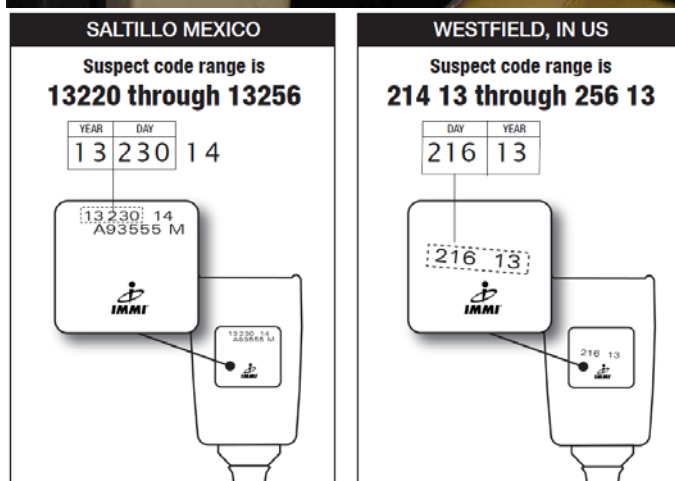
*If the date code does NOT fall within either range, do NOT replace the part.*

Select the retractable shoulder belt in assembly #864813.

Install on wall.

Torque belt anchor to 27 lbf-ft
