# ***SERVICE PROCEDURE***

**13519  
FEBRUARY 2014**

**SUBJECT: NON-COMPLIANCE RECALL**  
**Driver seat belt buckle on certain AE, BE, CE, and RE school bus models built 8 August 2013 thru 14 November 2013 having certain IMMI seat belt assemblies with L9 end-release seat belt buckles**

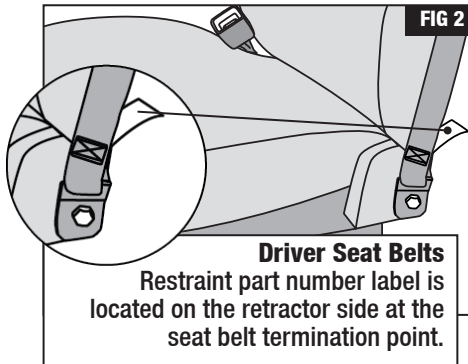
### Driver Seat Belts

1. Inspect date code on back of driver buckle on identified vehicles. See instructions on the right.
2. Note restraint part number for any buckles that fall within suspect date code range.
3. **IF** you have buckles that fall into the date code range, then gather restraint part numbers (FIG 2) and total quantities for ordering replacement buckles from IMMI.

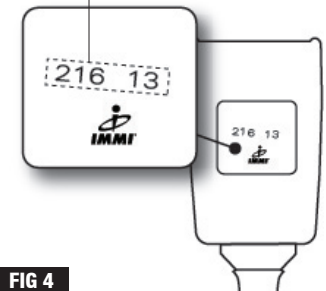
3. Find the buckle assembly date code on the back housing of the buckle. (FIG 3 and 4)
4. There are 2 different date code formats as illustrated below. (FIG 3 and 4)

#### FORMAT 2

Suspect code range is  
**214 13 through 256 13**

5. If your buckle code is within either of the ranges above, follow instructions to order, then replace the buckle.
6. If your code does NOT fall within either range, you do NOT need to replace your buckle.
