14V-218
(3 pages)

NISSAN NORTH AMERICA, INC.

DEFECT INFORMATION REPORT

Certain 2014 Model Year Nissan Rogue vehicles manufactured in the Smyrna, TN plant from January 10, 2014 to January 17, 2014.

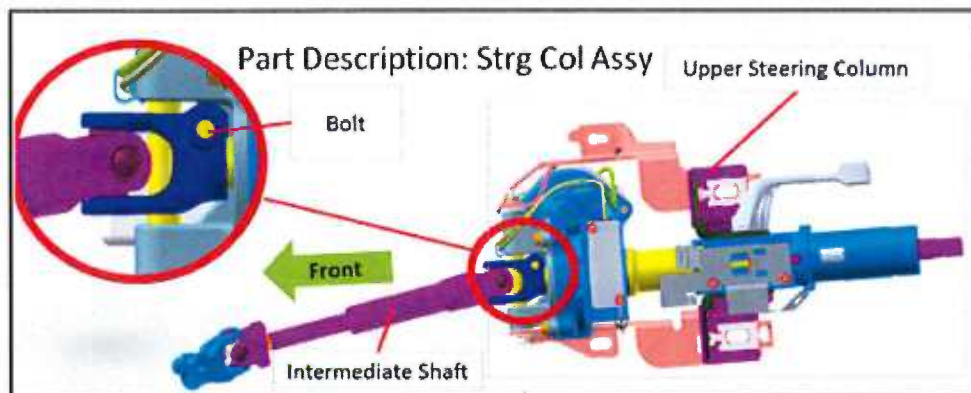
Figure 1 – Bolt location

Due to an isolated supplier parts delivery error, an incorrect bolt may have been used in connecting the intermediate shaft to the upper steering assembly in the subject vehicles (Figure 1).

The incorrect bolt contains a flange that engages the walls of the shaft, preventing it from reaching the proper torque specification when tightened. This may cause the joint to lose tension, allowing the bolt to loosen, which will create a rattle. If this is ignored, the bolt could eventually loosen further over time and fall out, potentially causing loss of vehicle control, increasing a risk of a crash.

Owners of all potentially affected vehicles will be notified to take their vehicle to a Nissan dealer. The dealers will inspect the steering column assembly. If an incorrect bolt is installed, the dealer will remove and reassemble the steering column assembly using the correct bolt.
