Recall Bulletin

PRODUCT SAFETY RECALL

SUBJECT: Front Axle Right Half Shaft Fracture

MODELS: 2013-2014 Chevrolet Cruze Equipped with 1.4L Turbo Engine (LUV)

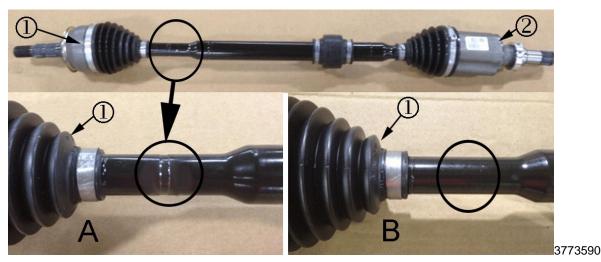
- 1. Raise and support the vehicle. Refer to Lifting and Jacking the Vehicle in SI.
- 2. Inspect the right (passenger side) half shaft near the front wheel. Determine if a machined groove is present on the half shaft.

(1) Wheel Side of Half Shaft (2) Transmission Side of Half Shaft (A) Machined Groove (B) No Groove

- If the machined groove is present (A) on the half shaft, no further action is required. Lower the vehicle.
- If the machined groove is NOT present (B) on the half shaft, proceed to step 3.
- 3. Inspect the right (passenger side) half shaft near the transmission. Determine if a green stripe is present on the half shaft.

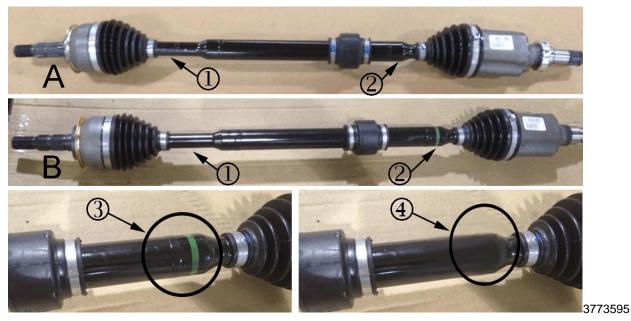
(1) Wheel Side of Half Shaft (2) Transmission Side of Half Shaft (A) Automatic Transmission (B) Manual Transmission (3) Green Stripe (4) No Stripe

• If a green stripe is present (3) on the half shaft, no further action is required. Lower the vehicle.

Note: Replace the half shaft if a blue stripe or no stripe (4) is present.

• If a green stripe is NOT present on the half shaft, replace the half shaft. Refer to *Front* Wheel Drive Shaft Replacement ---Right Side in this bulletin.
