GM CUSTOMER CARE AND AFTERSALES
DCS3212
URGENT - DISTRIBUTE IMMEDIATELY

Subject: 14079C – Safety Recall
Front Axle Right Half Shaft Fracture
Revised Service Procedure

Models: 2013-14 Chevrolet Cruze Equipped with 1.4L Turbo Engine (LUV)

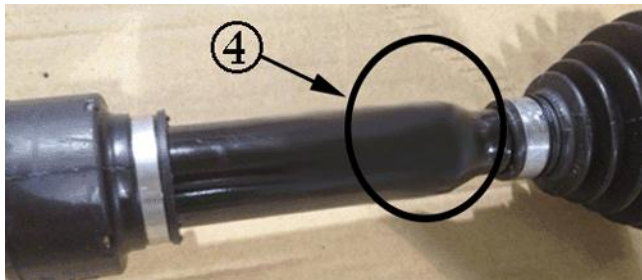
3802759

1. Inspect the inboard side of the shaft (shorter portion between rubber isolator and boot) for a green stripe, green dot or combination of green stripe and green dot.
 - If these markings are present, this is a good part.

- If there are no green markings on the inboard portion of the shaft (4) this part should be returned to General Motors under special return message G_0000187857 dated March 18, 2014 (US) or GMP 2014-073 dated March 17, 2014 (CN).

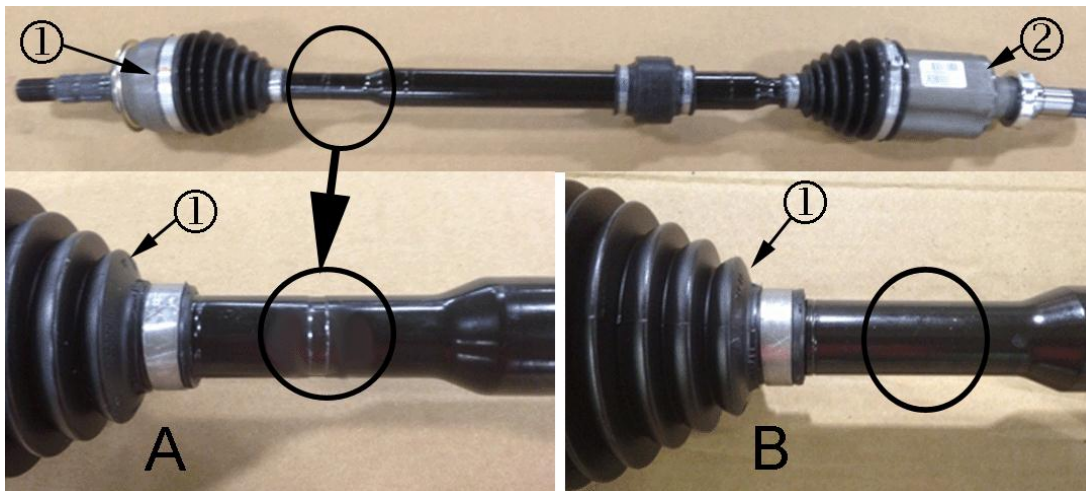
3773590

1. Inspect outboard side of the half shaft (longer portion of shaft between CV joint and isolator). Determine if a machined groove is present on the half shaft.
 - If the machined groove is present (A) on the half shaft, the part can be used for service.
 - If the machined groove is NOT present (B) on the half shaft, proceed to step 2.

2. Inspect the inboard side of the shaft (shorter portion between rubber isolator and boot) for a green stripe, green dot or combination of green stripe and green dot.
 - If these markings are present, this part can be used for service.
 - If no green strip, green dot, or green stripe and dot is present, this part should be returned to General Motors under special return message G_0000187857 dated March 18, 2014 (US) or GMP 2014-073 dated March 17, 2014 (CN).

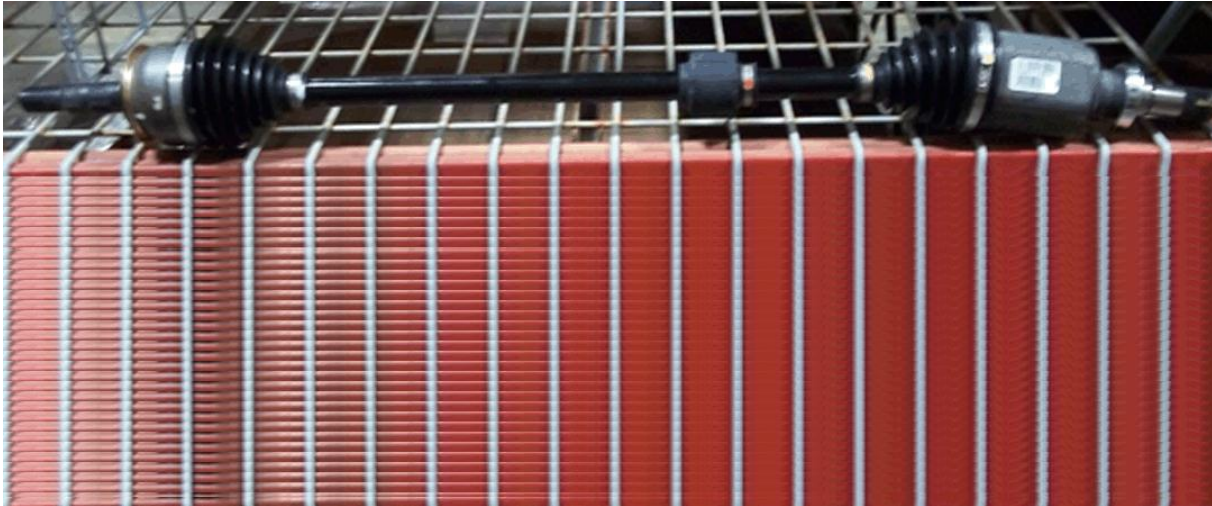
3802211

Note: Any additional paint marks found on this shaft can be disregarded.

1. Part can ONLY be used if the outboard side of the half shaft (longer portion of shaft between CV joint and isolator) is a solid painted bar shaft. Same diameter across entire shaft. There are no other identifications on the half shaft to look for.
 - If the part is a solid painted bar shaft, it can be used for service.
 - If part is a tubular non-painted bar shaft, then the half shaft assembly is to be scrapped from inventory.

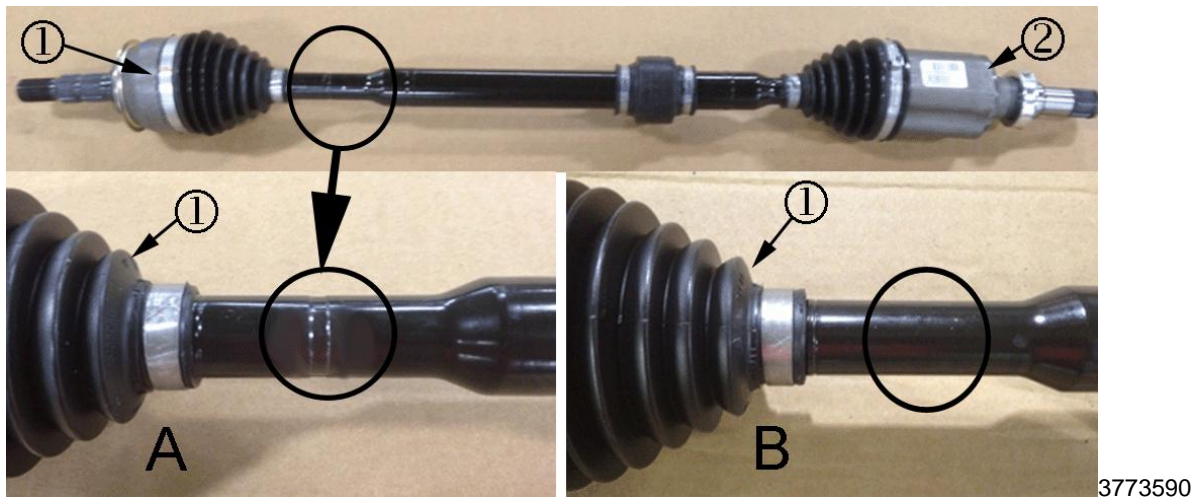
1. Raise and support the vehicle. Refer to *Lifting and Jacking the Vehicle* in SI.
2. Inspect the right (passenger side) half shaft near the front wheel. Determine if a machined groove is present on the half shaft.

- If the machined groove is present (A) on the half shaft, no further action is required. Lower the vehicle.
 - If the machined groove is NOT present (B) on the half shaft, proceed to step 3.
3. Inspect the right (passenger side) half shaft near the transmission. Determine if a green stripe, green dot, or green stripe and green dot is present on the half shaft bar.

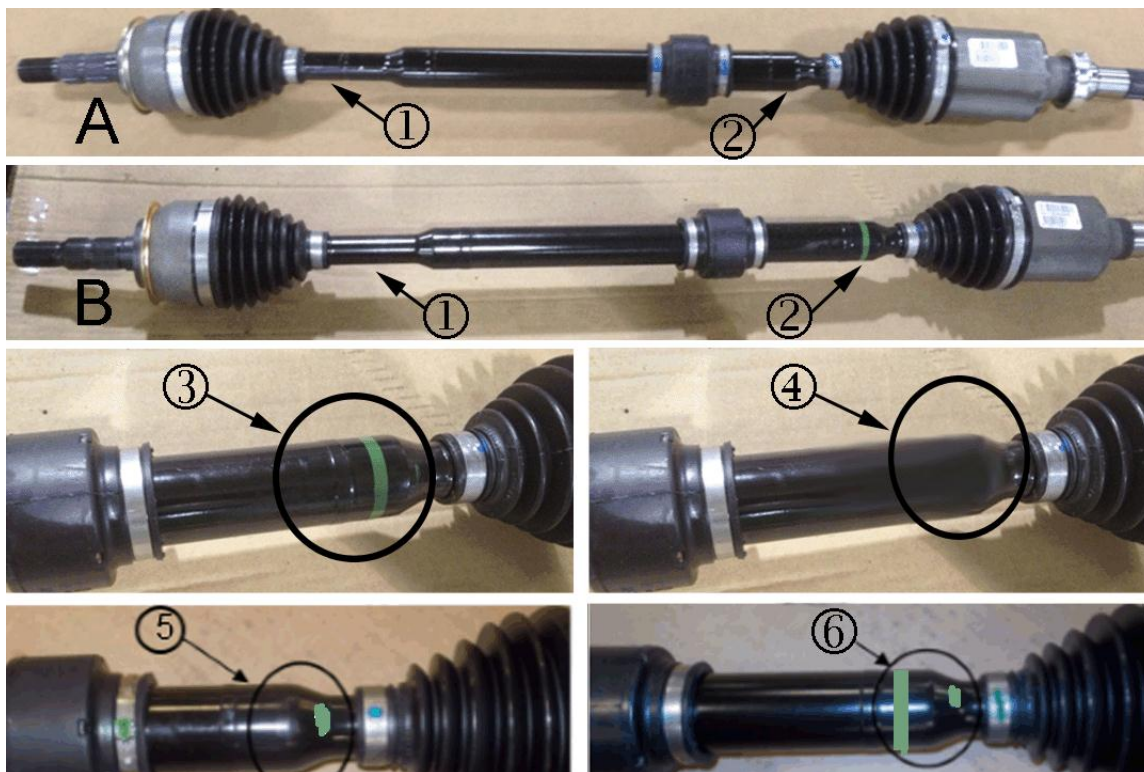
- If a green stripe, green dot, or a green stripe and green dot is present (3, 5, or 6) on the half shaft, no further action is required. Lower the vehicle.

Note: Replace the half shaft if a blue stripe, blue dot or no stripe (4) is present.

- If a green stripe, green dot or green stripe and green dot is NOT present on the half shaft, replace the half shaft. Refer to *Front Wheel Drive Shaft Replacement ---Right Side* in this bulletin.
