Re: 49 CFR Part 573; Recall of Mercedes-Benz Rear Seat Cushion ISOFIX Anchor Access

TO: Mercedes-Benz Dealer Principals, General Managers, Sales Managers, Service Managers, Parts Managers	FROM: Thomas Brunner, Department Manager, Vehicle Compliance and Analysis, Engineering Services
RE: Recall Campaign 2014040002- Replace Second Row 60% Seat Pan. Model X166 (GL). Model Year 2014	DATE: April 25, 2014

Campaign No. 2014040002, April 2014

SUBJECT: **Models X166 (GL), Model Year 2014**
Replace Second Row 60% Seat Pan

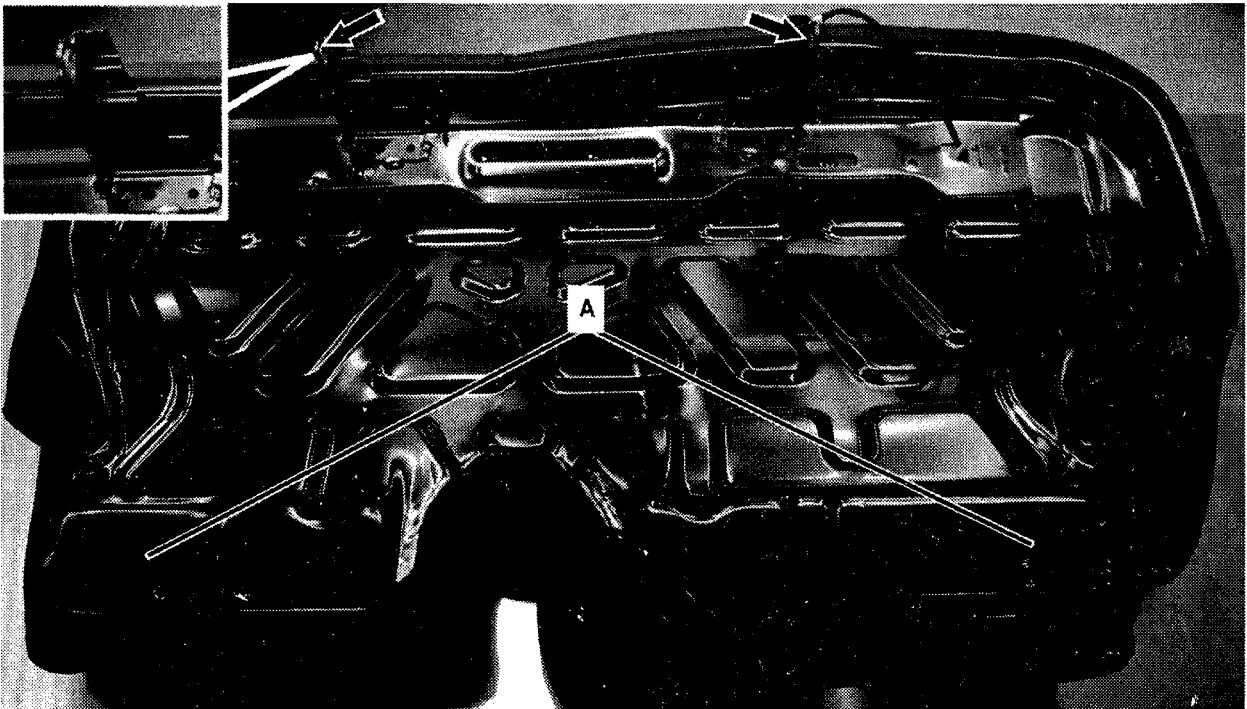
Figure 1

- Be sure to transfer grommets (A, Figure 1) and plastic sleeves with washers (arrows) from "old" seat cushion frame (pan) to "new" seat cushion frame (pan).
 - Reinstall cable tie mounting clip (attached to seat wiring harness) to new seat cushion frame (pan).
 - Secure seat wiring harness to new seat cushion frame (pan) with cable tie.
3.

Replace seat cushion frame (pan).

Assemble in reverse order.
