SUBJECT: 2001-2004 Tribute Front Subframe Corrosion - Safety Recall 7514D

2001-2004 TRIBUTE - FRONT SUBFRAME CROSSBRACE INSTALLATION

2001-2004 Tribute Subframe Corrosion - Safety Recall 7514D NHTSA Campaign No. 14V-174

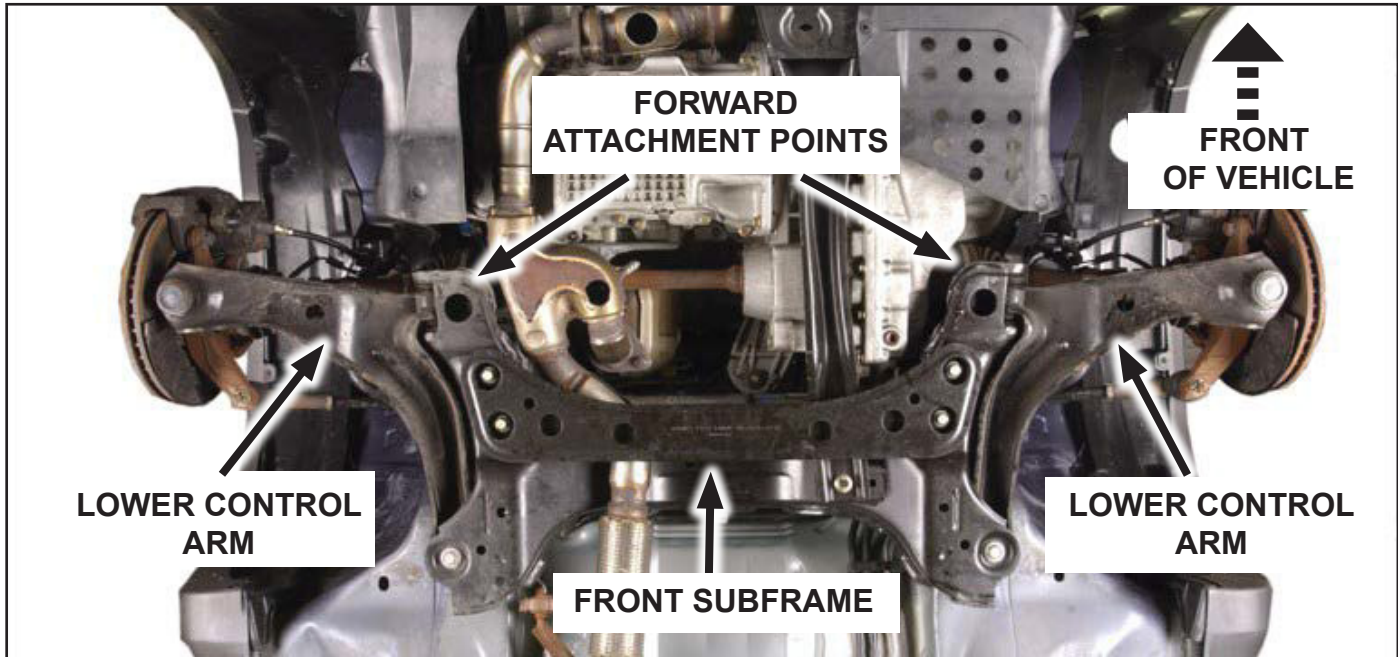
FIGURE 1

In some of the affected vehicles, a corrosion-related separation of the forward attachment of the lower control arm from the front subframe may occur when vehicles are operated for an extended period in high-corrosion environments. See Figure 1.

Install a reinforcement crossbrace on the front subframe (figure 2) or replace the front subframe (figure 3).

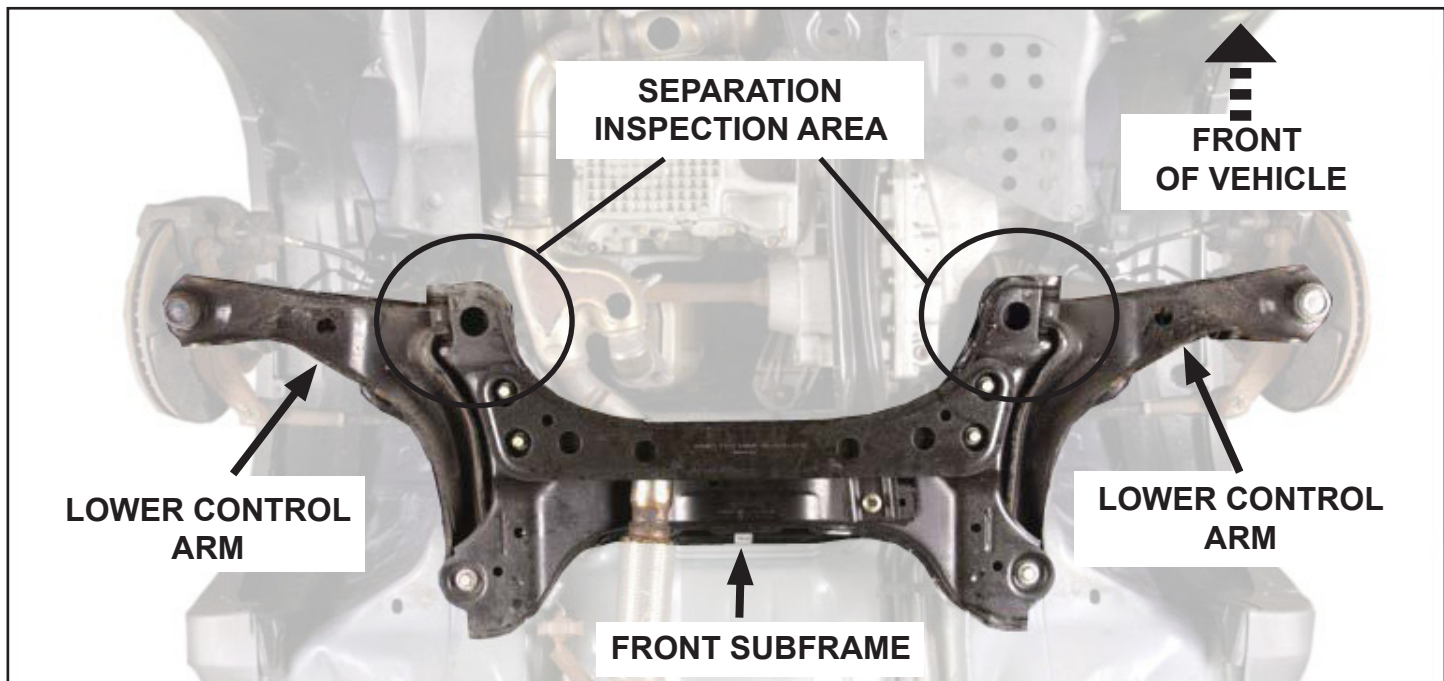
FIGURE 4

1. With the vehicle in NEUTRAL, position it on a hoist. For additional information, refer to MS3 online or Workshop Manual section 00-00.
2. Inspect the front lower control arms for separation from the front subframe in the areas indicated. See Figure 4.

- **NO LOWER CONTROL ARM SEPARATION:**
Proceed to D. CROSSBRACE INSTALLATION on page 4.
- **LOWER CONTROL ARM SEPARATION FROM SUBFRAME:**
