May 19, 2014

SUBJECT: DEMONSTRATION / DELIVERY HOLD - Safety Recall 14S03 - Supplement #1
Certain 2013-2014 Model Year Escape Vehicles
Exterior Door Handle Inspection and Adjustment

CERTAIN 2013 AND 2014 MODEL YEAR ESCAPE VEHICLES — EXTERIOR DOOR HANDLE INSPECTION AND ADJUSTMENT

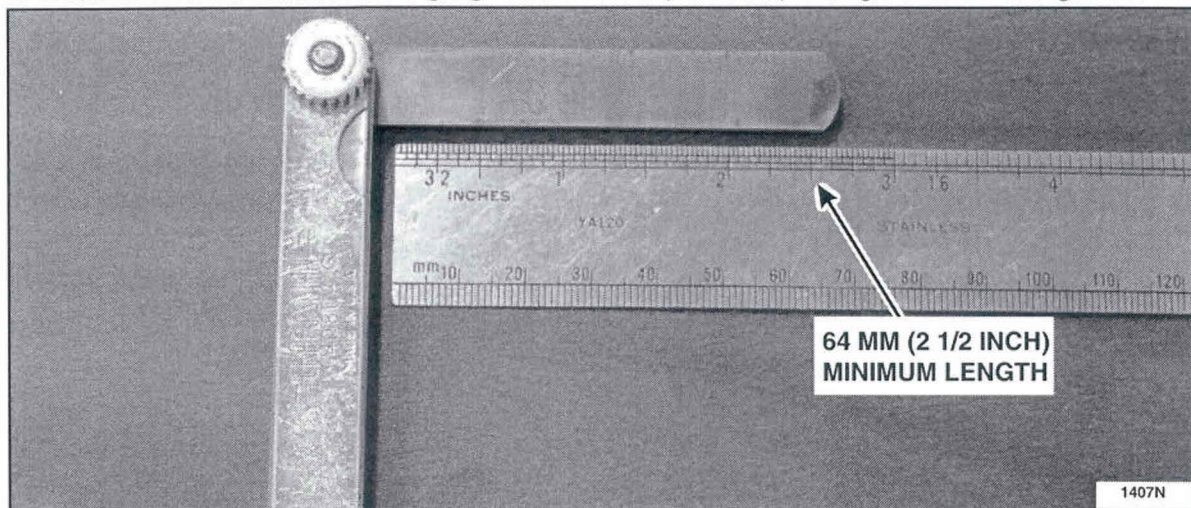
FIGURE 1

1. Obtain a standard flat blade feeler gauge with a 64 mm (2 1/2 inch) or longer blade. See Figure 1.

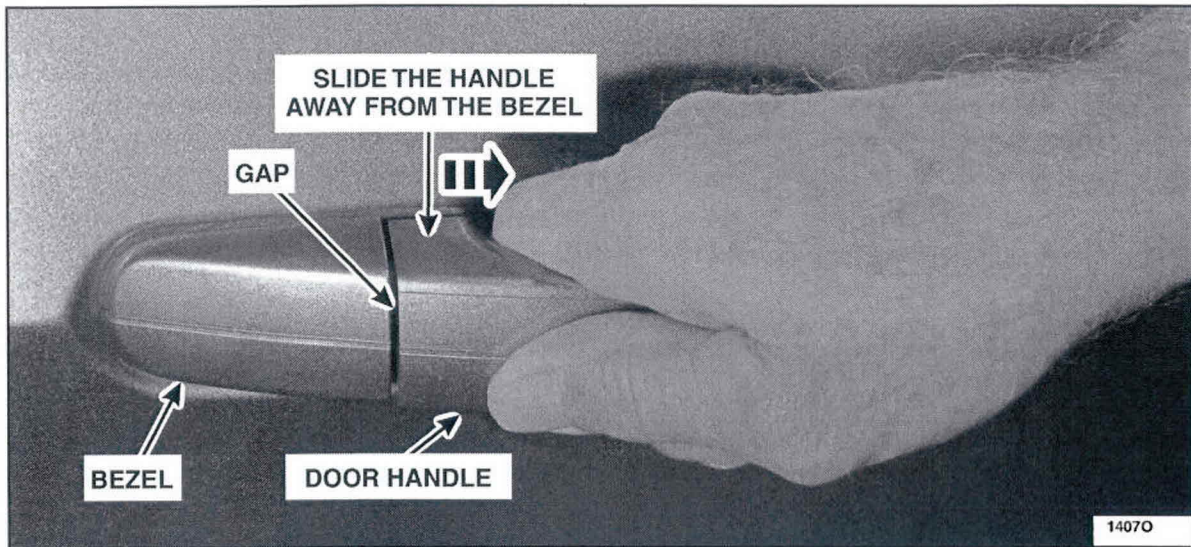
FIGURE 2

2. Open the door to the fully opened position.
3. Slide the door handle away from the bezel as far as possible to open the gap between the door handle and bezel. See Figure 2.

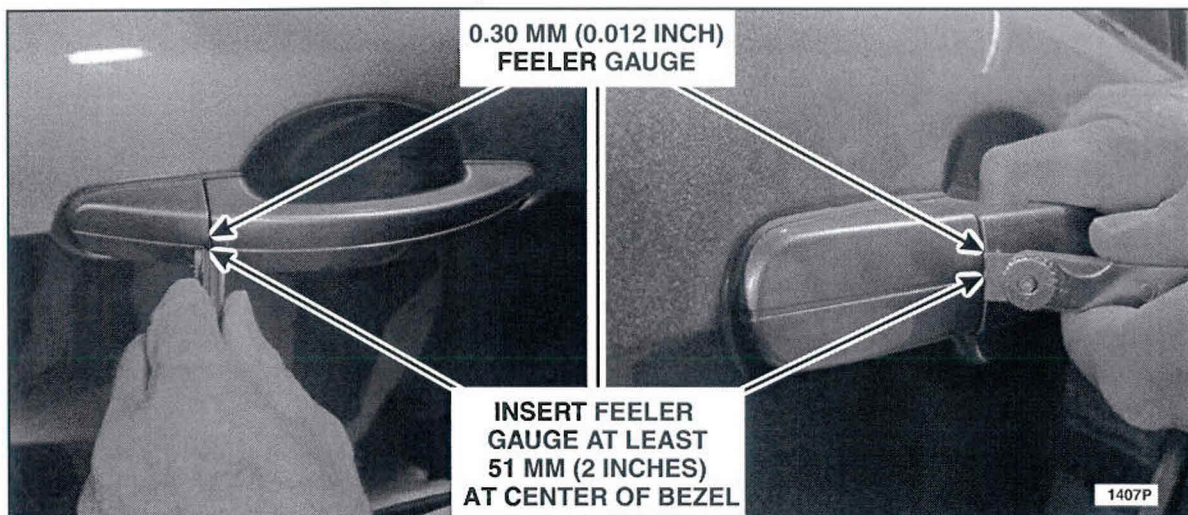
FIGURE 3

4. Insert the 0.30 mm (0.012 in) feeler gauge between the door handle and the bezel as shown. See Figure 3.

- The feeler gauge should be inserted:
 - at the center of the bezel.
 - at least 51 mm (2 inches).

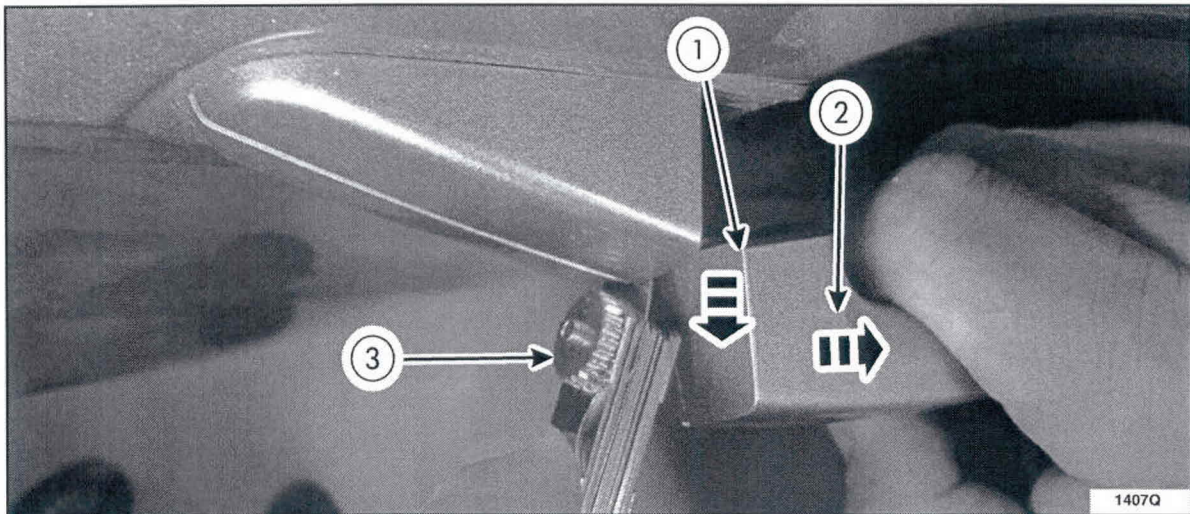
FIGURE 4

5. While holding the feeler gauge in position, complete the following steps in the order indicated.
See Figure 4.

- (1) Pull the door handle all the way open.
- (2) While holding the door handle in the open position, force the door handle forward (toward the front of the vehicle) as far as possible to increase the gap.
- (3) Gently pull the feeler gauge.

- **PASS INSPECTION:** If no resistance is felt when removing the feeler gauge, no further action is required for this door handle. Repeat Step 2 through Step 5 for remaining door handles.
- **DID NOT PASS INSPECTION:** If any resistance is felt when removing the feeler gauge, the door handle reinforcement needs adjustment. Repeat Step 2 through Step 5 for remaining door handles.
