**RE: Defect Information Report – Supplemental Report No. 1
14V-242 FL-653, Meritor Rear Axle Locking Snap Rings
Revised Dealer Notice**

June 2014
FL653A-C
NHTSA #13V-538 (FL653AB)
NHTSA #14V-242 (FL653C)
REVISED NOTICE

Subject: Meritor Rear Axle Locking Snap Rings

Models Affected: Specific Freightliner Cascadia vehicles manufactured August 6, 2012, through December 6, 2012, and equipped with ConMet Preset Plus Hubs.

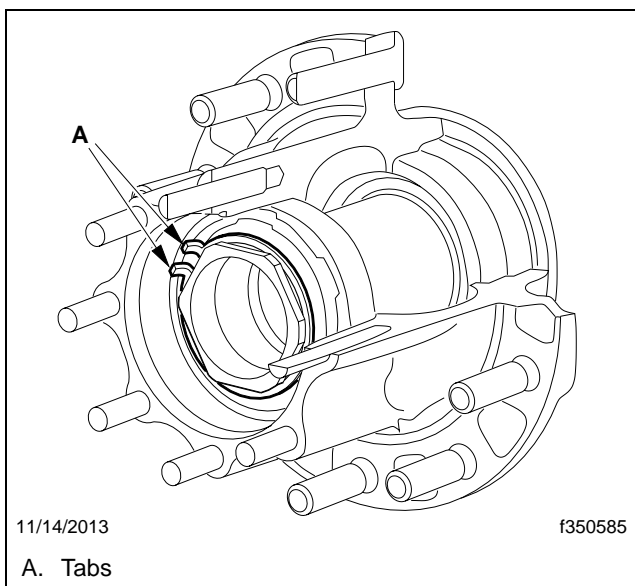
Fig. 2, Lock Ring, ConMet PreSet Plus Hub

6. If so equipped, remove the tapered dowels and washers from the drive axle flange.
7. Remove the drive axle shaft.
8. Remove and discard the gasket.
9. Check for the presence of a lock ring. See **Fig. 2**.
If the lock ring is present, go step 12.
If the lock ring is not present, continue to the next step.
10. Check the torque of the spindle nut to determine if it is 500 lbf·ft (678 N·m).
If it is below 500 lbf·ft (678 N·m), replace the hub and check the spindle for damage. Go to Hub Replacement and Spindle Inspection on page 8.
If it is 500 lbf·ft (678 N·m), continue to the next step.

11. Install the lock ring, as follows.
 - 11.1 One of the holes in the face of the spindle nut will line up with a hole in the washer. Insert the lock tab of the lock ring through aligned holes.
 - 11.2 Using the tabs, seat the lock ring in the machined grooves of the spindle nut. See **Fig. 2**.
12. Install a new gasket and the drive axle shaft. The splined end of the axle shaft must seat before the drive axle flange will fit over the studs.
13. If needed, install the tapered dowels and washers on the drive axle studs. Install the drive axle stud nuts and washers. Using the sequence shown in **Fig. 3**, tighten the nuts to the torque values given in the table in **Table 3**.
