# Recall Bulletin

## F/CMVSS NONCOMPLIANCE RECALL

**SUBJECT:** Loss of Driver Door Master Window Function due to Damaged Splice

**MODELS:** 2014 Buick LaCrosse

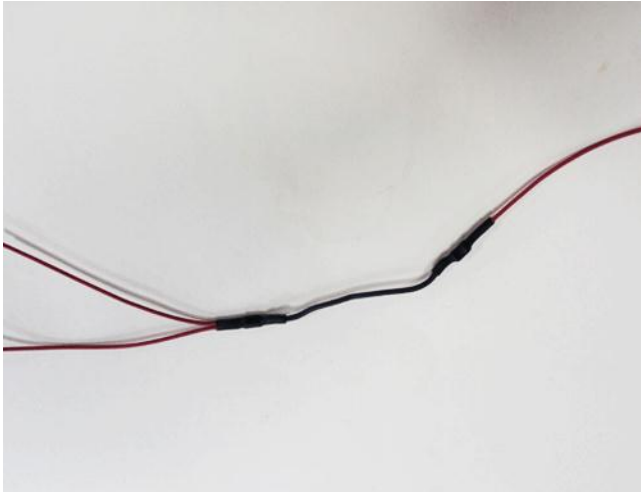
3926787

**Note:** The graphic above is an off-vehicle example of the completed jumper repair.

8. Add an appropriate length jumper wire, obtained locally.
  - 8.1 Strip off approximately 10mm (0.40 in) of insulation from each end of the jumper wire.
  - 8.2 Fold over one end of the jumper wire and position it together with the twisted wires.
