REFERENCE NHSTA RECALL # 14E009

VILLA INTERNATIONAL				
ABTS HINGE LINK, RECALL INSPECTION				
JGM 4.28.14	SIZE	FSCM NO.	DWG NO.	REV
	SCALE		01

VILLA INTERNATIONAL				
ABTS HINGE LINK, RECALL REPAIR				
JGM 4.21.14	SIZE	FSCM NO.	DWG NO.	REV
	SCALE		02

VILLA INTERNATIONAL
RECALL REPAIR 14E-009

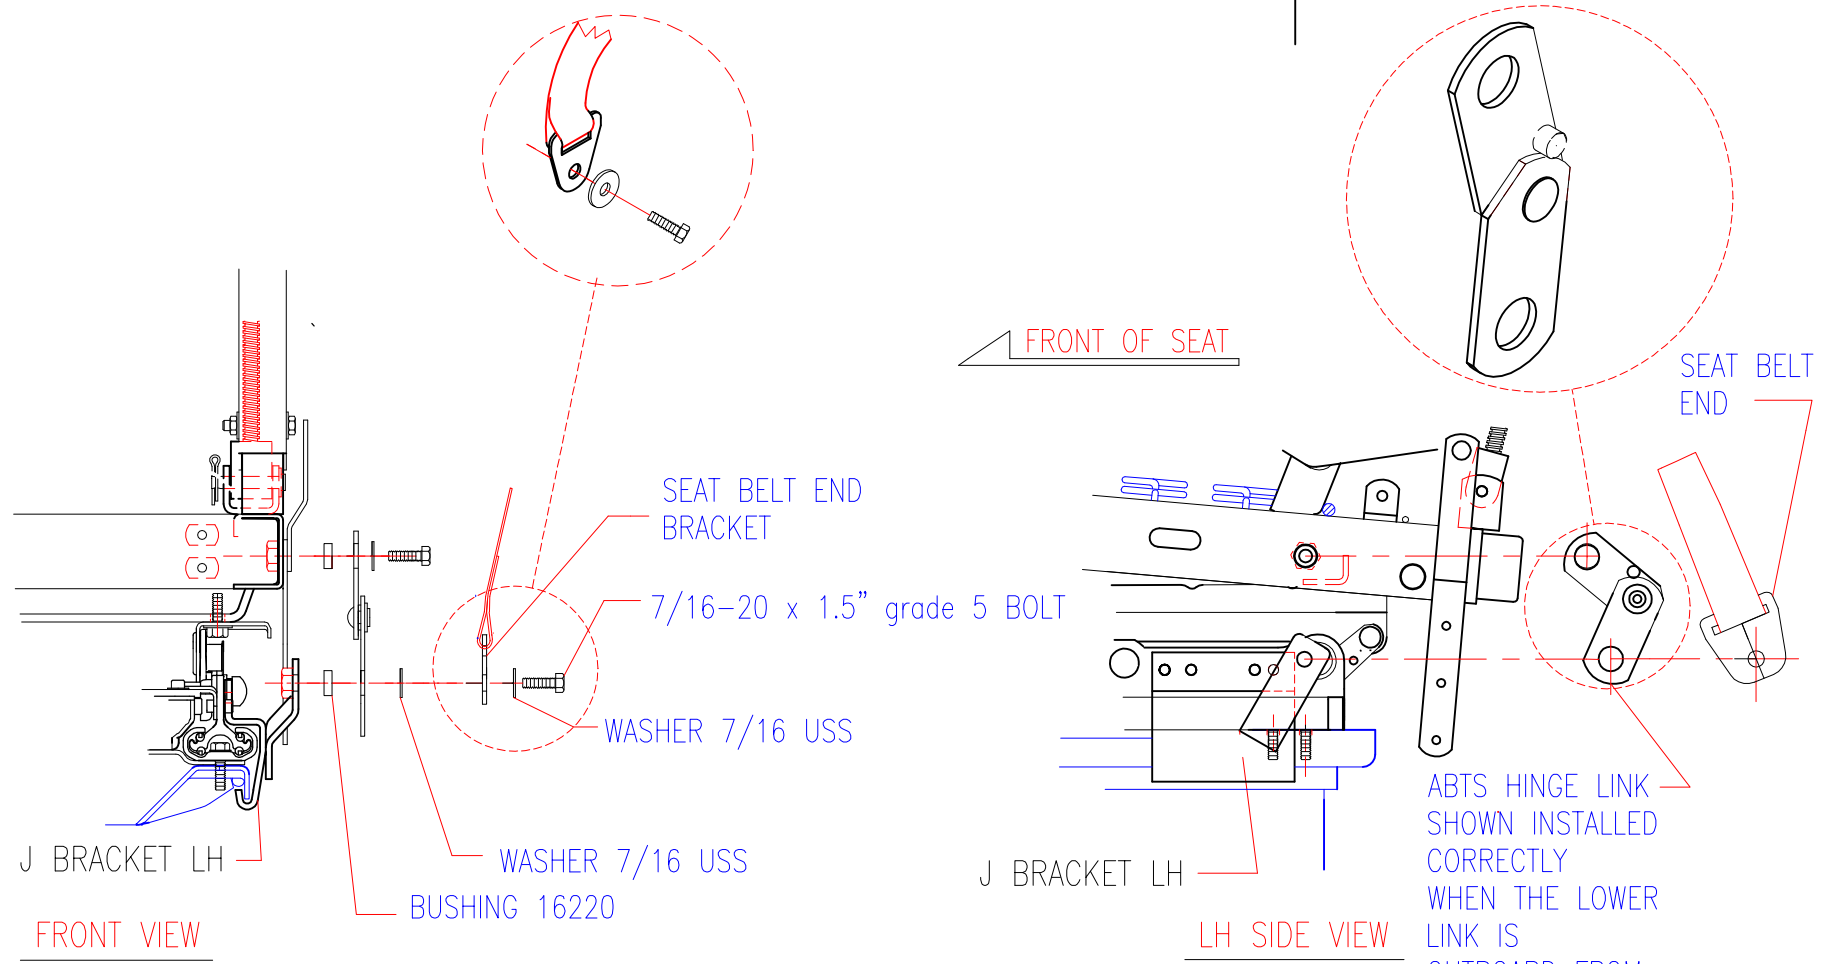
THIS DRAWING SHOWS THE CORRECT HINGE INSTALLATION FOR ABTS SEATING.

LEFT SIDE OF DRIVERS SEAT SHOWN
RIGHT SIDE PASSENGER SEAT THE SAME.

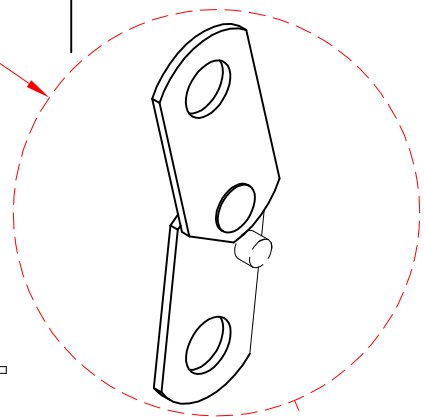
FRONT OF SEAT

ABTS HINGE LINK SHOWN INSTALLED INCORRECTLY WHEN THE LOWER LINK IS INBOARD TOWARD THE SEAT FRAME.

NOTE:
 THIS REPAIR IS INTENDED ONLY FOR THOSE ABTS HINGES INSTALLED INCORRECTLY AS SHOWN IN THE LH SIDE VIEW.
 * IDENTIFIES REPAIR KIT HARDWARE.
 REMOVE TWIST IN SEAT BELT BEFORE INSTALLING SHEATH AND FASTENING END.
 TIGHTEN REPLACEMENT BOLT TO 20 FT-LB.
 LEFT SIDE OF DRIVERS SEAT SHOWN
 RIGHT SIDE PASSENGER SEAT THE SAME.

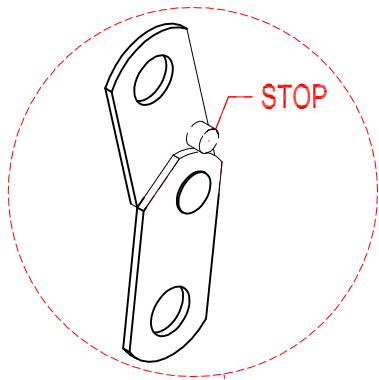
CORRECT INSTALLATION
OF THE ABTS HINGE LINK.

THE ABTS HINGE LINK IS INSTALLED
CORRECTLY
WHEN THE UPPER LINK WITH THE STOP IS
TOWARD THE SEAT FRAME AND THE LOWER
LINK IS OUTBOARD FROM THE SEAT FRAME.
NO REPAIR IS REQUIRED.

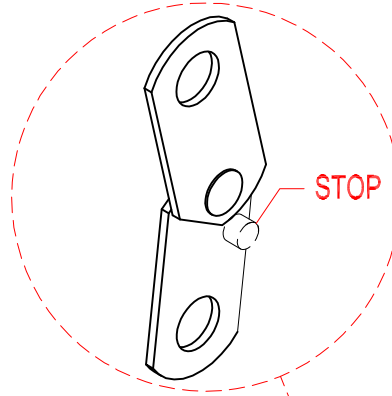
INCORRECT INSTALLATION
OF THE ABTS HINGE LINK.

THE ABTS HINGE LINK IS INSTALLED
INCORRECTLY
WHEN THE UPPER LINK IS
OUTBOARD FROM THE SEAT FRAME AND THE
LOWER LINK WITH THE STOP IS INBOARD FROM
THE SEAT FRAME.
USE REPAIR KIT 14E-009T/B FOR REPAIR.
