SUBJECT: DEMONSTRATION / DELIVERY HOLD - Safety Recall 14S17

Certain 2013 and 2014 Model Year Focus ST and Escape Vehicles Equipped with a 2.0L Engine
Engine Wiring Splice Repair

CERTAIN 2013 AND 2014 MODEL YEAR ESCAPE VEHICLES EQUIPPED WITH A 2.0L ENGINE — ENGINE WIRING SPLICE REPAIR

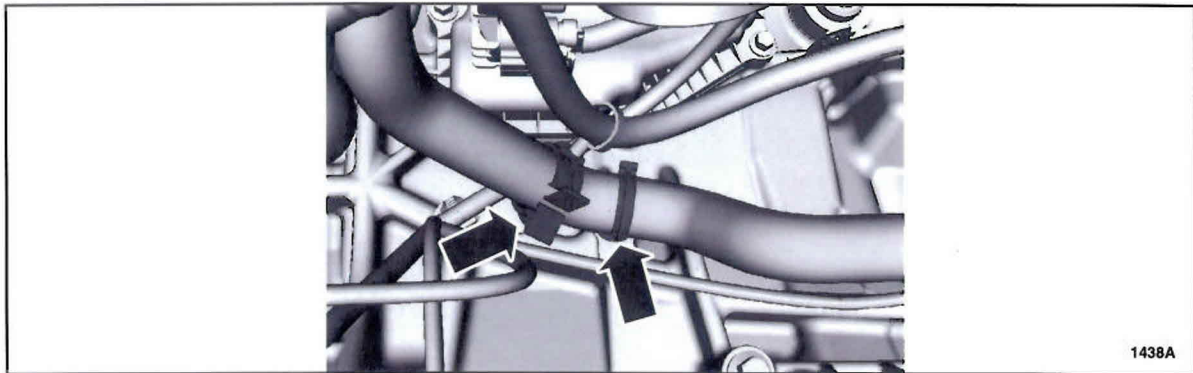
FIGURE 1

1. Disconnect the battery ground cable. For additional information, refer to Workshop Manual (WSM) Section 414-01.
2. Remove the engine appearance cover.
3. Remove the air cleaner and air cleaner outlet pipe. For additional information, refer to WSM Section 303-12B.
4. Remove the lower radiator hose retaining clip and detach the push pin retainer from the transmission. See Figure 1.
 - Position the lower radiator hose aside.

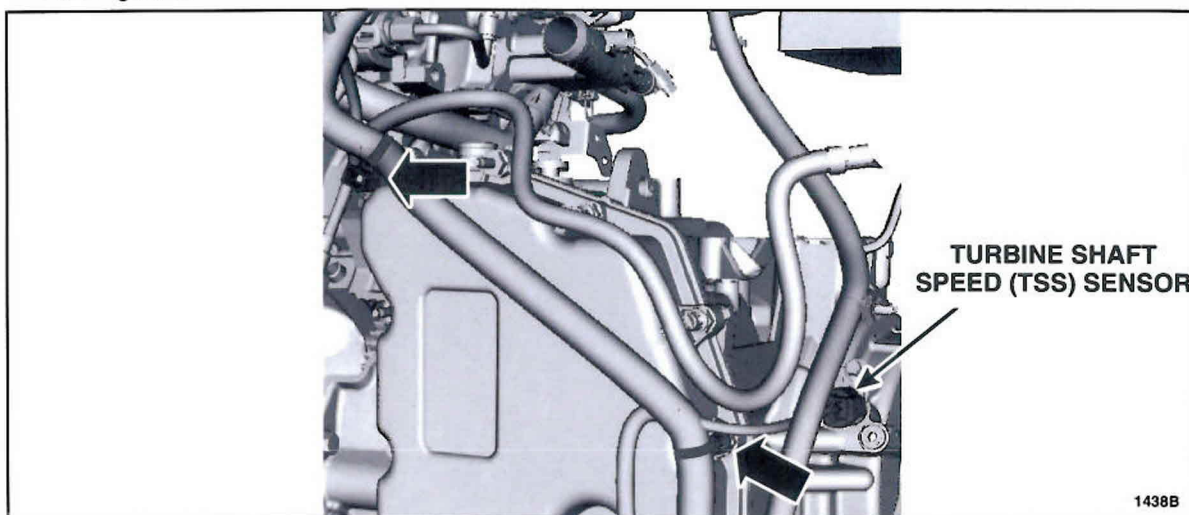
FIGURE 2

5. Disconnect the two wire harness retainers and disconnect the Turbine Shaft Speed (TSS) Sensor. See Figure 2.

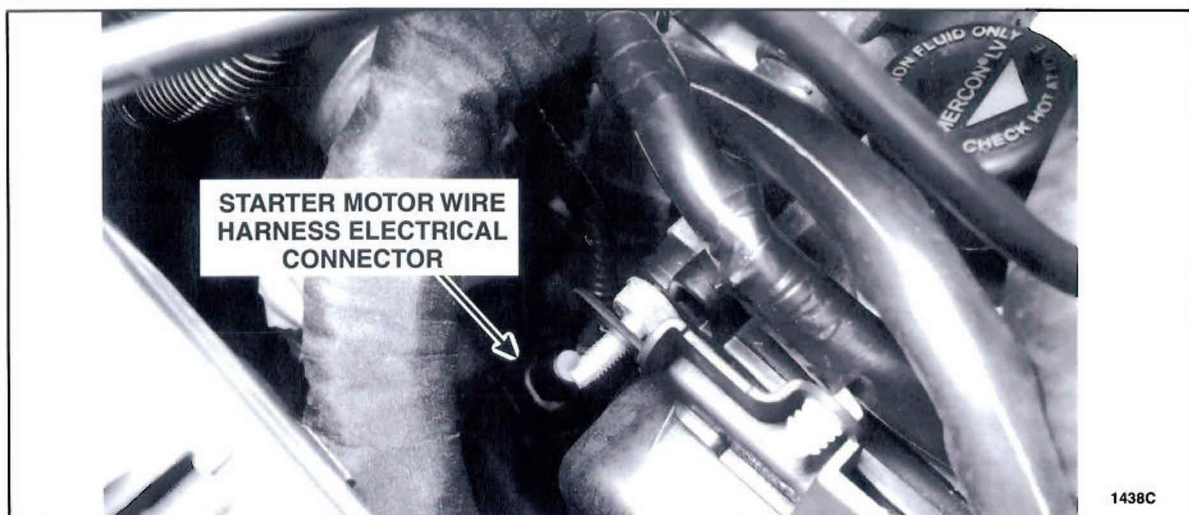
FIGURE 3

6. Disconnect the starter motor wire harness electrical connector. See Figure 3.

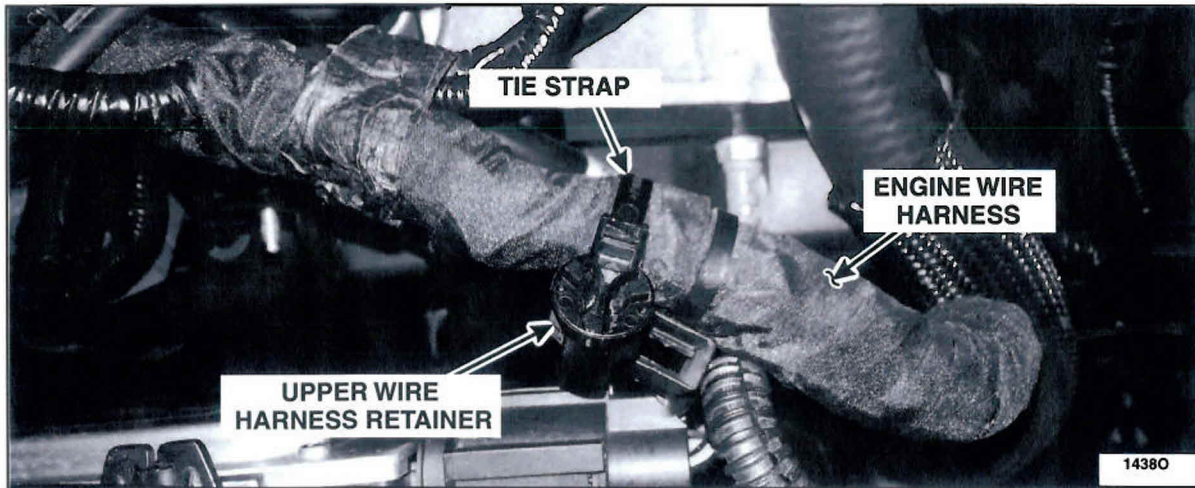
FIGURE 4

7. Cut the upper wire harness retainer tie strap and remove it from the engine wire harness.
See Figure 4.

- Remove the tie strap from the upper wire harness retainer. Save the retainer as it will be used during reassembly.

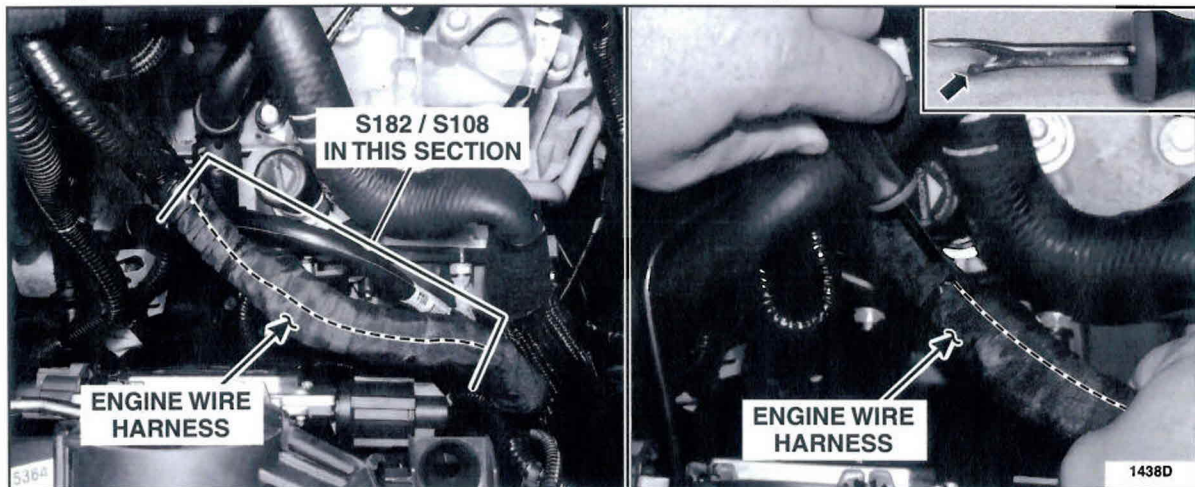
FIGURE 5

8. Pull the engine wire harness upward to provide better access for the repair. Locate the section of engine wire harness that contains splice S182 and S108. See Figure 5.

9. Using a commercially available sheathing ripper such as Snap-On SGTT4A or equivalent, carefully strip the wire harness tape from the section of wire harness that contain splice S182 and S108.
See Figure 5.
- Insert the **ball end** of the sheathing ripper into the wire harness.
 - Use caution not to damage the wires or wire insulation when stripping the wire harness tape to access splice S182 and S108.

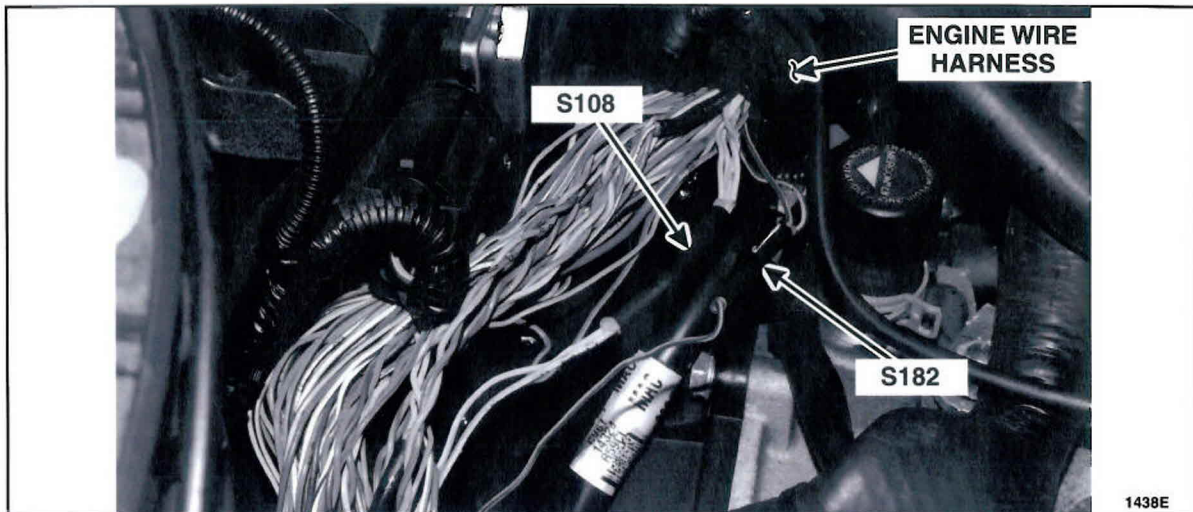
FIGURE 6

10. Locate splice S182 and S108. See Figure 6.

- S182 is a one (1) wire into two (2) wire splice with Gray/Brown wires.
- S108 is a two (2) wire into four (4) wire splice with Yellow/Green wires.

NOTE: There is another splice with Yellow/Green wires in this area. Be sure the splice you repair with Yellow/Green wires is splice S108 having four (4) wires on one side and two (2) wires on the other.

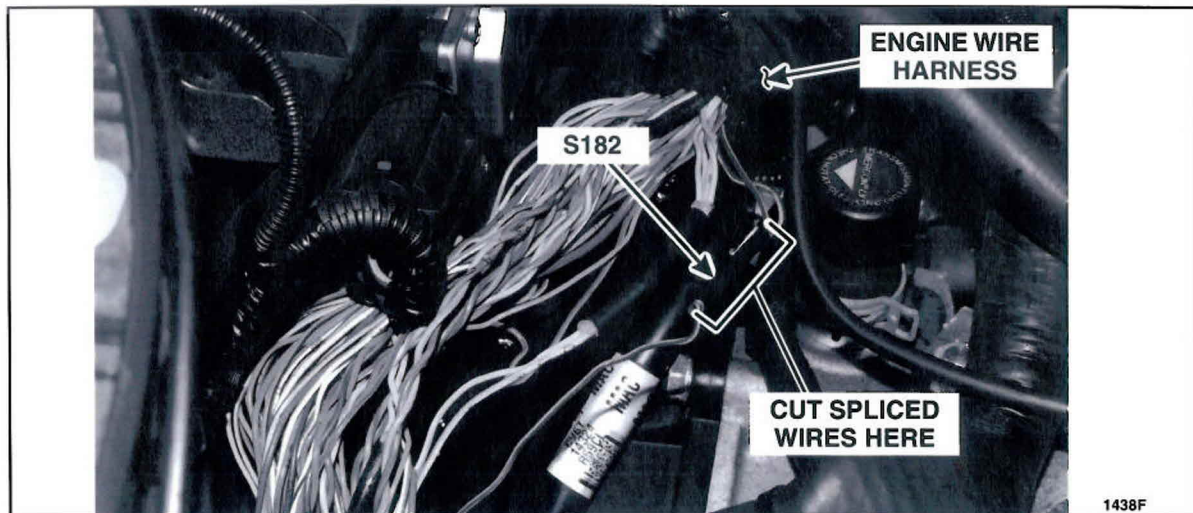
FIGURE 7

11. Cut the wires on each side of the splice S182 and strip off 19 mm (0.75 in) of insulation from each of the Gray/Brown wires. See Figure 7.

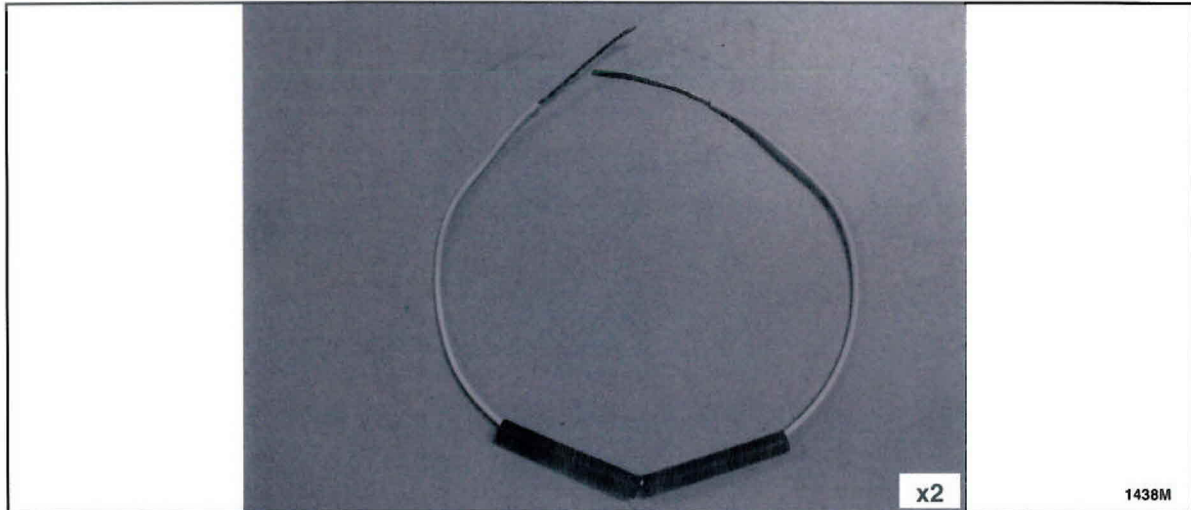
FIGURE 8

12. Prepare two lengths of wire for splicing as follows. See Figure 8.

- a. Obtain locally two 40.6 cm (16 in) lengths of 18 AWG wire meeting Ford specification ESB-M1L123-A (3TAD) or SAE J1128-SXL, or equivalent.
- b. Strip 38 mm (1.5 in) of insulation from each end of the wire.
- c. Position two (2) lengths of ES-1 double wall heat shrink tubing onto each wire.

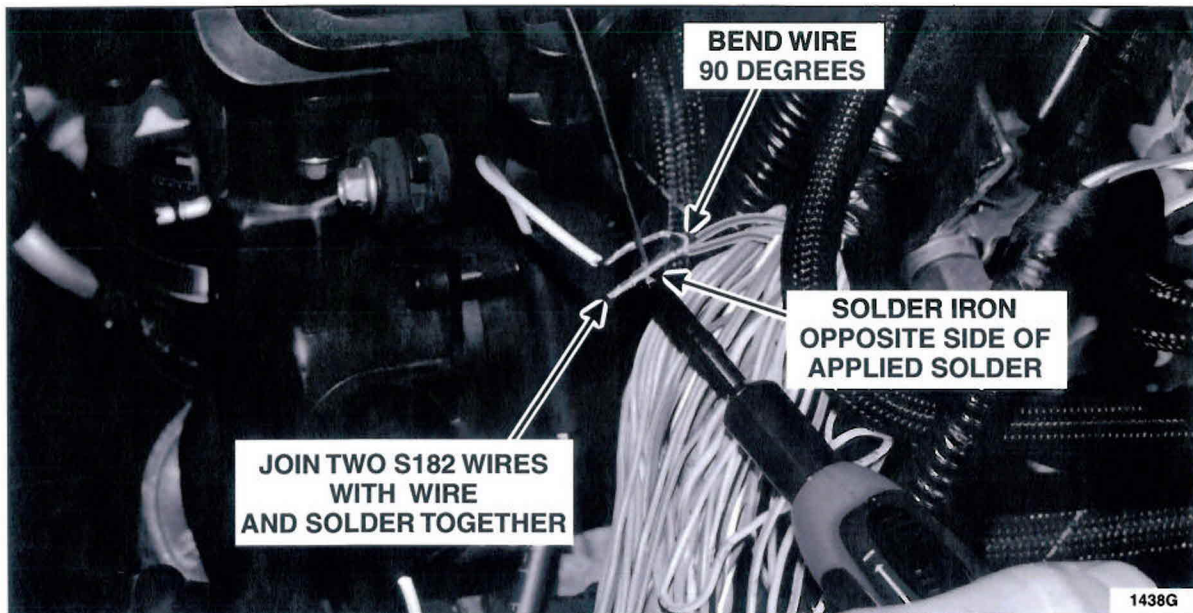
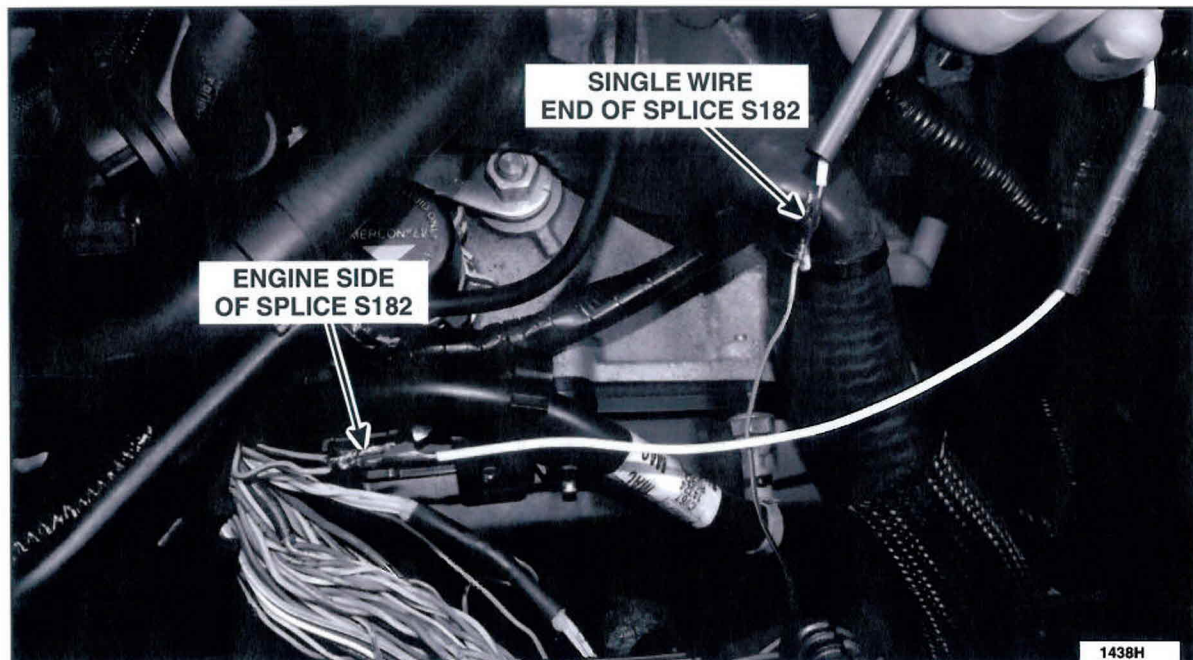
13. Join the two Gray/Brown wires on the engine side of the harness with one end of the previously prepared 40.6 cm (16 in) length of wire. Twist 13 mm (0.5 in.) of the ends of the wires together and bend the splice wire 90 degrees to the harness wire at the end of the twisted area. Solder the wires together using lead free electrical solder, with the heat being applied opposite of the applied solder. See Figures 9 and 10.

- Repeat this step to join the single wire end of the splice S182 Gray/Brown Wire to the opposite end of the prepared wire.

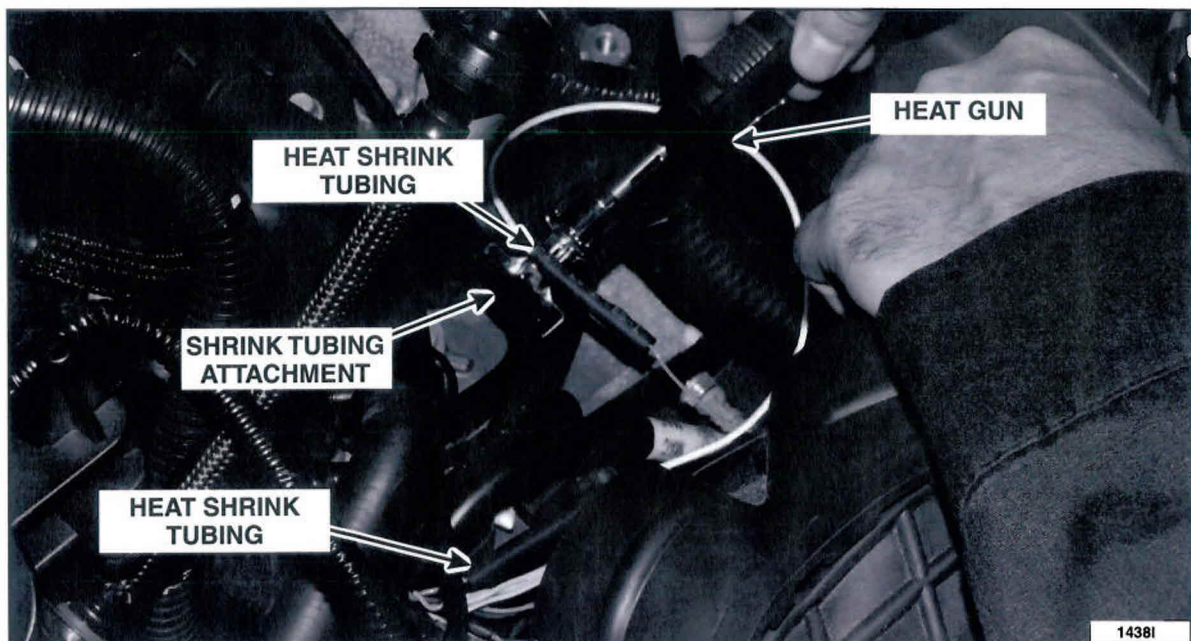
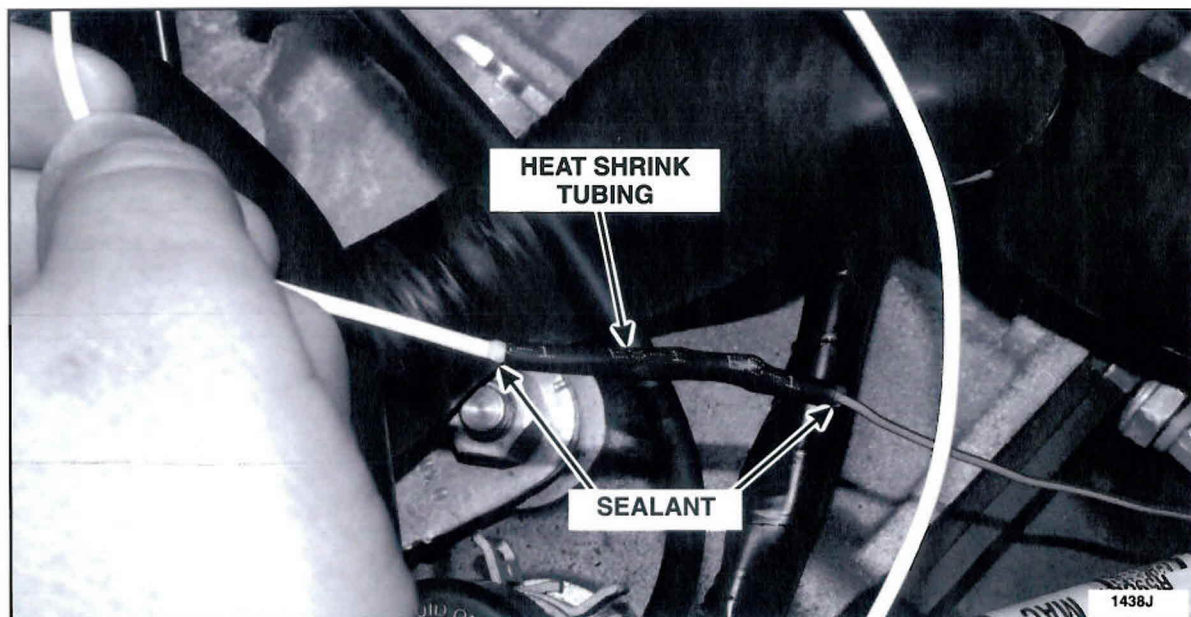
14. Position the heat shrink tubing over both ends of the splice wire. Use a suitable heat gun such as Rotunda Shielded Flameless Heat Gun with Heat Deflector, number NAIAT-R5902, that is equipped with a shrink tubing attachment, to heat the heat shrink tubing until the sealant comes out of both ends. See Figures 11 and 12.

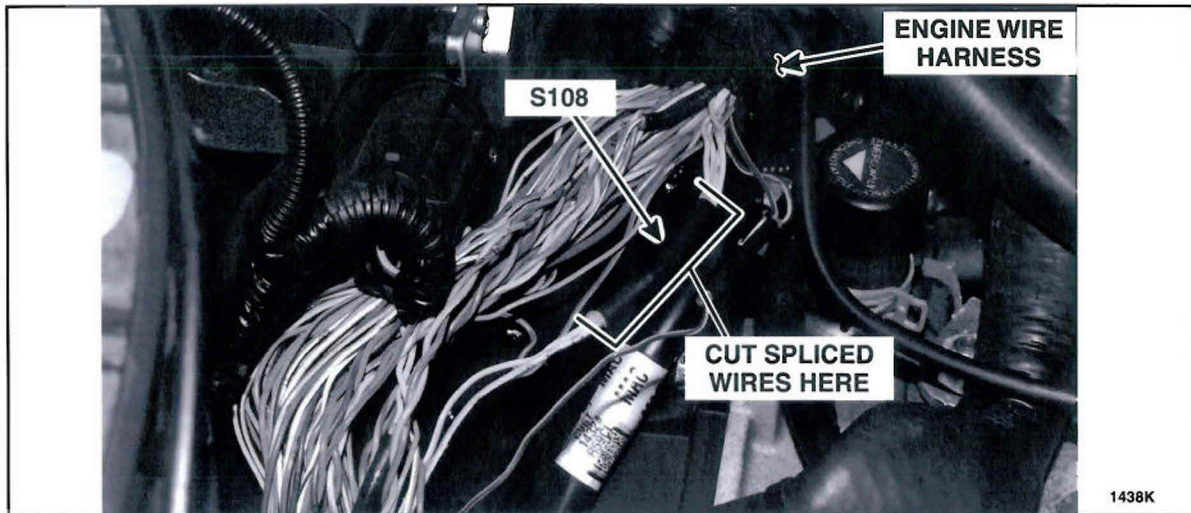
FIGURE 13

15. Cut the wires on each side of the splice S108 and strip off 19 mm (0.75 in) of insulation from each of the Yellow/Green wires. See Figure 13.

NOTE: There is another splice with Yellow/Green wires in this area. Be sure the splice you repair with Yellow/Green wires is splice S108 having four (4) wires on one side and two (2) wires on the other.

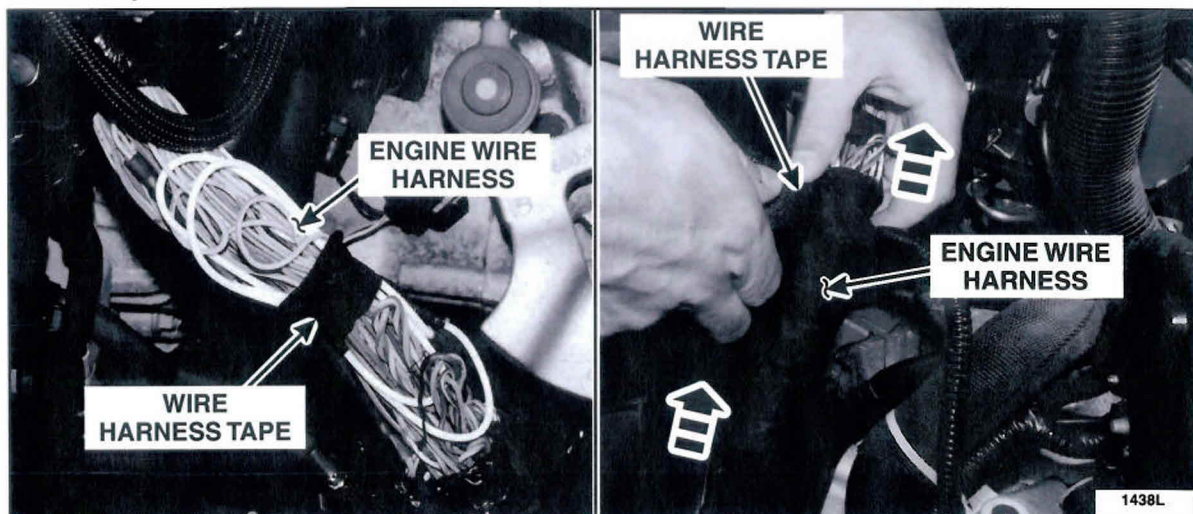
FIGURE 14

16. Repeat Steps 13 and 14 for both ends of the splice S108 Yellow/Green wires.
17. Bundle the wires as shown and apply wire harness tape to the harness, starting from the bottom of the previously cut harness tape and working upward until all exposed wires are covered. See Figure 14.
