SUBJECT: DEMONSTRATION / DELIVERY HOLD - Safety Recall 14S17 – Supplement #1
Certain 2013 and 2014 Model Year Focus ST and Escape Vehicles Equipped with a
2.0L Engine
Engine Wiring Splice Repair

DEMONSTRATION / DELIVERY HOLD Safety Recall 14S17 – Supplement #1
Certain 2013 and 2014 Model Year Focus ST and Escape Vehicles Equipped with a 2.0L Engine
Engine Wiring Splice Repair

CERTAIN 2013 AND 2014 MODEL YEAR ESCAPE VEHICLES EQUIPPED WITH A 2.0L ENGINE — ENGINE WIRING SPLICE REPAIR

CERTAIN 2013 AND 2014 MODEL YEAR FOCUS ST VEHICLES — ENGINE WIRING SPLICE REPAIR

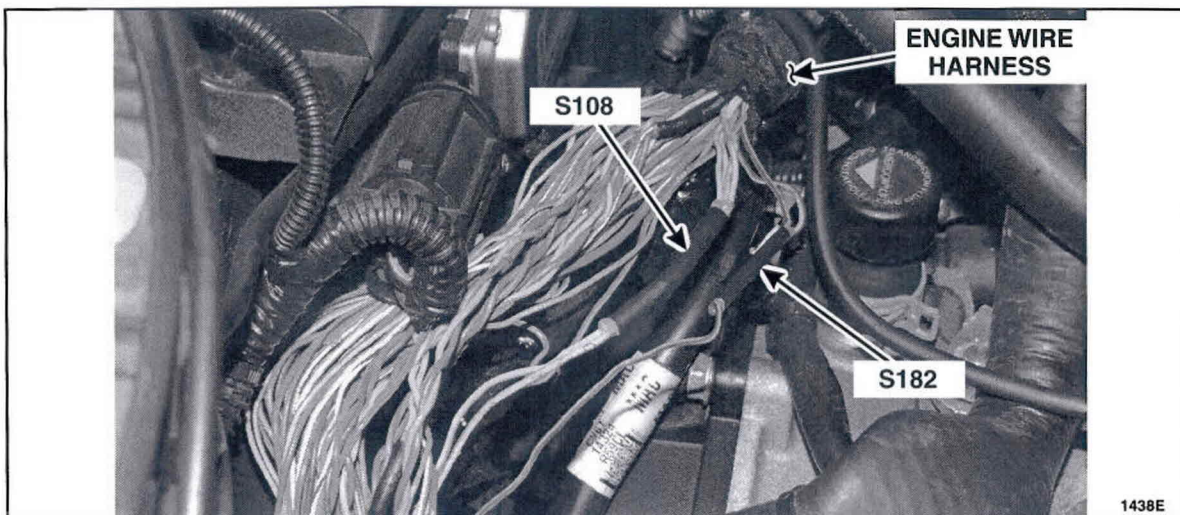
FIGURE 6

- S182 is a one (1) wire into two (2) wire splice with Gray/Brown wires.
- S108 is a two (2) wire into four (4) wire splice with Yellow/Green wires.

10. Locate splice S182 and S108. See Figure 6.

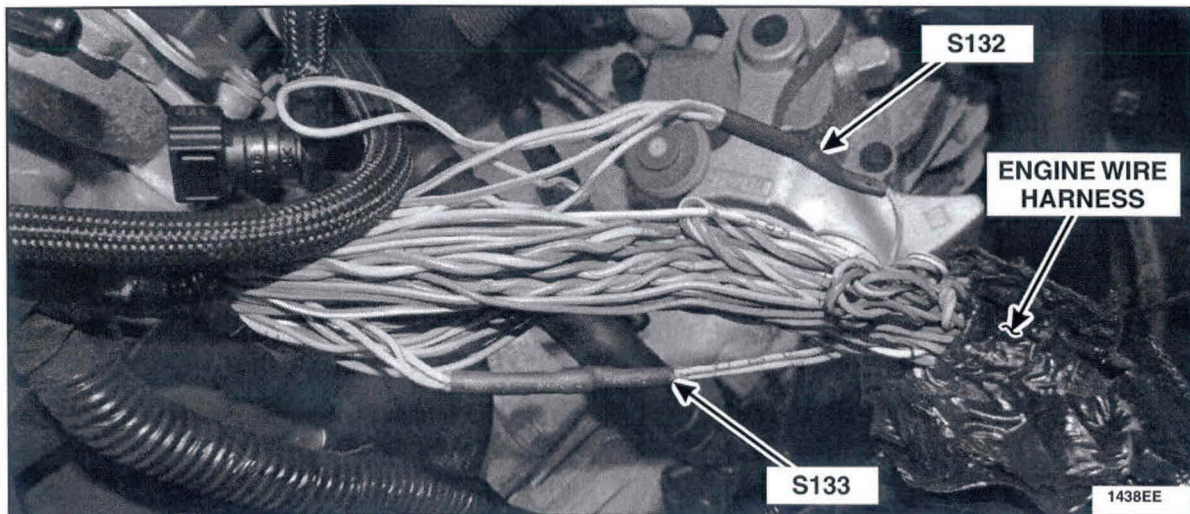
FIGURE 6

- S132 is a one (1) wire into four (4) wire splice with Yellow/Green wires.
- S133 is a two (2) wire into three (3) wire splice with Yellow/Violet wires.

10. Locate splice S132 and S133. See Figure 6.
