SUBJECT: 2008 Tribute Hybrid Motor Electronics Coolant Pump Replacement Safety Recall 7814I

2008 TRIBUTE HYBRID - MOTOR ELECTRONICS COOLANT PUMP REPLACEMENT

**2008 Tribute Hybrid Vehicles
Motor Electronics Coolant Pump Replacement - Recall 7814I
NHTSA Campaign No. 14V-552**

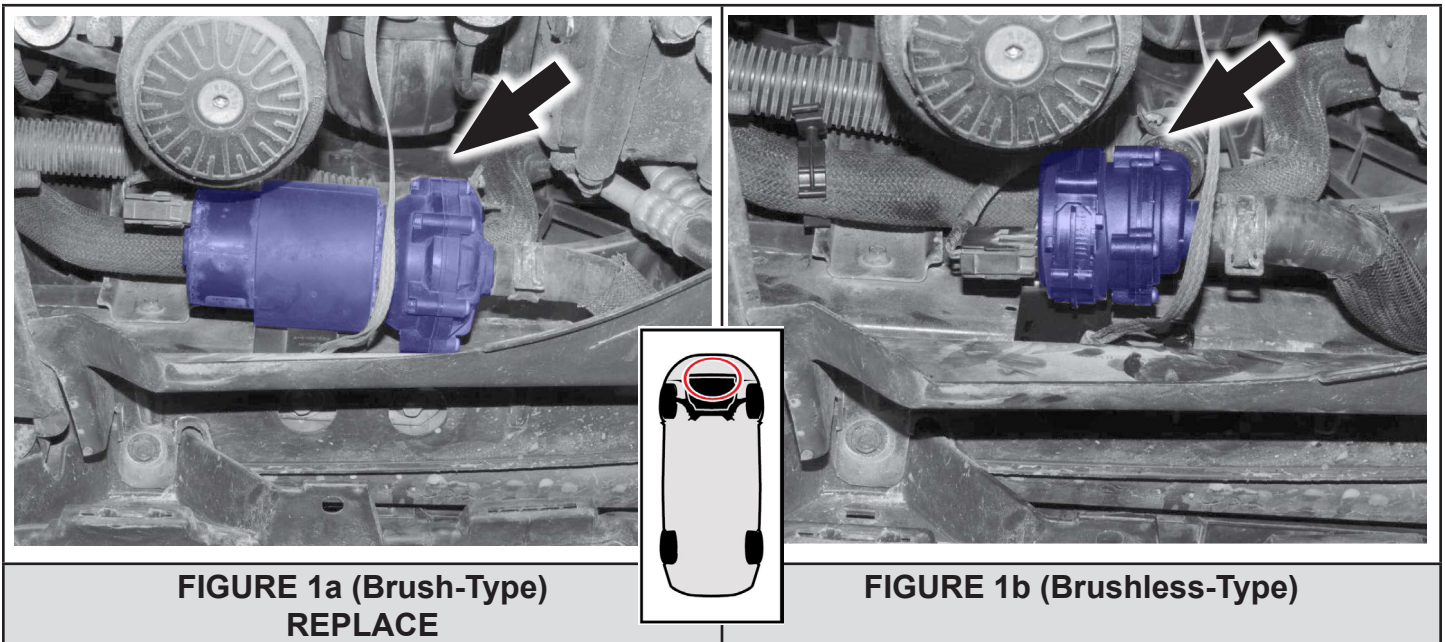
3. Position the vehicle on a hoist. Refer to MS3 online (section 00-00 LIFTING).
4. Inspect the MECP located behind the radiator support near the oil filter (see Figure 1a and 1b). Reference the flowchart on Page 3 for inspection and repair criteria.

5. If directed by the flowchart, install the updated brushless-type MECP (Figure 1b) using the MECP service kit. For additional information, refer to MS3 online (section 05-17 MOTOR ELECTRONICS PUMP REMOVAL/INSTALLATION — HYBRID).
