SERVICE PROCEDURE

14515

SUBJECT: SAFETY RECALL

Lower Clutch Rod on certain TranStar® models built 2 April 2014 thru 18 June 2014 with feature code 11MHD, 11MGR, or 11MGZ Easy-pedal Advantage clutch with mechanical pull type control.

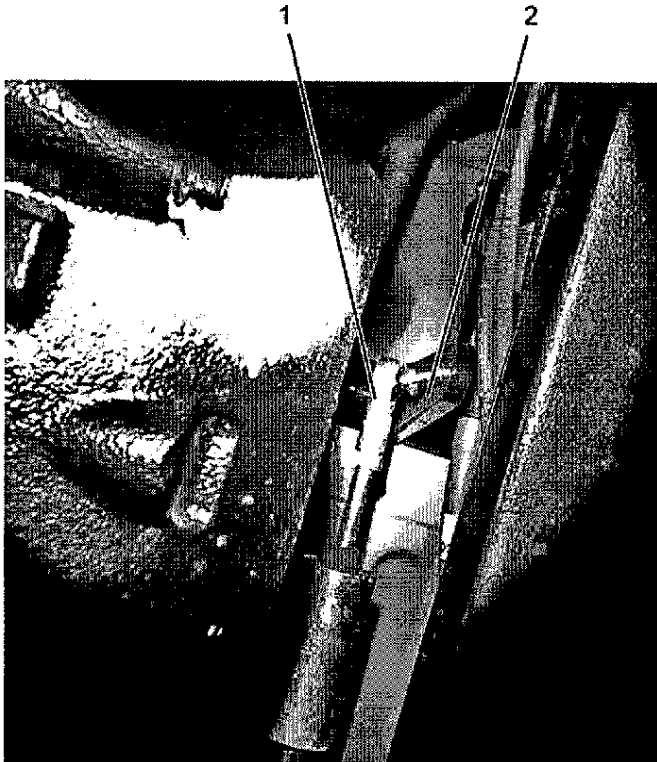
Figure 1. Lower Clutch Rod.

The lower clutch rod nut may not be tightened to the specified torque and in some cases, the lower clutch rod nut may be missing. If the lower clutch rod were to separate while the vehicle is stopped or decelerating, the vehicle may lunge unexpectedly in the direction of the selected gear, which may contribute to a vehicle crash, possibly resulting in property damage, personal injury, or death.

6. Inspect lower clutch rod (Figure 1, Item 1) to verify it is connected to lower bell crank arm (Figure 1, Item 2).
 - a. If lower clutch rod (Figure 1, Item 1) is disconnected from lower bell crank arm (Figure 1, Item 2), connect lower clutch rod to lower bell crank arm and install a new nut. Proceed to Step 7.
 - b. If lower clutch rod (Figure 1, Item 1) is connected to lower bell crank arm (Figure 1, Item 2) and nut is present, proceed to Step 7.
7. Using torque wrench, tighten nut to 28 - 33 lb-ft (37 - 46 N•m).
8. Install fender extension.
9. Close and latch hood.
10. Remove wheel chocks.
