This Service Information bulletin supersedes SI 71 02 14 dated **September 2014**.

Delivery Stop: Compact Spare Wheel

F55 and F56 (Hardtop 4-door and 2-door)

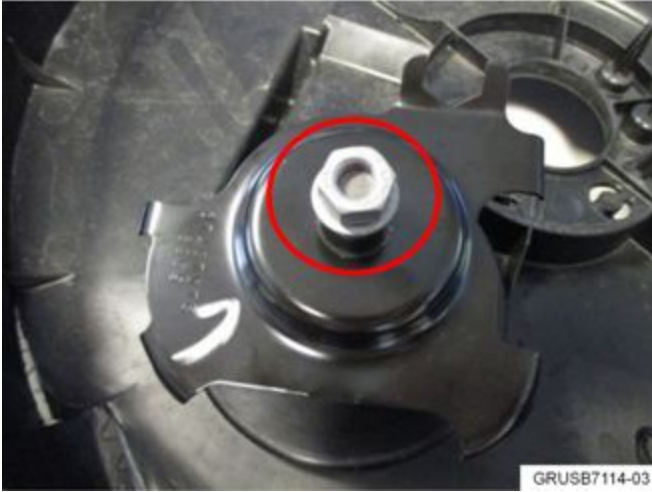
The securing nut of the compact spare wheel has to be replaced in these vehicles.

Remove the nut from the bracket holding the compact spare wheel. Fit the new self-locking flange nut (P/N 22 11 6 779 973) and torque to 19 Nm.
