After-sales Retailer Support

2011-2015 Infiniti QX56/QX80 and 2011-2015 M56/Q70 Fuel Pressure Sensor Voluntary Safety Recall Campaign

Reference: R1417

Date: November 26, 2014

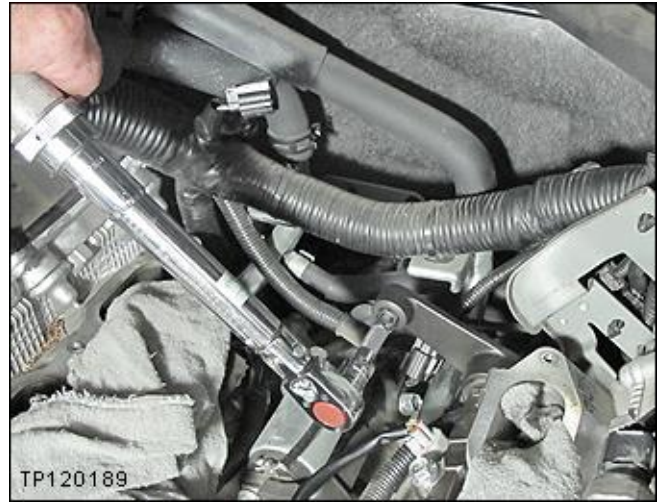
Figure 13

19. Torque the fuel rail pressure sensor as follows:

- c. Attach special tool J-50991 to your torque wrench – use an extension if needed.
- d. Torque the sensor to the specified torque.

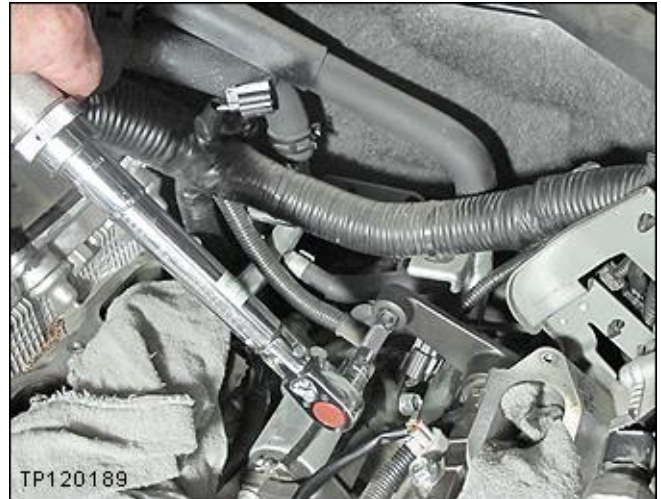
Figure 22m

27. Torque the fuel rail pressure sensor as follows:

- c. Attach special tool to J-50991 to your torque wrench – use an extension if needed.
- d. Torque the sensor to the specified torque.
