Michael A. Berardi
Director
Service Engineering Operations
Ford Customer Service Division

November 3, 2014

SUBJECT: **Safety Recall 14S25**
Certain 2005 through 2011 Model Year Crown Victoria, Grand Marquis, and Town Car Vehicles Repaired Under Safety Recall 13S08 or Regional Program 13R01 Upper Intermediate Steering Shaft Inspection and Replacement

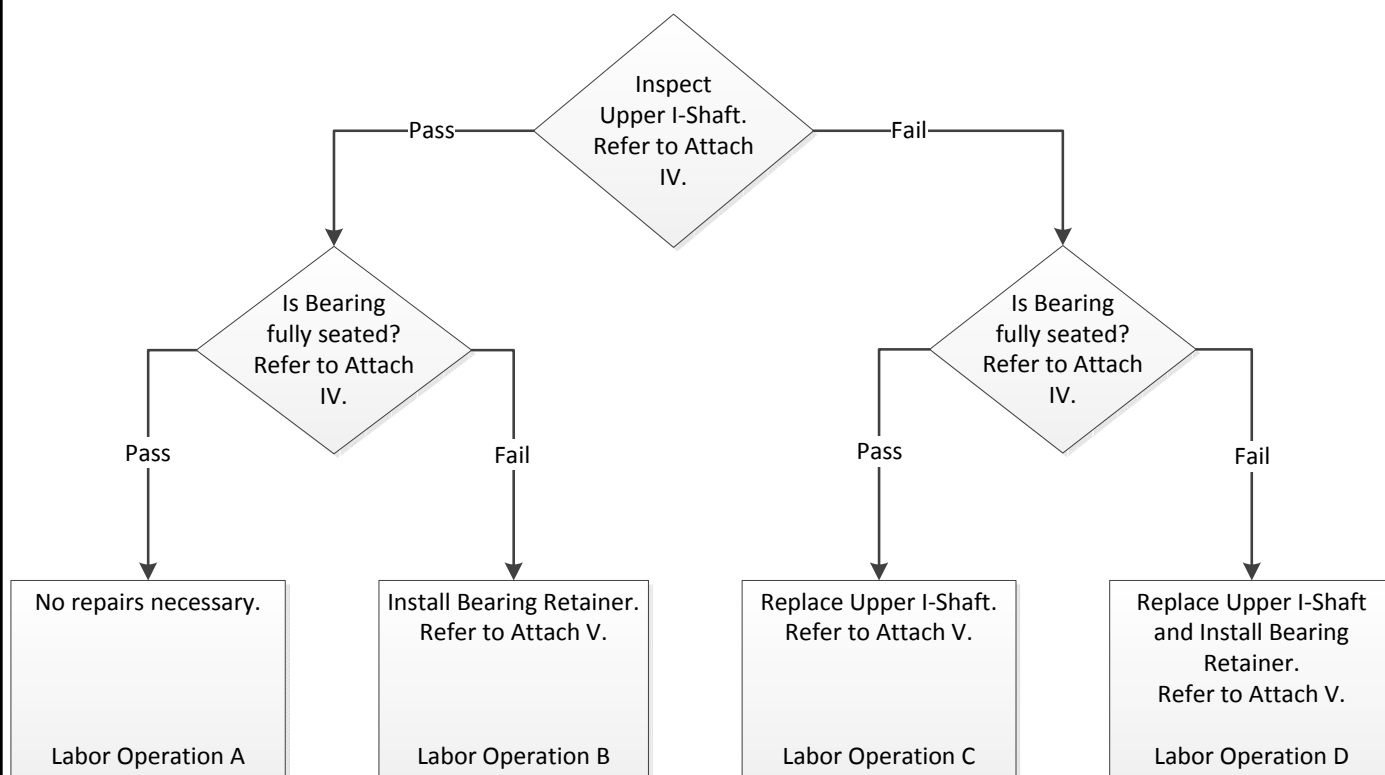
Refer to the following flow chart for inspection and repair criteria:

NOTE: Review all subsequent inspection areas before completing repairs.

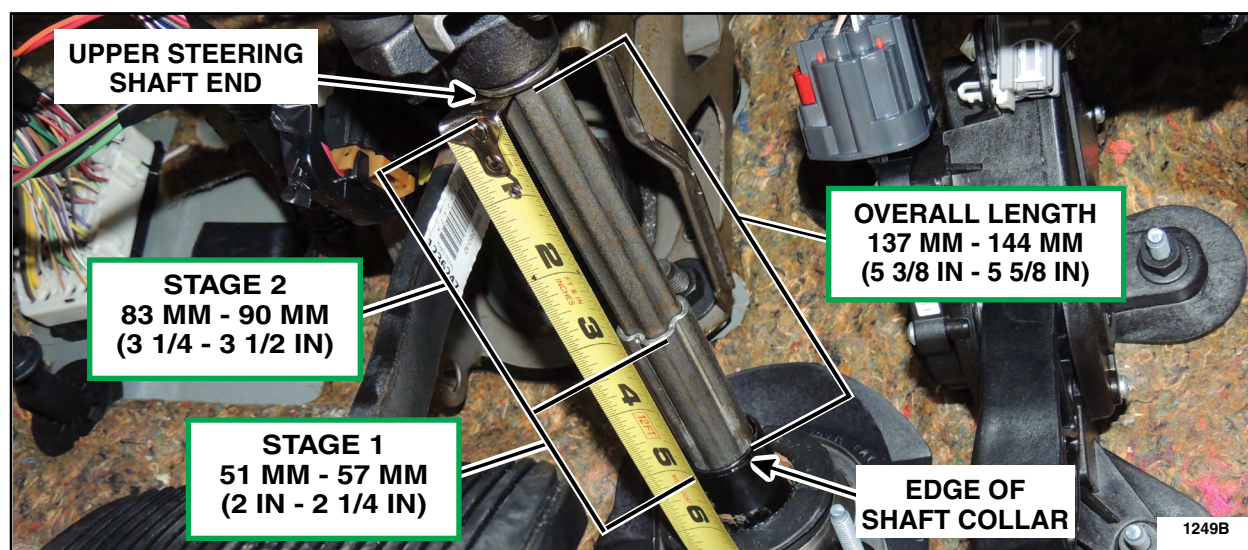
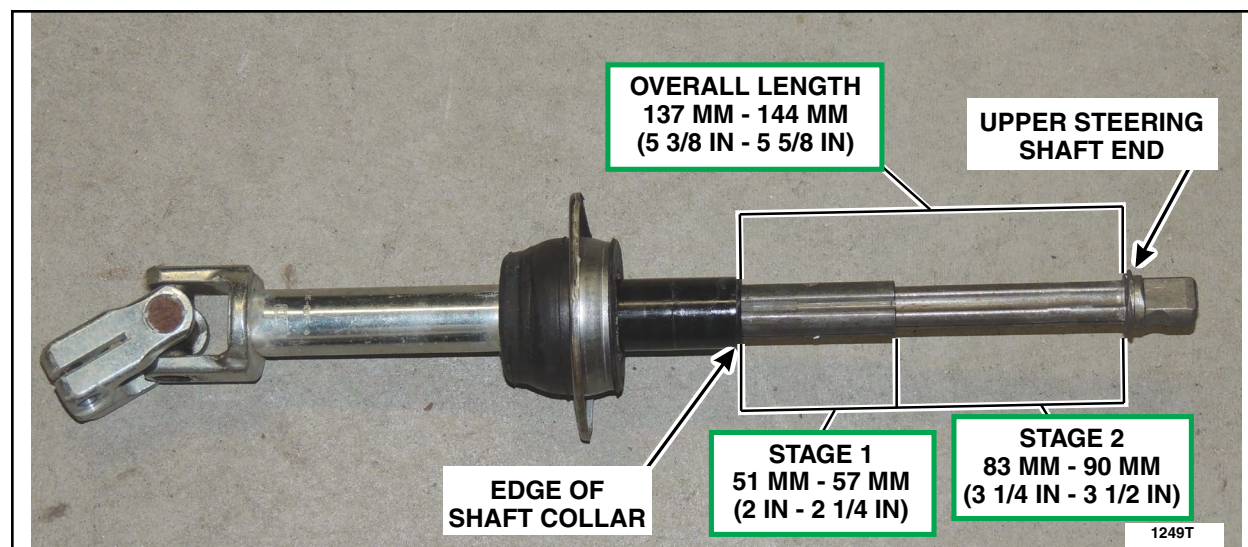
FIGURE 1

1. Measure the length of Stage 1, Stage 2, and the overall length between the upper steering shaft end and the edge of the shaft collar. See Figures 1 and 2.
 - If Stage 1 is less than 51 mm (2") or greater than 57 mm (2 1/4"), it fails inspection.
 - If Stage 2 is less than 83 mm (3 1/4") or greater than 90 mm (3 1/2"), it fails inspection.
 - If the upper steering shaft overall measurement is less than 137 mm (5 3/8") or greater than 144 mm (5 5/8"), it fails inspection.

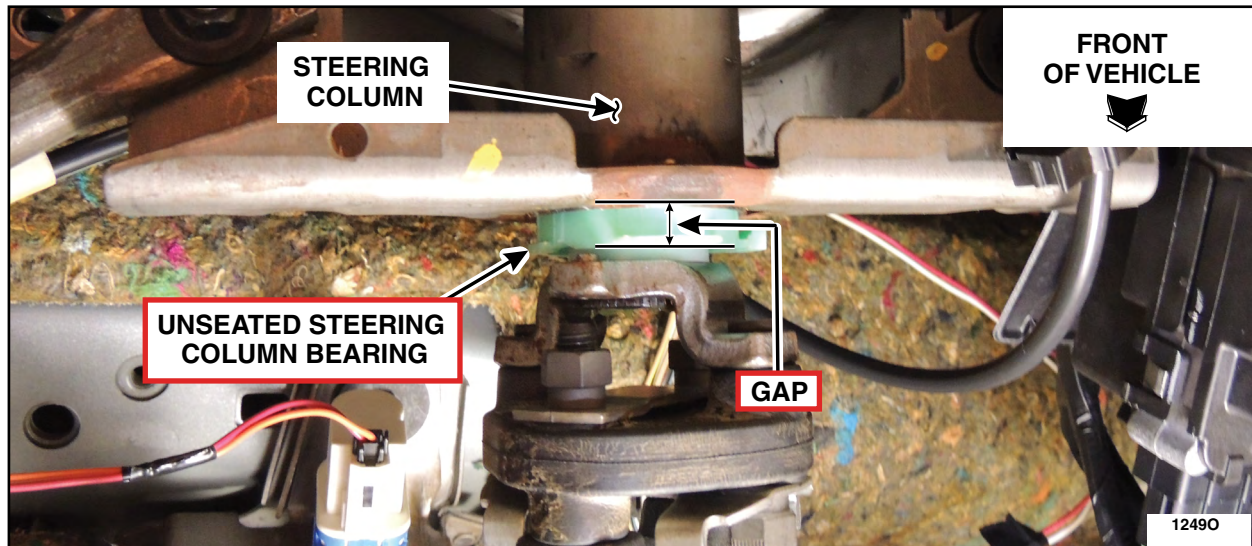
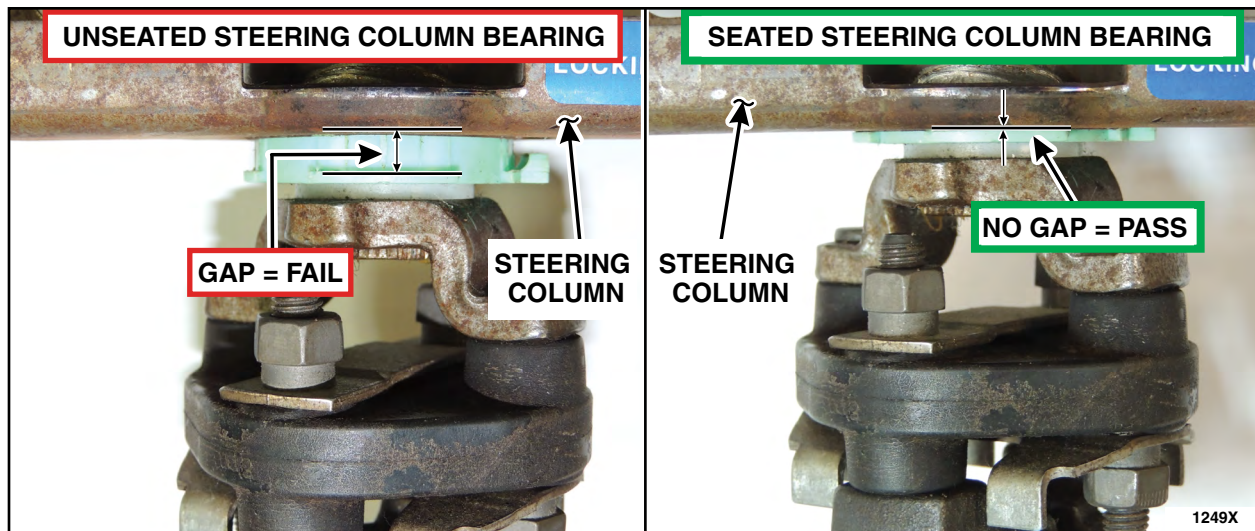
FIGURE 3

1. Inspect the steering column for an unseated steering column bearing. See Figures 3 and 4.

- If the steering column bearing is unseated, it fails inspection.

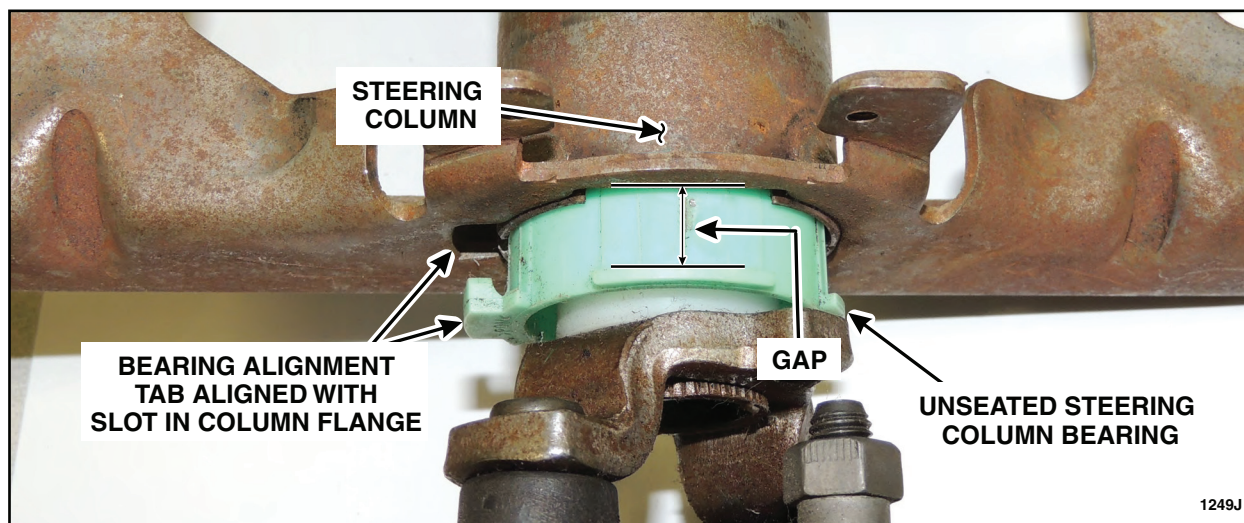
FIGURE 4

NOTE: In some instances the steering column bearing orientation tab may have broken off. If the tab has broken off, the bearing is still usable and can be seated within the steering column in any orientation.

2. Align the bearing alignment tab with the slot in the column flange. See Figure 4.
