Michael A. Berardi  
Director  
Service Engineering Operations  
Ford Customer Service Division

November 24, 2014

**SUBJECT:** **DEMONSTRATION / DELIVERY HOLD – Safety Recall 14S23**  
Certain 2015 Model Year Transit Vehicles with Diesel Engine  
Install Fuel Filter Reinforcement Bracket

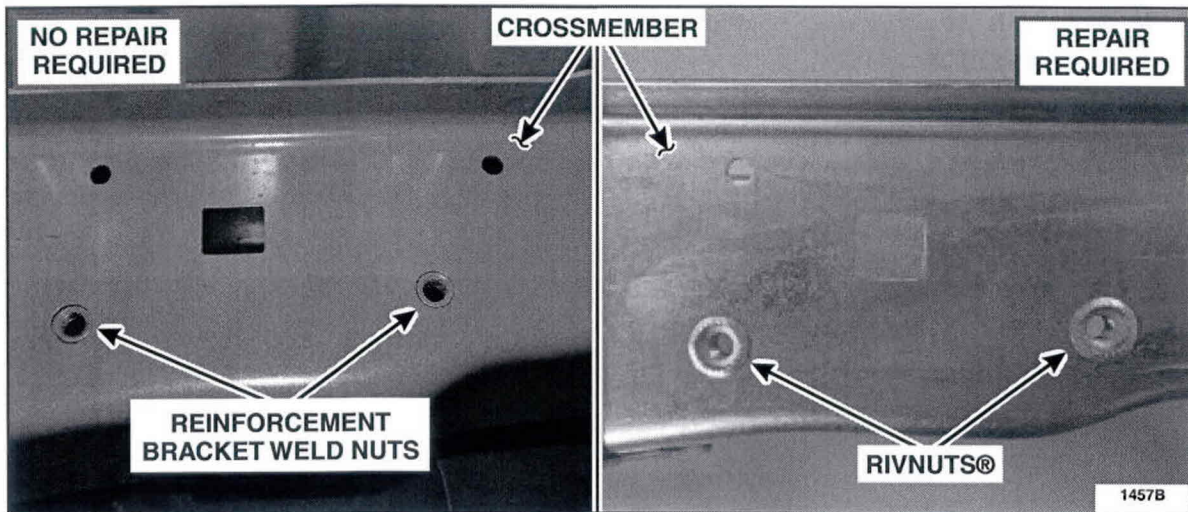
FIGURE 2

3. Inspect the crossmember area behind the fuel filter bracket location to determine if Rivnuts® have been installed. Rivnuts® are identifiable by a raised surface on the crossmember similar to a rivet. See Figure 2.

- If Rivnuts® have been installed, proceed to Step 4 below.
- If Rivnuts® have not been installed, proceed to Step 19.
