November 13, 2014

DEMONSTRATION / DELIVERY HOLD - Compliance Recall 14C10 - Supplement #1
Certain 2014 Model Year F-150 and Flex Vehicles with Manual Passenger Seats and

Certain Vehicles Serviced with a Suspect Seat Track Assembly

Seat Frame Clearance Adjustment

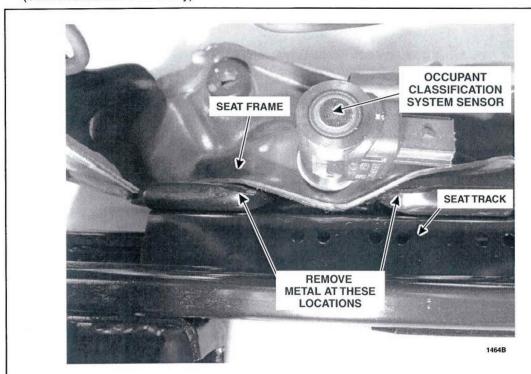
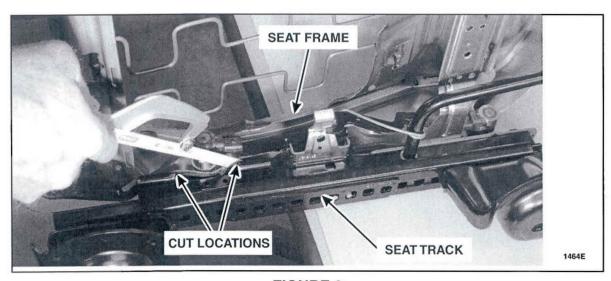
Reduced clearance between the seat frame and adjacent seat track may cause the Occupant Classification System (OCS) to inaccurately register the weight of the passenger. We anticipate that approximately 95% of the affected vehicles will have this condition. Therefore, the technician may find the clearance between the seat frame and seat track is already equal to or greater than the specified 0.7 mm (0.028 in), and no clearance adjustment is necessary.

3. Using a 32 teeth per inch metal hacksaw blade, insert the blade down alongside the seat frame. Using gentle force on the hacksaw blade, cut the metal as you move the blade through the contact area. Do this at both locations at each side of the sensor. See Figures 1 and 2 (Seat disassembled for clarity).
