This Service Information bulletin supersedes SI M52 01 14 **dated October 2014.**

**Delivery Stop: Seat Backrest Adjustment**

**NEW** F56 (Cooper)

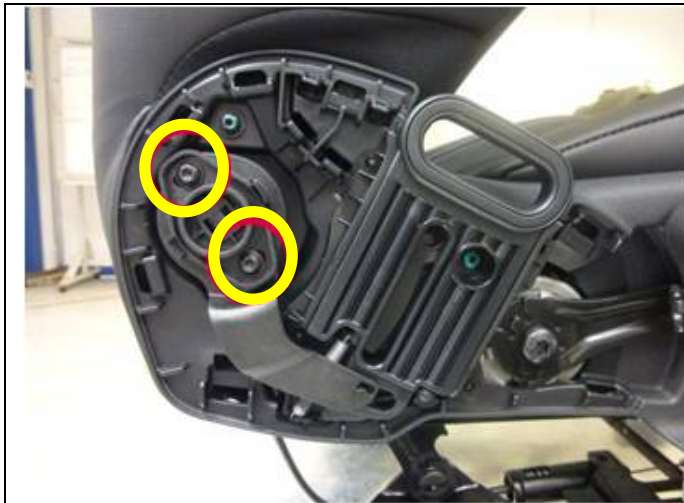
The screws for the seat backrest adjuster are circled.
