Subject: Haldex Life Seal Brake Chambers

Models Affected: Specific Freightliner 108SD, 114SD, 122SD, Argosy, Business Class M2, Cascadia, and Coronado vehicles and Western Star 4700 and 4900 vehicles manufactured September 17, 2014, through February 20, 2015.

Recall Campaign

September 2015
FL676A-N
NHTSA #14V-758 and #15V-158
Transport Canada #14-548

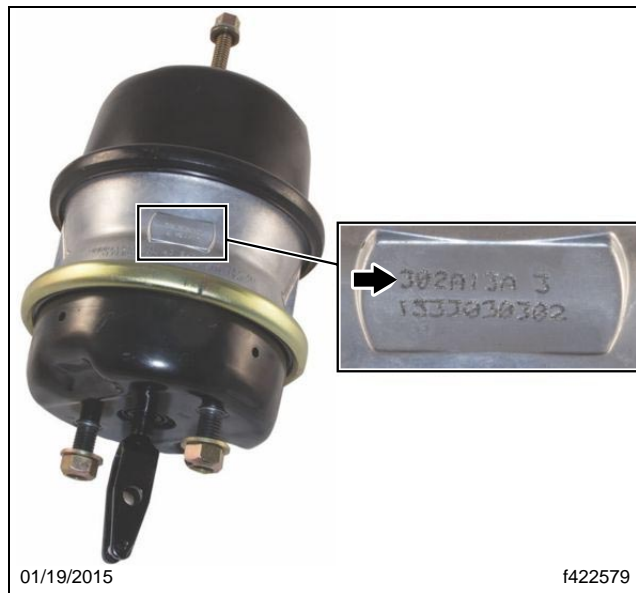
Fig. 1, Date Code

The Julian date is on the stamp-side of the brake chamber. See **Fig. 1**.

The first three digits indicate the Julian calendar day of the year. The fifth and sixth digits indicate the last two numbers of the year. In the example shown, the Julian date is 302 of 2013 (October 29, 2013).

If the date code is within the Julian dates of **09 through 301 of 2014**, (January 9, 2014, through October 28, 2014), the brake chamber needs to be replaced. Write down the Julian date code and part number of each suspect brake chamber (this information will be required on the campaign payment claim), then proceed with step 4.

If the date code is not within the suspect date, no further work is needed. Clean a spot on the base label (Form WAR259). Write the campaign number, FL676, on a blank red completion sticker (Form WAR260) to indicate the work has been completed and attach it to the base label.

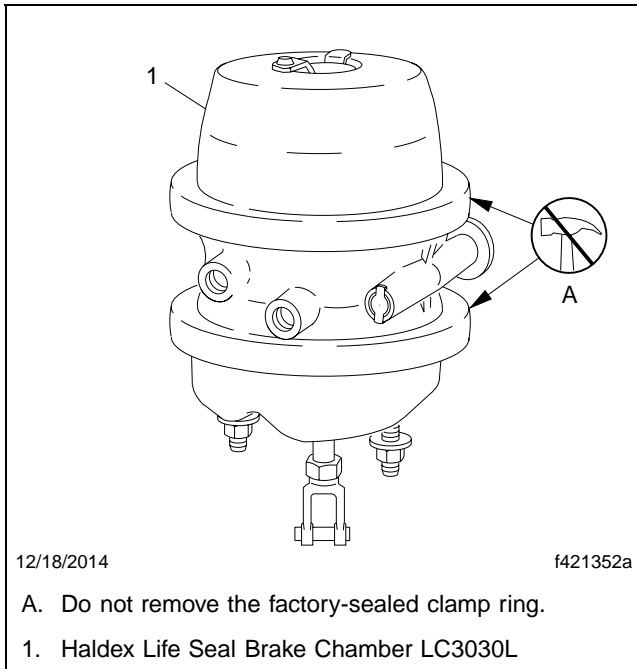
Fig. 2, Brake Chamber

Do not attempt to remove the factory-sealed parking brake clamp ring, shown in Fig. 2, for any purpose, at any time. The parking/emergency brake section is not intended to be serviced. Serious injury or death may result from the sudden release of the power spring.
