# IMPORTANT SAFETY RECALL

General Motors has decided that a defect which relates to motor vehicle safety exists in your 2003- 2011 model year (MY) Cadillac CTS or 2004-2006 MY Cadillac SRX vehicle. As a result, GM is conducting a safety recall. We apologize for this inconvenience. However, we are concerned about your safety and continued satisfaction with our products.

GM Recall Number: 14172

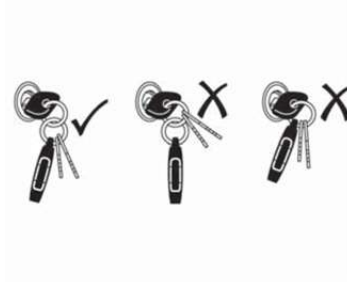
The combination and size of the rings that came with your keys were specifically selected for your vehicle. The rings are connected to the key like two links of a chain to reduce the risk of unintentionally moving the key out of the RUN position. Do not add any additional items to the ring attached to the ignition key. Attach additional items only to the second ring, and limit added items to a few essential keys or small, light items no larger than an RKE transmitter.
