## IMPORTANT SAFETY RECALL

NHTSA Safety Recall No. 14V-616
------------------------------------

# Customer Service Notice

## Trailer Tongue Inspection and Repair

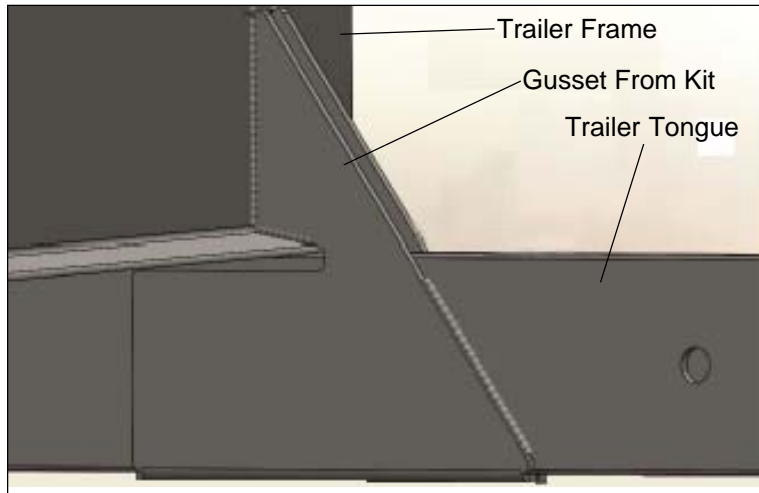
1. Position the unit on a level surface and chock the wheels.
2. Look at the point where the trailer tongue joins the frame. If the gusset (refer to Figure 1) has already been installed, the trailer has already been repaired and no further action is required. Continue to Step 7. If there is no gusset, continue to Step 3.

**Figure 1 — Gusset Installed**

Each of the affected trailers must have also the Tongue Reinforcement Kit, part number 970471319, installed to strengthen the joint between the tongue and the trailer frame. Contact Altec at 1-877-GO-ALTEC (1-877-462-5832) to order the kit or to schedule the work to be done by an Altec service technician at an Altec facility. Customers are responsible for the labor and travel costs of an Altec Mobile Service technician if the technician performs the inspection at the owner's location.

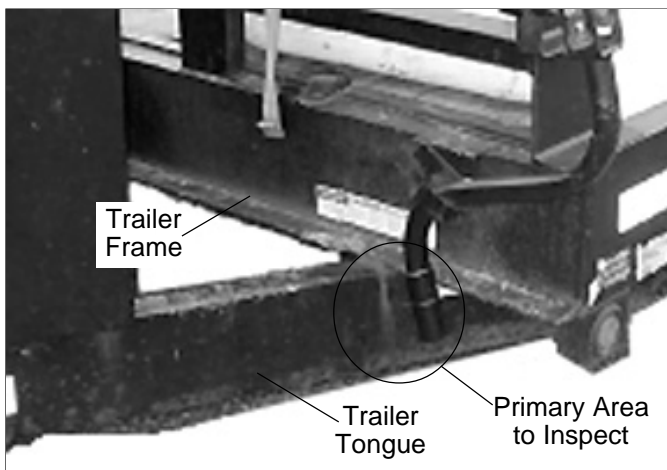
The trailer tongue may have cracks where the tongue tube attaches to the trailer frame. If the cracks are not repaired or the repair kit is not installed, the tongue can separate from the frame. **Death or serious injury can result from unexpected movement of the trailer while traveling.**

3. Clean all corrosion or dirt and debris from the area where the trailer tongue attaches to the frame. Use a wire brush or rotary sander to complete the cleaning.
4. Use a strong light to search for any evidence of cracks in the tongue tube (refer to Figures 2 and 3). Make sure to inspect all of the tube surfaces on both sides of the tongue.

**Figure 2 — Possible Crack Location**

5. If any cracks are found, measure the length and note the location of any crack. If the crack is more than 3 inches long, contact Technical Support (1-877-GO-ALTEC , prompt 4) for further assistance. If the crack is less than 3 inches, it must be repaired before any repair kit is added. Use the following steps to repair the crack.

- c. Drill a  $\frac{3}{16}$  inch diameter hole through the material one inch past the end of the crack. This stop drill hole is to prevent the crack from extending.

- d. Grind out the crack in the shape of a “V” between the edge of the material and the stop drill hole. The depth of the “V” should be approximately  $\frac{1}{8}$  inch.

- e. Weld along the “V” groove using low hydrogen ER70S-6 wire with CO<sub>2</sub> shielding or LH7018 electrodes. The weld should fill the groove and the stop drill hole, leaving a convex bead. An AWS qualified welder using AWS standards should apply the weld. The welding ground clamp must be connected to the frame of the trailer.

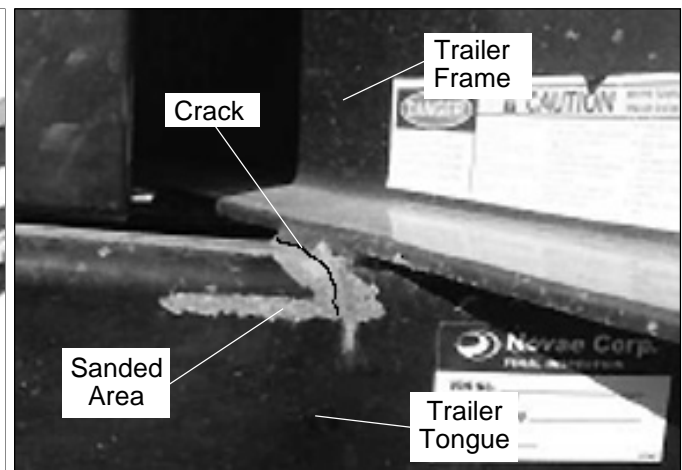
**Figure 3 — Close View Of Crack**
