VILLA INTERNATIONAL				
ABTS HINGE LINK, RECALL REPAIR				
JGM 4.21.14	SIZE	FORM NO.	DWG NO.	REV
	SCALE		02

REFERENCE NHSTA RECALL # 14E009

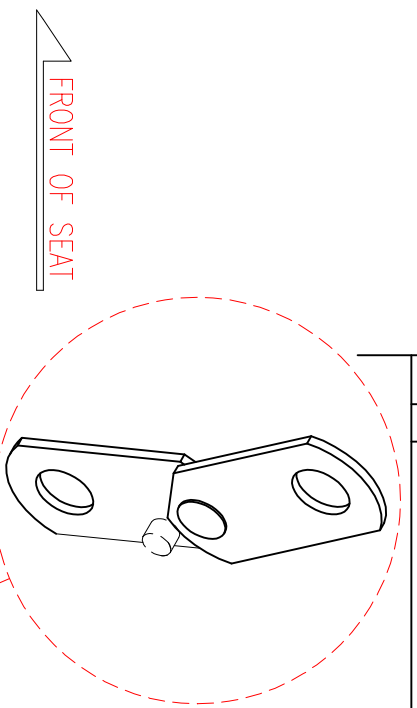
LH SIDE VIEW

ABTS HINGE LINK
SHOWN INSTALLED
INCORRECTLY
WHEN THE LOWER
LINK IS INBOARD
TOWARD THE SEAT
FRAME.

THIS REPAIR IS INTENDED ONLY FOR THOSE ABTS HINGES INSTALLED INCORRECTLY AS SHOWN IN THE LH SIDE VIEW.

REMOVE TWIST IN SEAT BELT BEFORE INSTALLING SHEATH AND FASTENING END.
