### **Delivery Stop: I12 Check Fuel Tank**

I12 (i8)

**FUEL TANK GROUND STUD INSPECTION**

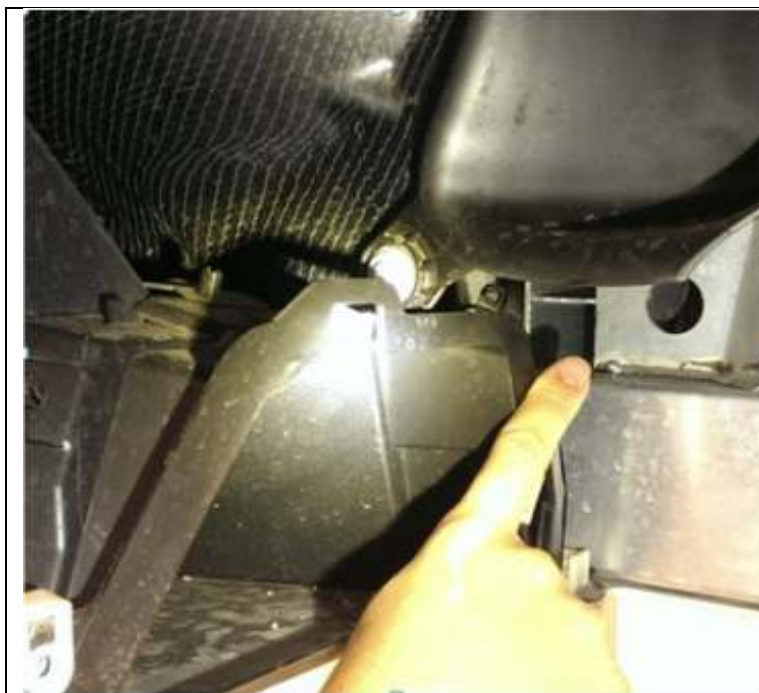
1. Remove the rear left wheel arch cover per Repair Instruction REP 51 71 041, "Removing and installing/replacing rear left or right wheel arch cover."

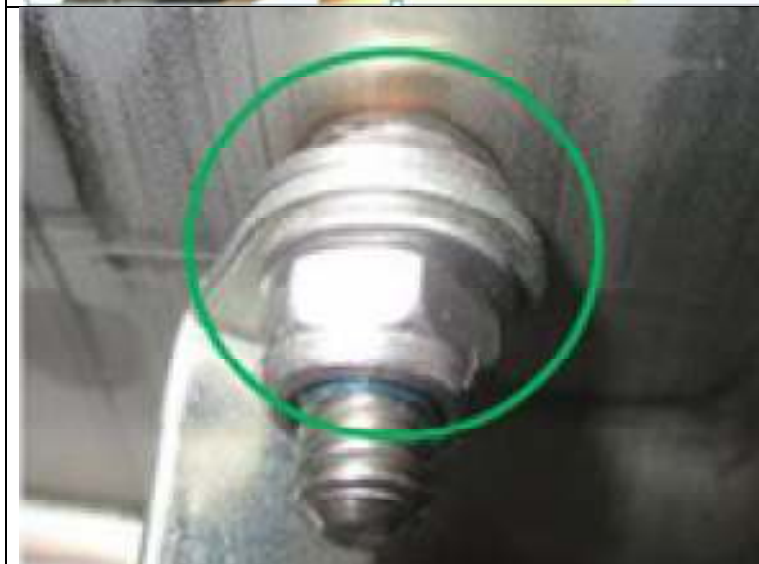
2. Visually inspect the weld of the fuel tank ground stud through the wheel arch.
