Delivery Stop: I12 Check Fuel Tank

I12 (i8)

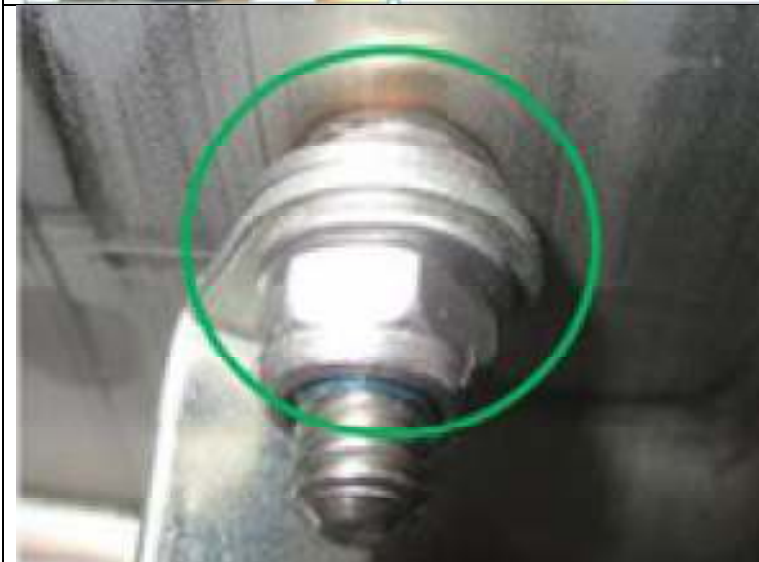
2. Visually inspect the weld of the fuel tank ground stud through the wheel arch.

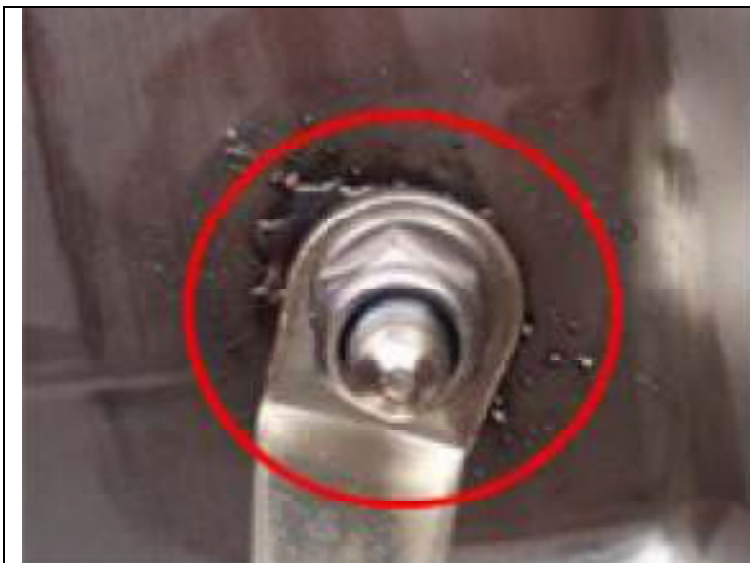
3. If the weld is clean and free of weld spatter and is not leaking, no further steps are required and the vehicle can be delivered to the customer.

4. If weld spatter is found or the weld is leaking, **do not** release the vehicle to the customer. Submit a technical PuMA case and further information will be provided.
