PART 573 Defect and Non-compliance Report

Hino Motors, Ltd. (HML)

Vehicle Type: MY2012-2015 XJC and XFC on-road Light Duty Truck

MY2012 -2015 XJC and XFC models equipped with hydro-assist brake

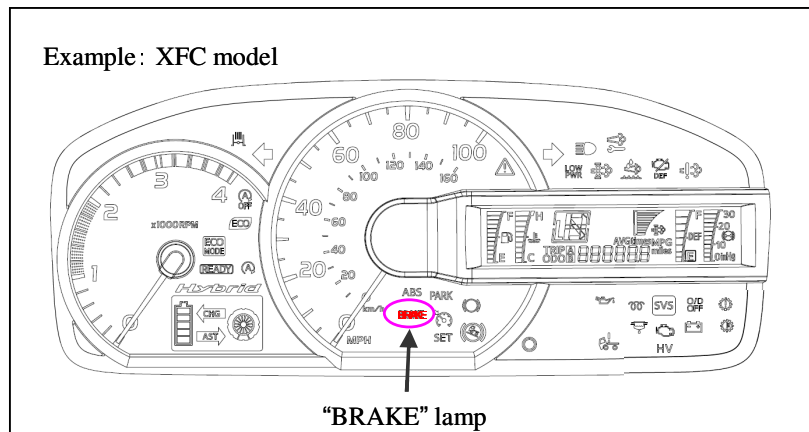
The red “BRAKE” warning lamp in the combination meter, which indicates a loss of brake fluid pressure, or low brake fluid level, may not illuminate during the check of lamp function when the ignition switch is turned to the “ON” position when the engine is not running. This does not comply with the requirements of Federal Motor Vehicle Safety Standard 105 S5.3.2.

The software of the ABS ECU is incomplete. The software required to initiate the illumination of the red “BRAKE” warning lamp during the check of lamp function, when the ignition switch is turned to the "ON" position, when the engine is not running, is not included.

The ABS ECU will be reprogrammed. The Software which illuminates the red "BRAKE" warning lamp when the ignition key is turned to the "ON" position when the engine is not running will be installed.
