## Technical Bulletin

### ConMet PreSet Plus™ Hub Lock Ring Inspection and Repair Procedures

Inspection Program C14AA

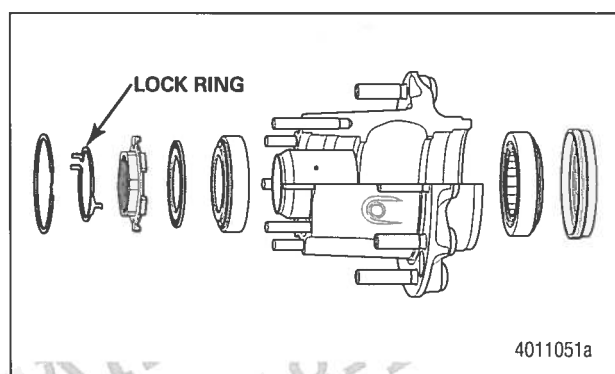
Figure 1

This publication provides the procedure required to check for the presence of the ConMet PreSet Plus™ hub lock ring at each drive axle wheel-end assembly. This inspection only applies to specific axles in a very limited number of vehicles. There is no need to perform this inspection unless specifically contacted by the OEM or Meritor. Figure 1.

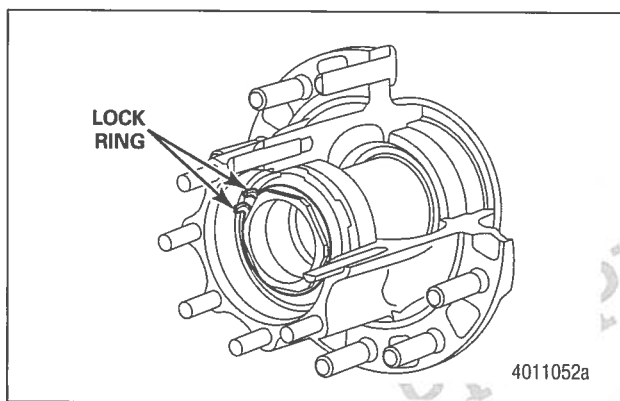
1. Wear safe eye protection. Park the vehicle on a level surface. Block the wheels to prevent the vehicle from moving.
2. Remove the axle shaft fasteners from all drive axle wheel ends.
3. Remove the axle shaft from each drive axle wheel end. Some lubricant will drain from the hub upon axle shaft removal. Use a small drain bucket to catch the lubricant.
4. Check for the presence of the lock ring on all drive wheel axle wheel ends. The lock ring is a bright red color. Refer to Figure 2 for the location of the lock ring.
  - **If the lock ring was present on all drive axle wheel ends:** Continue to the Reassembly procedure.
  - **If one or more lock rings were missing from the drive axle wheel ends:** Continue to the Missing Lock Ring Procedure.

1. Check that the spindle nut torque is 500 lb-ft (677 N•m) on each wheel end missing a lock ring.
  - **If the spindle nut torque is correct:** Install a lock ring in the correct orientation per the OEM's or ConMet's assembly guidelines.
  - **If the spindle nut torque is not correct:** Replace the ConMet PreSet Plus™ hub assembly on the wheel end.
2. Continue to the Reassembly procedure in this publication.
