# Recall Bulletin

## PRODUCT SAFETY RECALL

**SUBJECT:** Ignition Switch Replacement

**MODELS:** 2006-2007 Chevrolet HHR  
2006-2007 Pontiac Solstice  
2003-2007 Saturn Ion  
2007 Saturn Sky

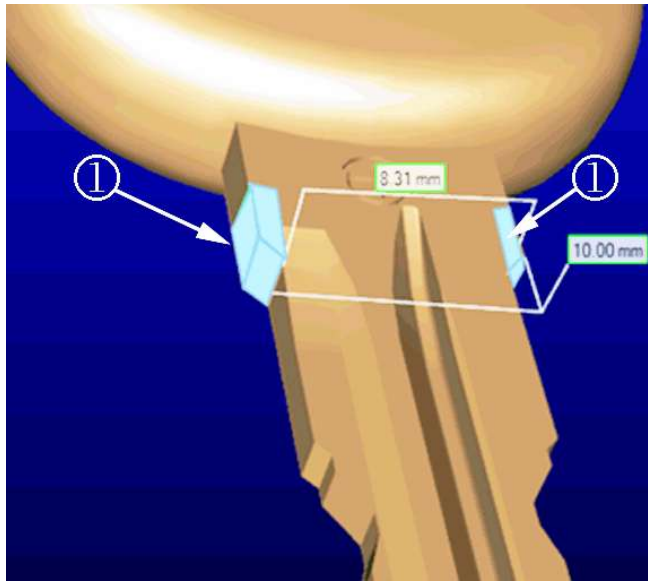
3816569

For the Saturn Ion only, if the replacement key profile is wider near the key head than the original equipment manufacturer (OEM) key, it may only work in the ignition lock cylinder and not in the doors or trunk. The replacement key may require modification BEFORE it can be used to open a vehicle door or trunk. Perform the Key Modification procedure in this bulletin if the replacement key will not open the doors or trunk of the vehicle.

1. Using a file, remove the extra width of key near the over molded head as shown in blue (1) in the photograph above. Removing this material makes the width of the key 8.3mm (same as the OEM key) rather than 10mm. This will allow the key to enter fully into the door and trunk lock cylinders.

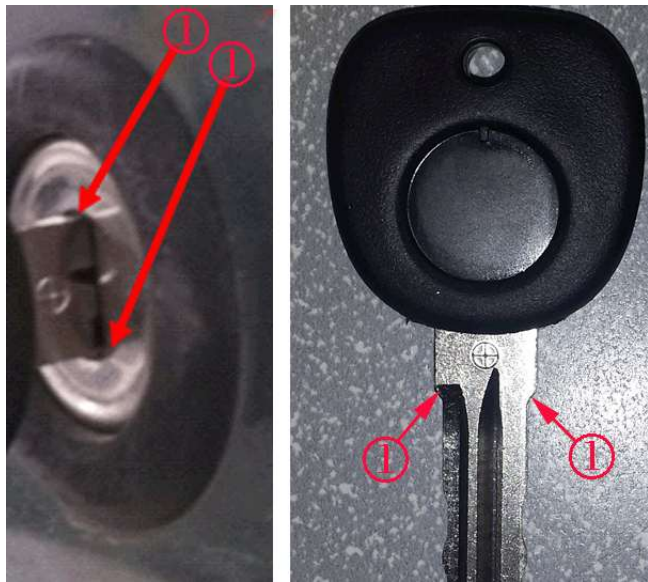
3817005

**Note:** Without the modification, the key stops on the shoulder and will not fully enter the key lock cylinder. Refer to the photograph.
