GM CUSTOMER CARE AND AFTERSALES
DCS3183
URGENT - DISTRIBUTE IMMEDIATELY

Subject: 14063 - Safety Recall
Ignition Switch Replacement

Models: 2006-2007 Chevrolet HHR
2006-2007 Pontiac Solstice
2003-2007 Saturn Ion
2007 Saturn Sky

SUBJECT: Ignition Switch Replacement

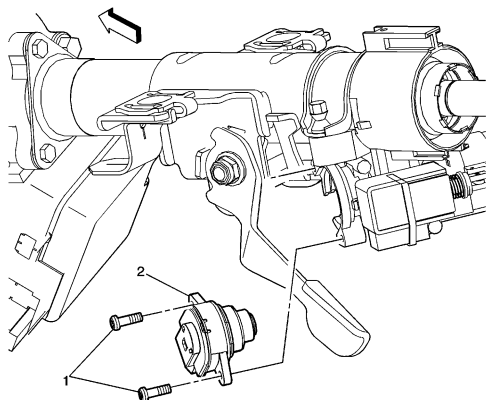
2085987

General Motors has decided that a defect which relates to motor vehicle safety exists in 2006-2007 model year (MY) Chevrolet HHR, 2006-2007 MY Pontiac Solstice, 2003-2007 MY Saturn Ion, and 2007 MY Saturn Sky vehicles. There is a risk, under certain conditions, that the ignition switch may move out of the “run” position, resulting in a partial loss of electrical power and turning off the engine. This risk increases if the key ring is carrying added weight (such as more keys or the key fob) or the vehicle experiences rough road conditions or other jarring or impact related events. If the ignition switch is not in the run position, the air bags may not deploy if the vehicle is involved in a crash, increasing the risk of injury or fatality.

1. Remove the ignition switch from the vehicle. Refer to *Ignition and Start Switch Replacement* in SI.
2. Install a new ignition switch. Refer to *Ignition and Start Switch Replacement* in SI.
