Exhaust Catalyst Inlet Cummins ISL-G LEU

SC0376, Exhaust Catalyst Inlet

(April 2014)

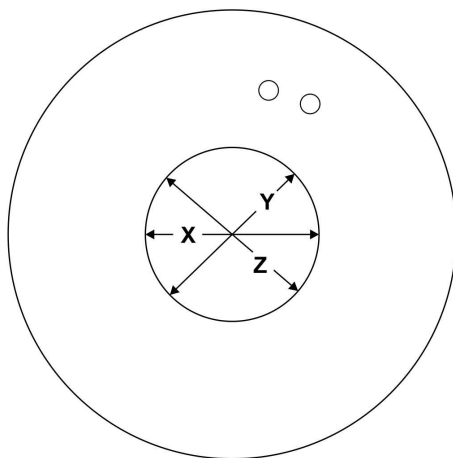
W2089472

- 9 Inspect the exhaust catalyst inlet flange by measuring the inside diameter at three locations (X, Y and Z). The inside diameter must be 101.7 – 102.7 mm (4 – 4.04 in).

If inside diameter of flange is damaged or does not meet specification, the exhaust catalyst inlet must be replaced. Continue to Step 10.

If inside diameter of flange is not damaged and meets specification, proceed to Step 26.
