## Exhaust Catalyst Inlet Cummins ISL-G LEU

### SC0376, Exhaust Catalyst Inlet

(April 2014)

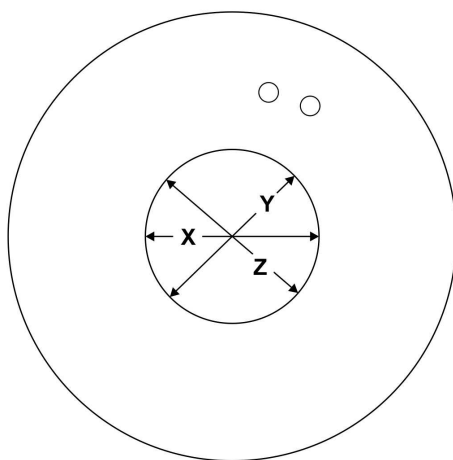
W2089472

- 9 Inspect the exhaust catalyst inlet flange by measuring the inside diameter at three locations (X, Y and Z). The inside diameter must be 101.7 – 102.7 mm (4 – 4.04 in).

If inside diameter of flange is damaged or does not meet specification, the exhaust catalyst inlet must be replaced. Continue to Step 10.

If inside diameter of flange is not damaged and meets specification, proceed to Step 26.

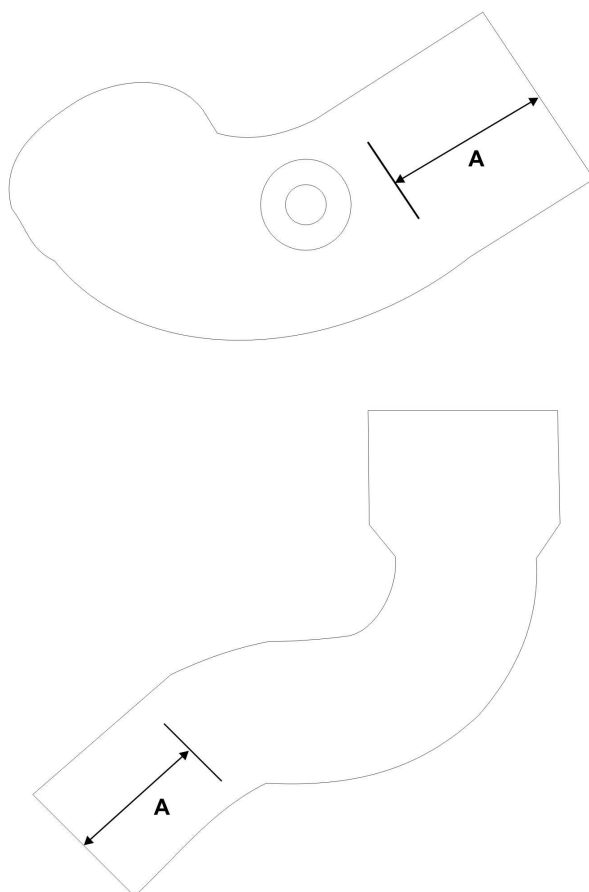
W2089516

A = 76 mm (3 in)

28 To determine insertion depth of piping into clamps, mark the turbocharger outlet pipe and the catalyst inlet pipe 76 mm (3 in) inward from the mating end to the flex pipe.

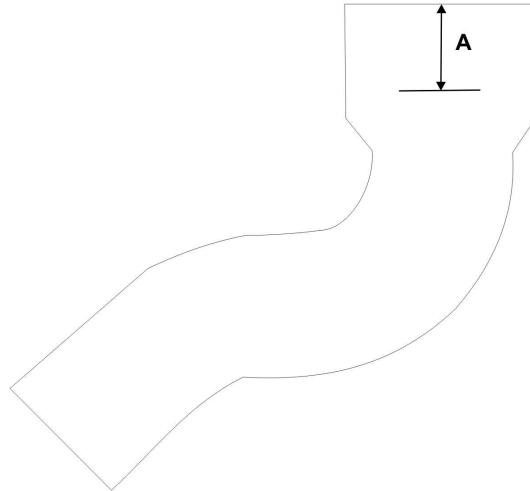
W2089517

A = 58 mm (2.25 in)

- 29 To determine insertion depth of the inlet pipe into catalyst inlet flange, mark 58 mm (2.25 in) from end of catalyst inlet pipe.
