AE01 - Replacing Engine (Recall Campaign)

Vehicle Type: **911 GT3 (991)**

Concerns: **Connecting rod bolts**

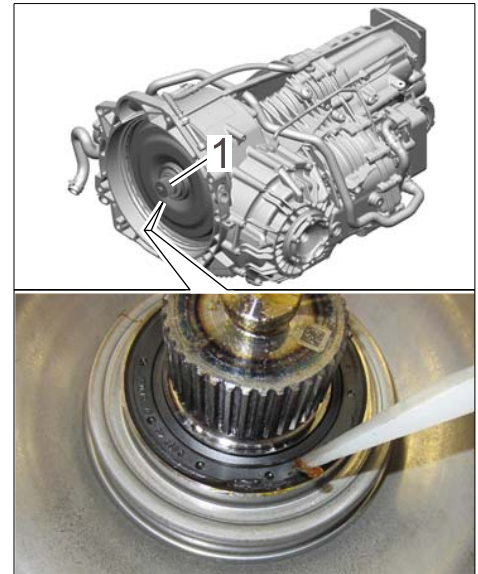
Grease residue in the drive journal area

- In the radial shaft seal area on the drive journal ⇒ *Grease residue in the drive journal area -1-*.

These **deposits and traces of grease** do **not impair** operation and must not be confused with **oil leaks (liquid)** .

If there are **oil leaks** in the double-clutch area on the PDK transmission, these must be documented and found if possible. Your importer must then contact the Porsche AG Technical Competence Centre in order to agree on how to proceed.

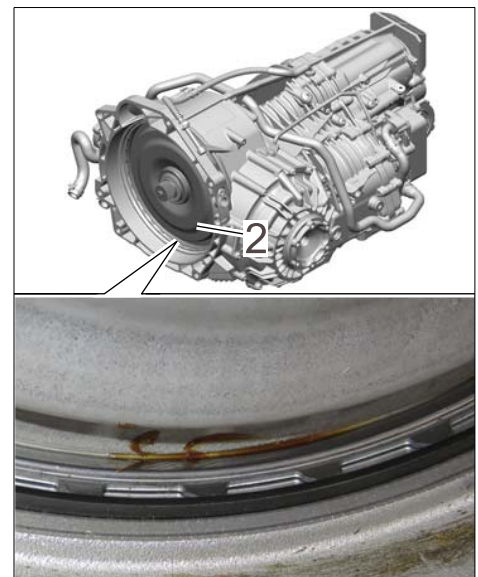
Grease residue in the double-clutch area

- In the transmission bell housing area or in the outer double-clutch area ⇒ *Grease residue in the double-clutch area -2-*.

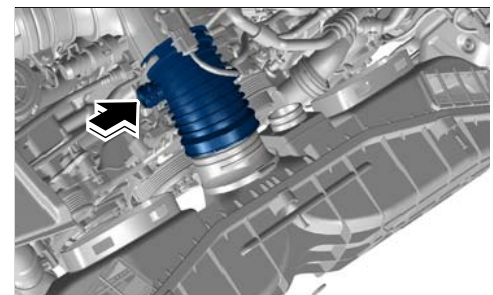
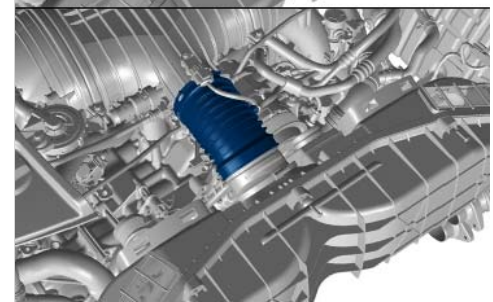
Different type of rubber scoop

Vehicles **up to** engine number **MA175 E 01068** (engine to be replaced) are fitted with a bleeding system for crankcase and oil tank ventilation, on which the vent line is connected to the rubber scoop ⇒ *Different type of rubber scoop -top-*.

Vehicles **as of** engine number **MA175 E 01069** (engine to be replaced) are fitted with a bleeding system for crankcase and oil tank ventilation, on which the vent line is connected to the resonance tube and as a result, there is no connection at the side of the rubber scoop ⇒ *Different type of rubber scoop -bottom-*.

The vent line is also connected to the resonance tube on the new engine to be installed as part of this measure. Given this, on vehicles with an engine that must be replaced - up to engine number **MA175 E 01068**, the rubber scoop on the air cleaner housing must be replaced by a modified rubber scoop with no side connection for the vent line when installing the new engine (Invoicing: Scope 1).
