Subject: 14048A - Noncompliance Recall
Transmission Shift Cable Adjuster Body Fracture
Customer Letter Added

Models: 2014 Buick Enclave, LaCrosse, Regal, Verano; Chevrolet Cruze, Impala,
Malibu, Traverse; and GMC Acadia

Recall Bulletin

SUBJECT: Transmission Shift Cable Adjuster Body Fracture

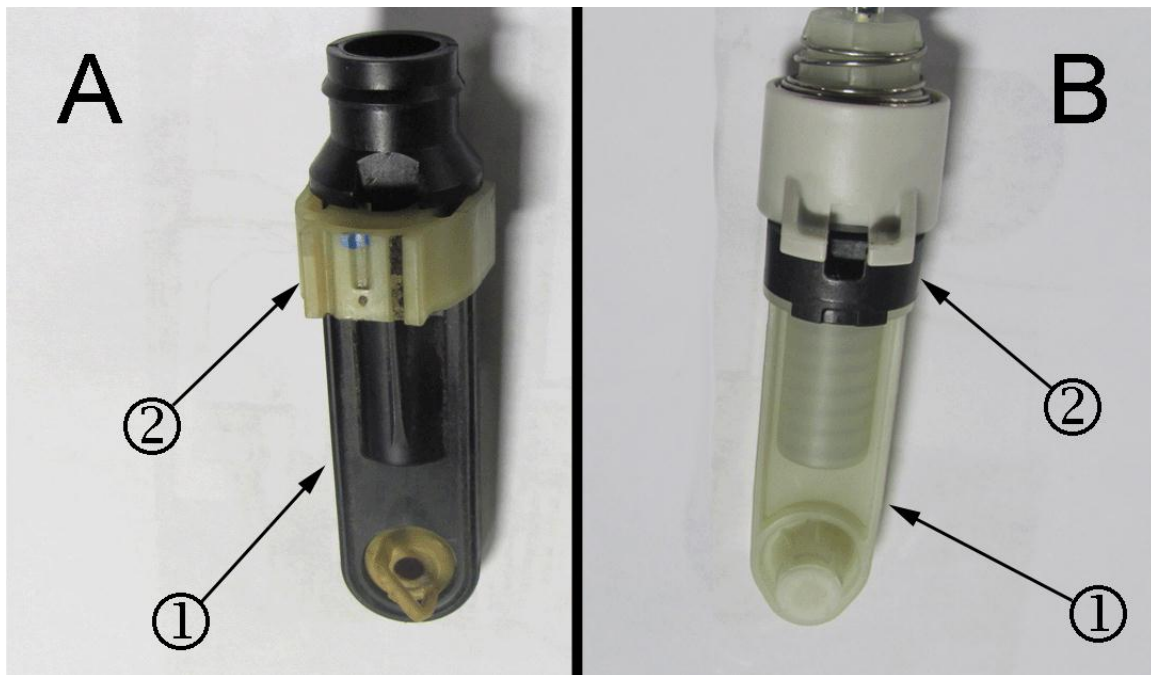
3723122

A first design shift cable adjuster body (1) is black and the lock clip is white (2). Refer to the 'A' portion of the photograph. A second design shift cable adjuster body is white and the lock clip is black. Refer to the 'B' portion of the photograph.

2. Determine what design shift cable adjuster body and lock clip are installed on the vehicle.
 - If the vehicle is equipped with a first design shift cable adjuster body and lock clip (A), no further action is required. A first design shift cable adjuster body is black (1) and the lock clip is white (2).
 - If the vehicle is equipped with a second design shift cable adjuster body and lock clip (B), proceed to step 3. A second design shift cable adjuster body is white (1) and the lock clip is black (2).
3. Ensure the transmission range selector lever is in the PARK position.
4. Ensure the transmission shift lever is in the PARK position.

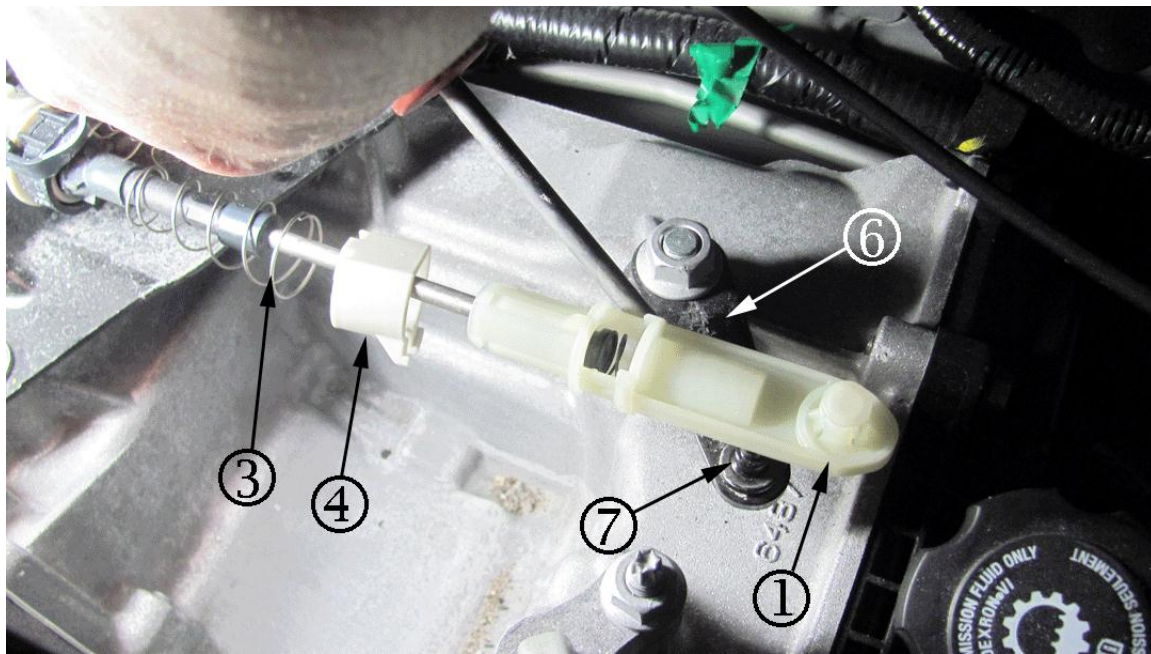
3723165

Caution: Do NOT aggressively pry the adjuster body end off (1) of the transmission lever ball stud (7). The end of the adjuster body (1) should only be raised high enough to clear the transmission lever ball stud (7) to avoid damaging the shift cable.

9. Carefully remove the front portion of the shift cable adjuster body (1) from the transmission lever ball stud (7).
10. Remove the adjuster body (1), secondary cover (4) and cover spring (3) from the shift cable.

Note: Do NOT reuse the white adjuster body, secondary cover or cover spring. The spring inside the white adjuster body, however, must be transferred to the black adjuster body.

11. Remove the spring inside the white adjuster body and insert it into the new black adjuster body.
