# Recall Bulletin

## PRODUCT SAFETY RECALL

**SUBJECT:** Brake Booster Pump – Cavity Plug

**MODELS:** 2013 and some 2014 Cadillac XTS

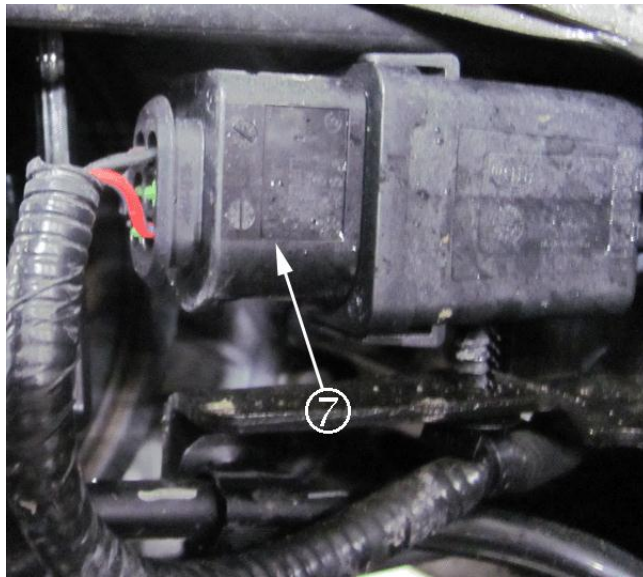
3773716

3. Locate the power brake booster pump electrical connector (7).
4. Disconnect the power brake booster pump electrical connector (7).
5. Inspect the connector for debris and/or corrosion. Clean the connector if required.
6. Determine if three green plugs are installed in the backside of the connector. The green plugs are installed into three of the six cavities on the backside of the connector. Refer to the photograph below.

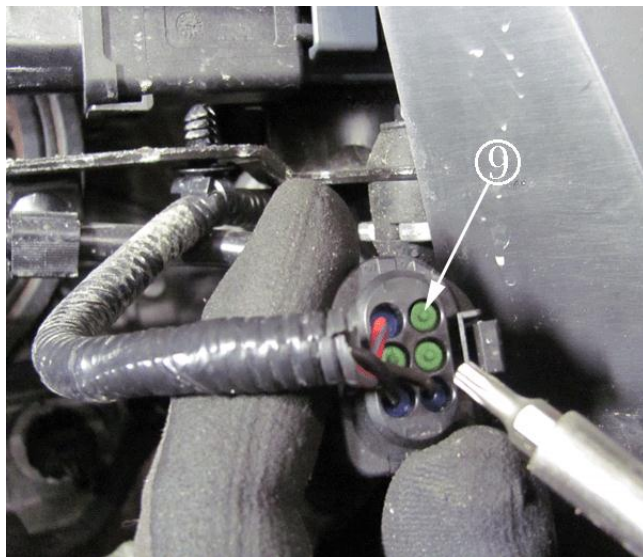
3773742

- If the three green plugs (9) are installed into three of the cavities on the backside of the connector, proceed to step 7.

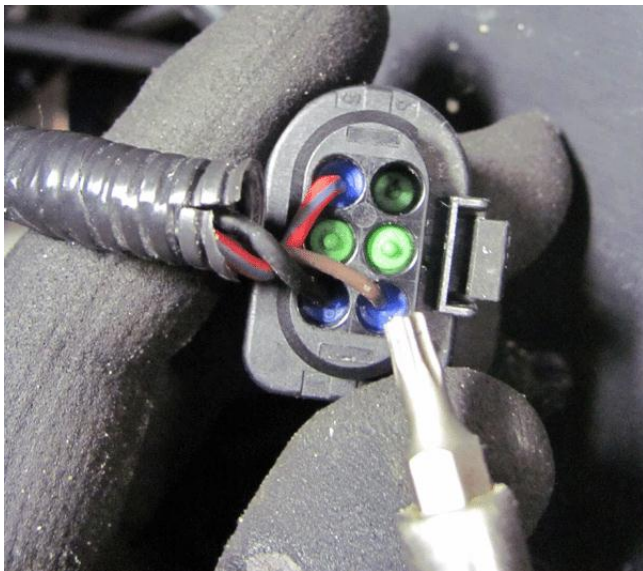
3773737

**Caution:** To avoid damaging the green plugs, do NOT use a sharp-edge tool to push the plug down into the cavity.

7. Lightly push the green plugs to the bottom of the cavity using a small Phillips head screwdriver or T-25 Torx head screwdriver.
