Bulletin No.: 14030A  
Date: April 2014

# Recall Bulletin

**SUBJECT:** Side Impact Airbag Connector

**MODELS:** Some 2008-2009 and all 2010-2013 Buick Enclave  
Some 2009 and all 2010-2013 Chevrolet Traverse  
Some 2008-2009 and all 2010-2013 GMC Acadia  
Some 2008-2009 and all 2010 Saturn OUTLOOK

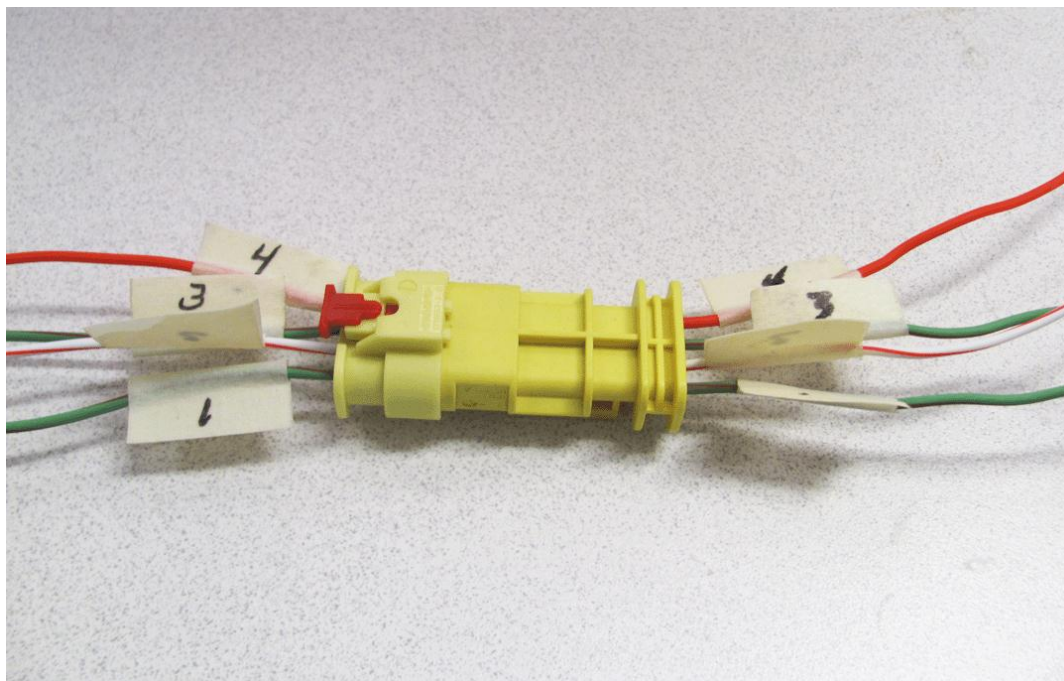
3782976

**Four-way connector shown with wire harness out of vehicle for illustration purposes. It is critical that the wire pairs are identified correctly to avoid splicing incorrect wire pairs.**

**Note:** Before removing the yellow connector from the seat and body harness, note the wire colors of the seat and body harness. Some wire pairs may be a slightly different color. Some wire pairs may have different colors. Ensure the wires are matched BEFORE splicing the wires of the seat and body harness together. Use the cutoff connector as a wire color template. BEFORE removing the connector from the harness, mark or identify wire pairs of similar color using a pen and tape to ensure the correct wires are spliced together. The first photograph shows a 4-way connector (1) and a 6-way connector (2).
