Subject: 14030 - Safety Recall – Release from Stop Delivery Upon
Completion of Recall
Side Impact Airbag Connector

Models: Some 2008-09 and all 2010-13 Buick Enclave and GMC Acadia;
some 2009 and all 2010-13 Chevrolet Traverse; and some 2008-
09 and all 2010 Saturn OUTLOOK

Recall Bulletin

SUBJECT: Side Impact Airbag Connector

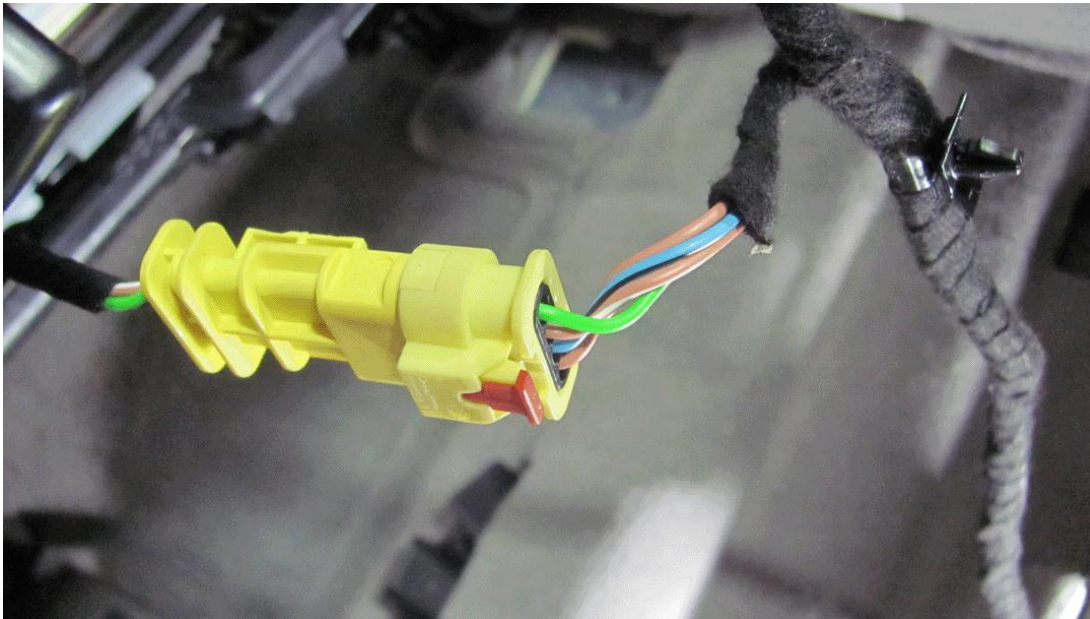
3714178

A yellow 4-way connector shown. The 2-way or 6-way yellow connector is similar.

3. Locate the yellow 2-way, 4-way, or 6-way connector under the seat.

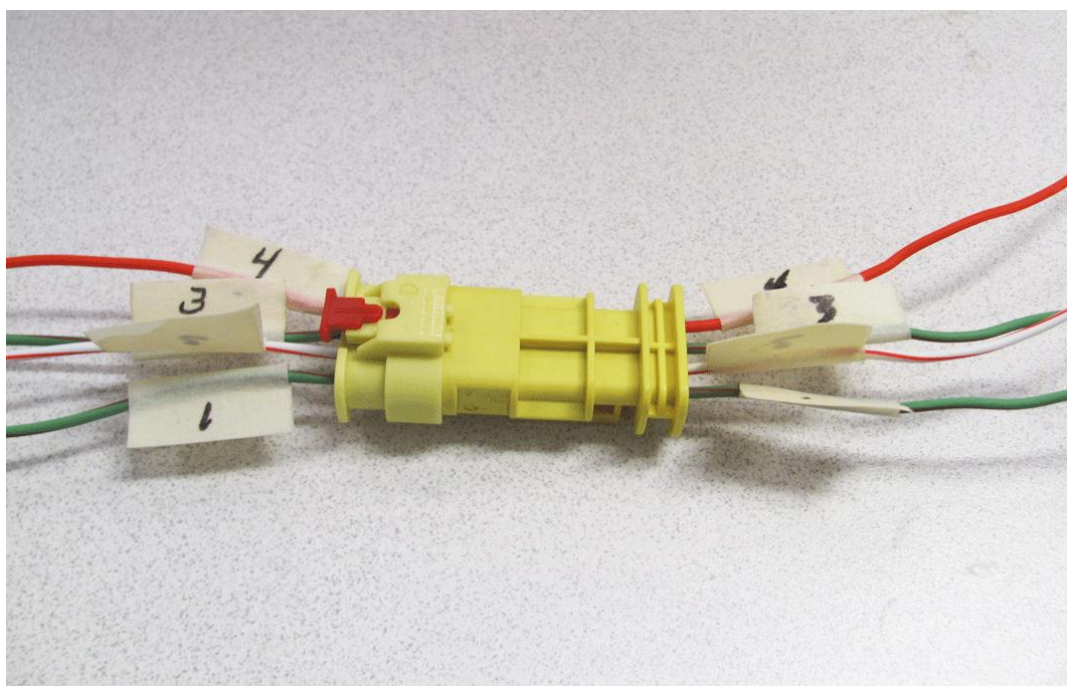
3782976

Four-way connector shown with wire harness out of vehicle for illustration purposes. It critical that the wire pairs are identified correctly to avoid splicing incorrect wire pairs.

Note: Before removing the yellow connector from the seat and body harness, note the wire colors of the seat and body harness. Some wire pairs are very similar in color. Some wire pairs may have different colors. Ensure the wires are matched BEFORE splicing the wires of the seat and body harness together. Use the cutoff connector as a wire color template. BEFORE removing the connector from the harness, mark or identify wire pairs of similar color using a pen and tape to ensure the correct wires are spliced together. The first photograph shows a 4-way connector (1) and a 6-way connector (2).
