Bulletin No.: 14030B  
Date: June 2014

# Recall Bulletin

**SUBJECT:** Side Impact Airbag Connector

**MODELS:** Some 2008-2009 and all 2010-2013 Buick Enclave  
Some 2009 and all 2010-2013 Chevrolet Traverse  
Some 2008-2009 and all 2010-2013 GMC Acadia  
Some 2008-2009 and all 2010 Saturn OUTLOOK

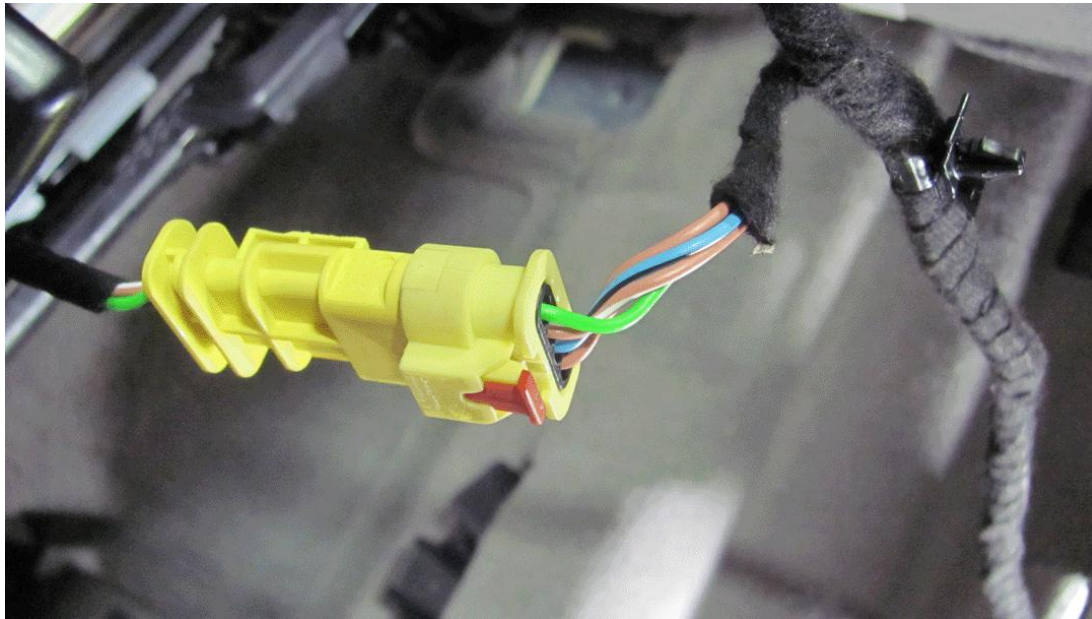
3714178

A yellow 4-way connector shown. The 2-way or 6-way yellow connector is similar.

3. Locate the yellow 2-way, 4-way, or 6-way connector under the seat.

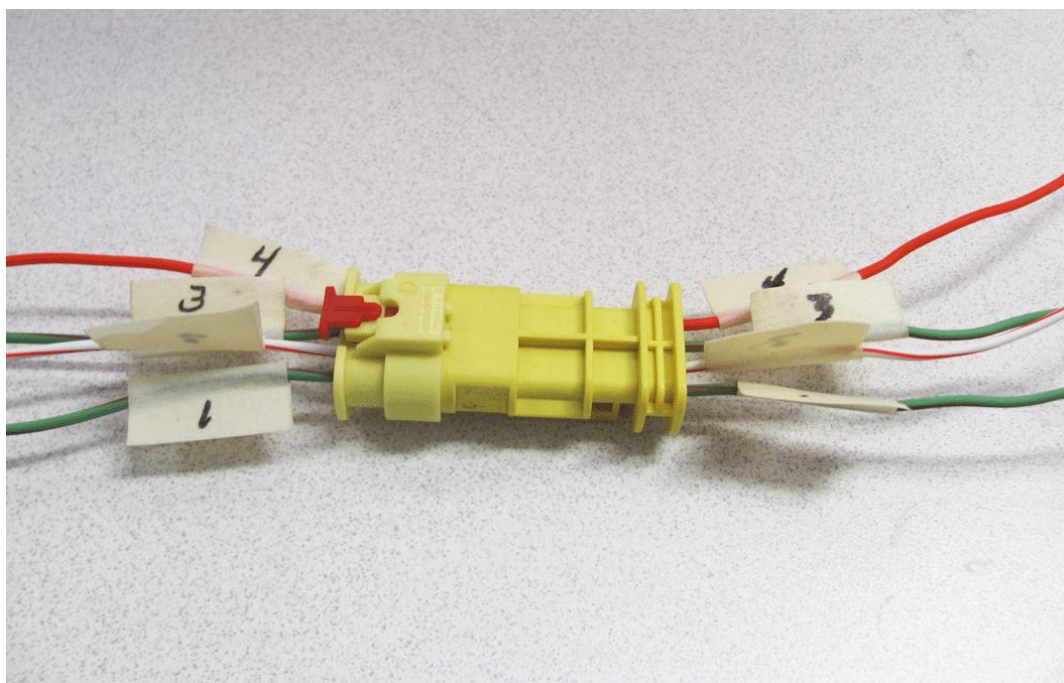
3782976

**Four-way connector shown with wire harness out of vehicle for illustration purposes. It is critical that the wire pairs are identified correctly to avoid splicing incorrect wire pairs.**

**Note:** Before removing the yellow connector from the seat and body harness, note the wire colors of the seat and body harness. Some wire pairs may be a slightly different color. Some wire pairs may have different colors. Ensure the wires are matched BEFORE splicing the wires of the seat and body harness together. Use the cutoff connector as a wire color template. BEFORE removing the connector from the harness, mark or identify wire pairs of similar color using a pen and tape to ensure the correct wires are spliced together. The first photograph shows a 4-way connector (1) and a 6-way connector (2).
