ITB14-015

VOLUNTARY SAFETY RECALL CAMPAIGN OCCUPANT CLASSIFICATION SYSTEM MODULE REPROGRAMMING

CAMPAIGN ID #: R1404

APPLIED VEHICLES: 2013 JX35 (L50)
2014 QX60 (L50)
2014 QX60 Hybrid (L50)
2014 Q50 (V37)
2014 Q50 Hybrid (V37)

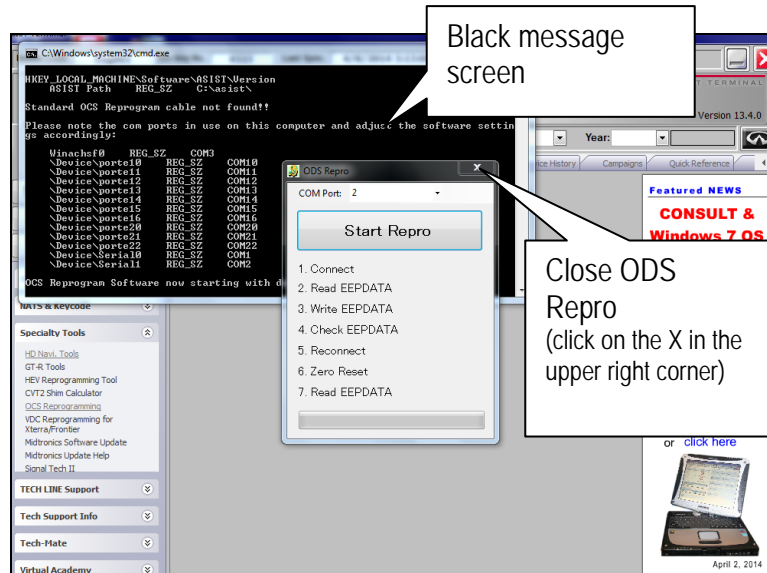
Figure 2

NOTE: If you get a black message screen as shown in Figure 2, this indicates that the reprogramming cable is not connected, or the cable driver did not install correctly.

- a. Close ODS Repro.
- b. Close ASIST.
- c. Start over from step 1.
