Recall Bulletin

PRODUCT SAFETY RECALL

SUBJECT: Front Axle Right Half Shaft Fracture

MODELS: 2013-2014 Chevrolet Cruze
Equipped with 1.4L Turbo Engine (LUV)

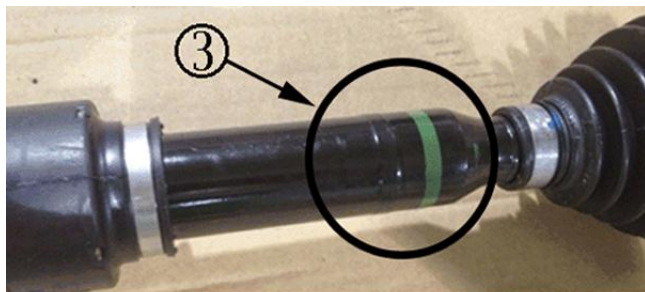
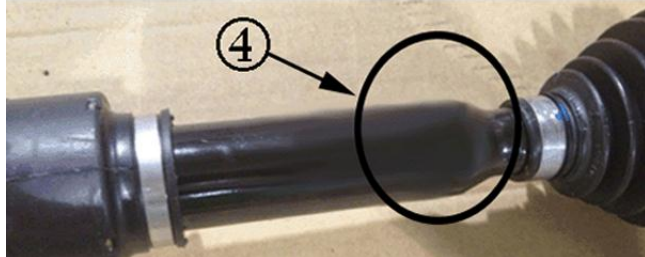
3924829

1. Inspect the inboard side of the shaft (shorter portion between rubber isolator and boot) for a green stripe, green dot or combination of green stripe and green dot.

- If one of these markings (3) are present, this is a good part.
- If there are no green markings on the inboard portion of the shaft (4) this part should be returned to General Motors under special return message G_0000187857 dated March 18, 2014 (US) or GMP 2014-073 dated March 17, 2014 (CN).

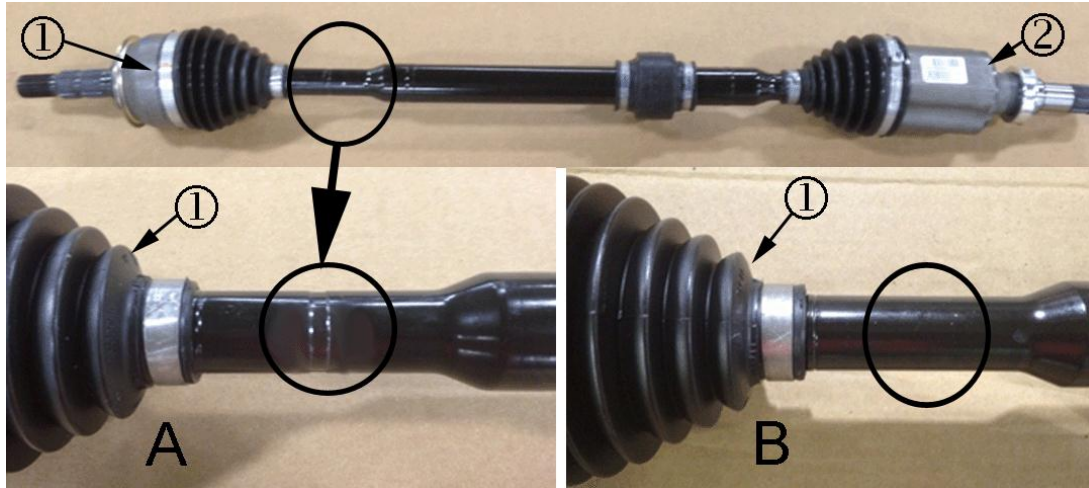
3773590

1. Raise and support the vehicle. Refer to *Lifting and Jacking the Vehicle* in SI.
2. Inspect the right (passenger side) half shaft near the front wheel. Determine if a machined groove is present on the half shaft.

(1) Wheel Side of Half Shaft (2) Transmission Side of Half Shaft (A) Machined Groove (B) No Groove

- If the machined groove is present (A) on the half shaft, no further action is required. Lower the vehicle.
 - If the machined groove is NOT present (B) on the half shaft, proceed to step 3.
3. Inspect the right (passenger side) half shaft near the transmission. Determine if a green stripe, green dot, or green stripe and green dot is present on the half shaft bar.

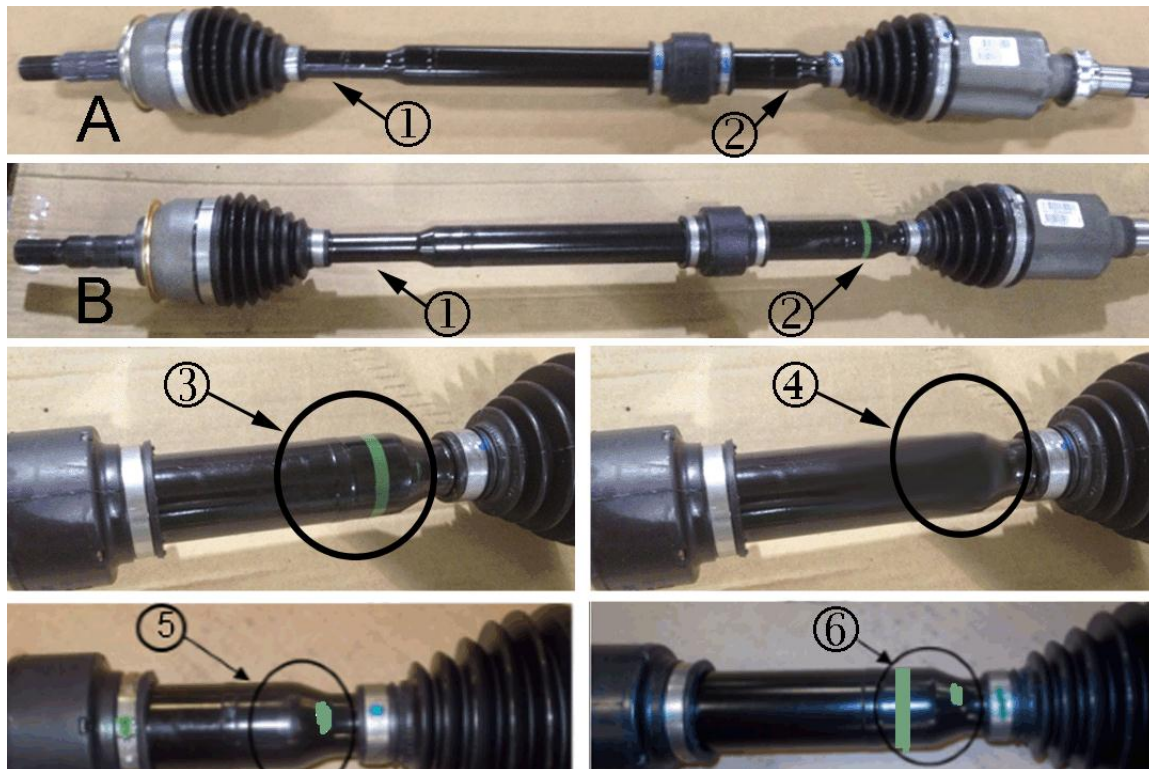
3802789

(1) Wheel Side of Half Shaft (2) Transmission Side of Half Shaft (A) Automatic Transmission (B) Manual Transmission (3) Green Stripe (4) No Stripe (5) Green Dot (6) Green Stripe and Green Dot

- If a green stripe, green dot, or a green stripe and green dot is present (3, 5, or 6) on the half shaft, no further action is required. Lower the vehicle.

Note: Replace the half shaft if a blue stripe, blue dot or no stripe (4) is present.

- If a green stripe, green dot or green stripe and green dot is NOT present on the half shaft, replace the half shaft. Refer to *Front Wheel Drive Shaft Replacement ---Right Side* in this bulletin.
