Recall Bulletin

PRODUCT SAFETY RECALL

SUBJECT: Front Axle Right Half Shaft Fracture

MODELS: 2013-2014 Chevrolet Cruze
Equipped with 1.4L Turbo Engine (LUV)

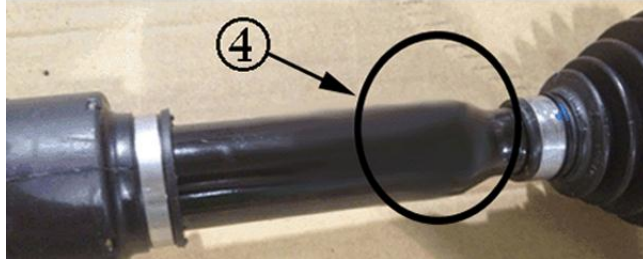
3924829

1. Inspect the inboard side of the shaft (shorter portion between rubber isolator and boot) for a green stripe, green dot or combination of green stripe and green dot.

- If one of these markings (3) are present, this is a good part.
- If there are no green markings on the inboard portion of the shaft (4) this part should be returned to General Motors under special return message G_0000187857 dated March 18, 2014 (US) or GMP 2014-073 dated March 17, 2014 (CN).

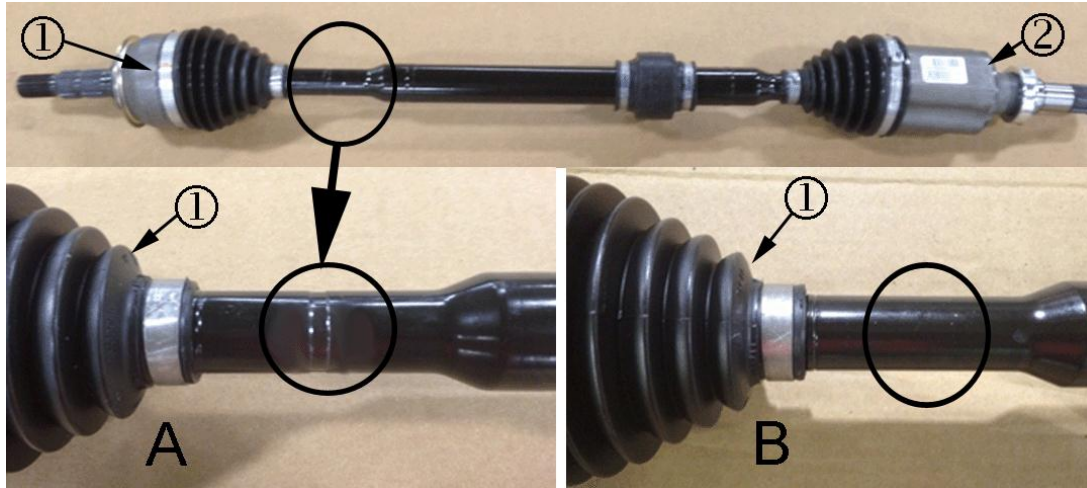
3773590

1. Raise and support the vehicle. Refer to *Lifting and Jacking the Vehicle* in SI.
2. Inspect the right (passenger side) half shaft near the front wheel. Determine if a machined groove is present on the half shaft.

(1) Wheel Side of Half Shaft (2) Transmission Side of Half Shaft (A) Machined Groove (B) No Groove

- If the machined groove is present (A) on the half shaft, no further action is required. Lower the vehicle.
 - If the machined groove is NOT present (B) on the half shaft, proceed to step 3.
3. Inspect the right (passenger side) half shaft near the transmission. Determine if a green stripe, green dot, or green stripe and green dot is present on the half shaft bar.
