Recall Bulletin

PRODUCT SAFETY RECALL

SUBJECT: Electric Power Steering Assist

MODELS: 2008 Chevrolet Malibu
2008 Pontiac G6
2008 Saturn Aura

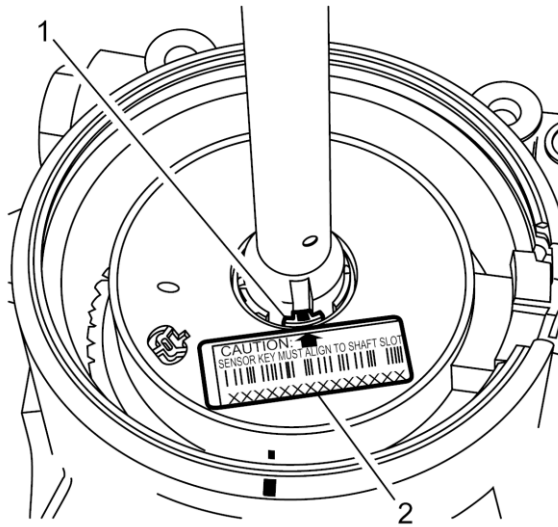
3824308

3. Document the last 9 digits of the NEW steering shaft torque sensor on the vehicle repair order. The serial number is located on the bottom of the caution label (2).
4. Remove the power steering assist motor. Refer to *Power Steering Assist Motor Replacement* in SI.
5. Install a new power steering assist motor. Refer to *Power Steering Assist Motor Replacement* in SI.
