PRODUCT SAFETY RECALL

SUBJECT: Electric Power Steering Assist

MODELS: 2009-2010 Chevrolet HHR (Non-Turbo)
2010 Chevrolet Cobalt
2004-2007 Saturn ION
Equipped with Electric Power Steering

Serviced under Safety Recall 10023 Prior to May 31, 2010

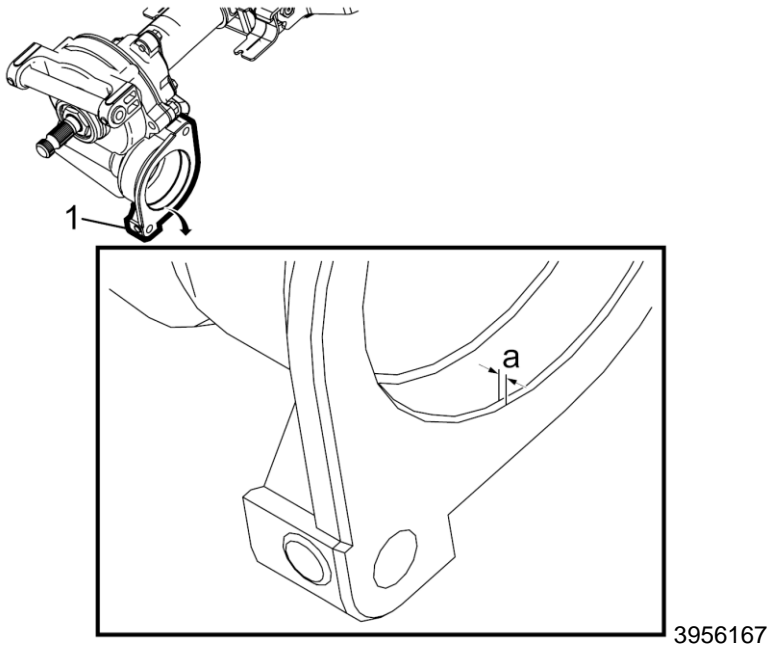
Power Steering Assist Motor Housing Inspection -- All Vehicles Except Chevrolet HHR

Caution: First design steering motor with a small chamfer does not require a seal. If a seal is installed on a first design steering motor, potential damage to the steering motor may occur resulting in loss of assist steering. Seal is only required for the second design steering motor with the larger chamfer. Before installing the power steering assist motor, inspect the power steering assist motor housing (1) to verify the steering column design.

- *First Design:* If the chamfer (a) is **1 mm (0.04 in)** and **30 degrees** then the steering column is the first design and a power steering assist motor O-ring seal is NOT needed.
- *Second Design:* If the chamfer (a) is **2.7 mm (0.11 in)** and **45 degrees** then the steering column is the second design and a NEW power steering assist motor O-ring seal IS needed.
