Recall Bulletin

PRODUCT SAFETY RECALL

SUBJECT: Electric Power Steering Assist

MODELS: 2004-2006 Chevrolet Malibu, Malibu Maxx
2008-2009 Chevrolet Malibu
2005-2006 Pontiac G6
2008-2009 Pontiac G6
2008-2009 Saturn Aura
Equipped with Electric Power Steering

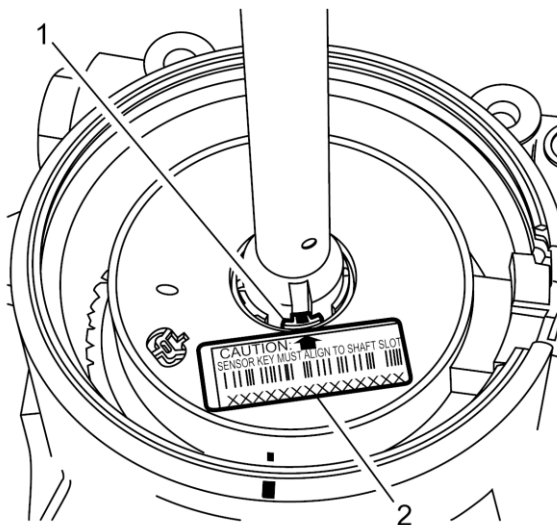
3824308

3. Document the last 9 digits of the NEW steering shaft torque sensor on the vehicle repair order. The serial number is located on the bottom of the caution label (2).
